TOWN OF HOPKINTON

CULVERT ASSESSMENT FOR

AQUATIC ORGANISM PASSAGE

HOPKINTON CONSERVATION COMMISSION

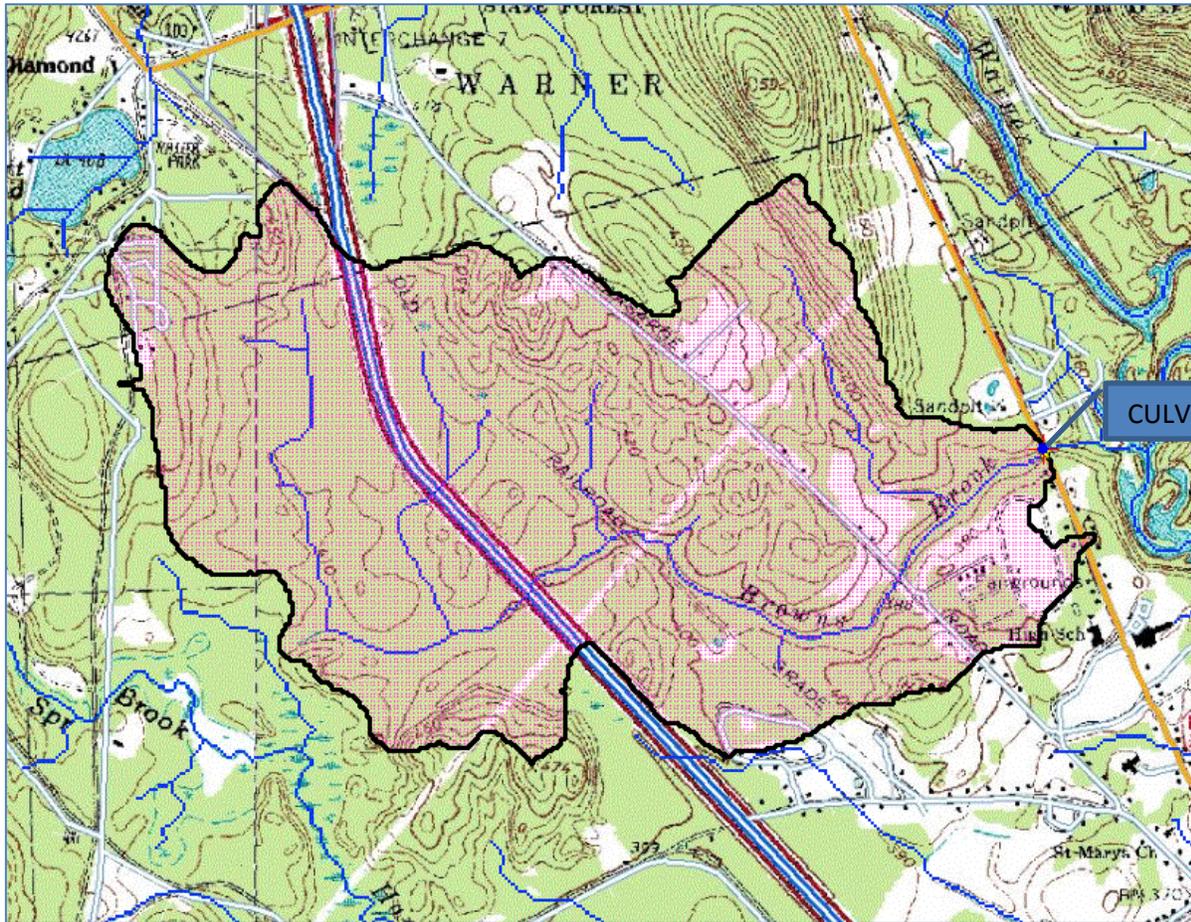
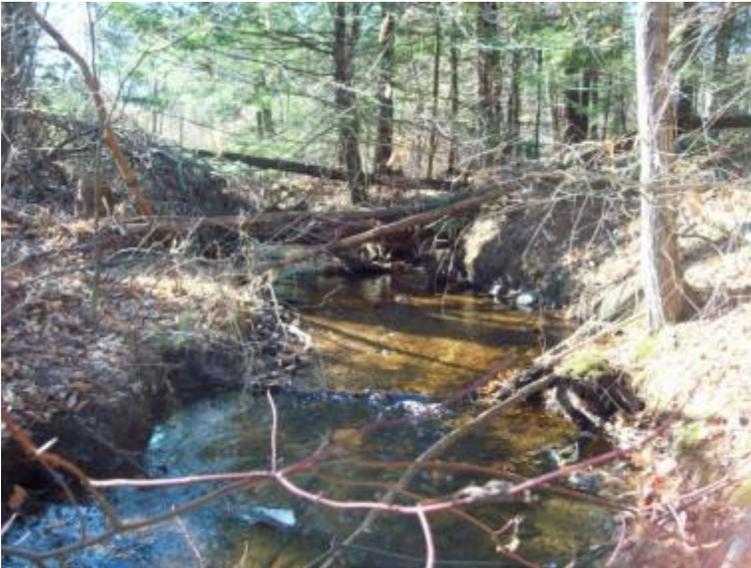
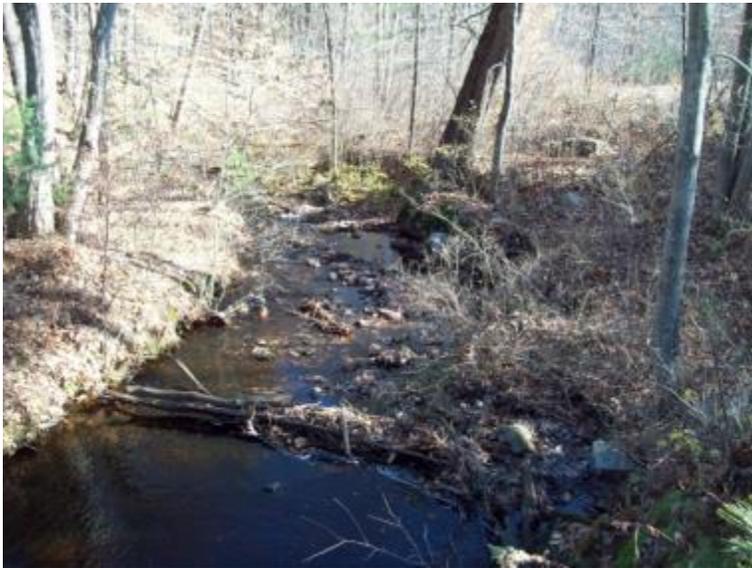
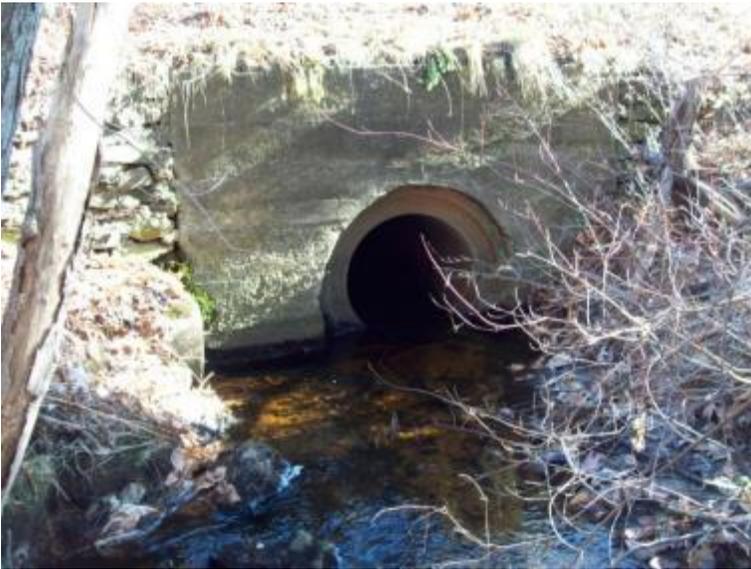
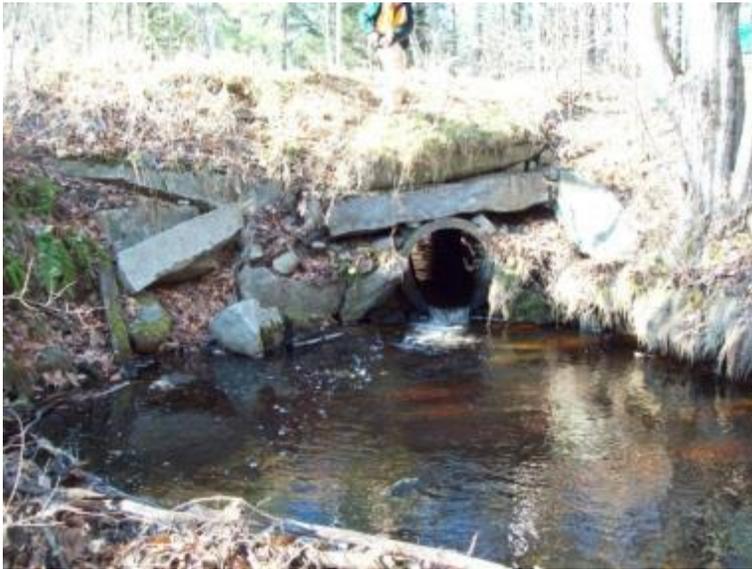
Browns Brook under Route 103 (BB1)

The Browns Brook culvert under Route 103 is north of a Fairgrounds entrance. The culvert is a 3-foot diameter, 50 foot long concrete culvert. It appears to be intact, although the bank armoring is failing on the downstream end, and there is some undercutting of the culvert and wing walls. The slope of the pipe is lower than the stream slope, but the water depth and velocity are similar to the stream channel. The outlet is slightly perched above the stream level (5-inch drop) and there is a 2.5-foot deep pool below the outlet. There is some bank erosion and sediment aggradation downstream of the pipe.

AQUATIC ORGANISM PASSAGE CONDITION: POOR

RECOMMENDATION: REPLACE (LONG TERM)

The state or town may wish to inspect the structural integrity of the structure, especially at the downstream end. When the culvert is replaced, the road reconstructed, or other opportunities arise, the culvert should ideally be replaced with a larger structure that spans the bankfull width.

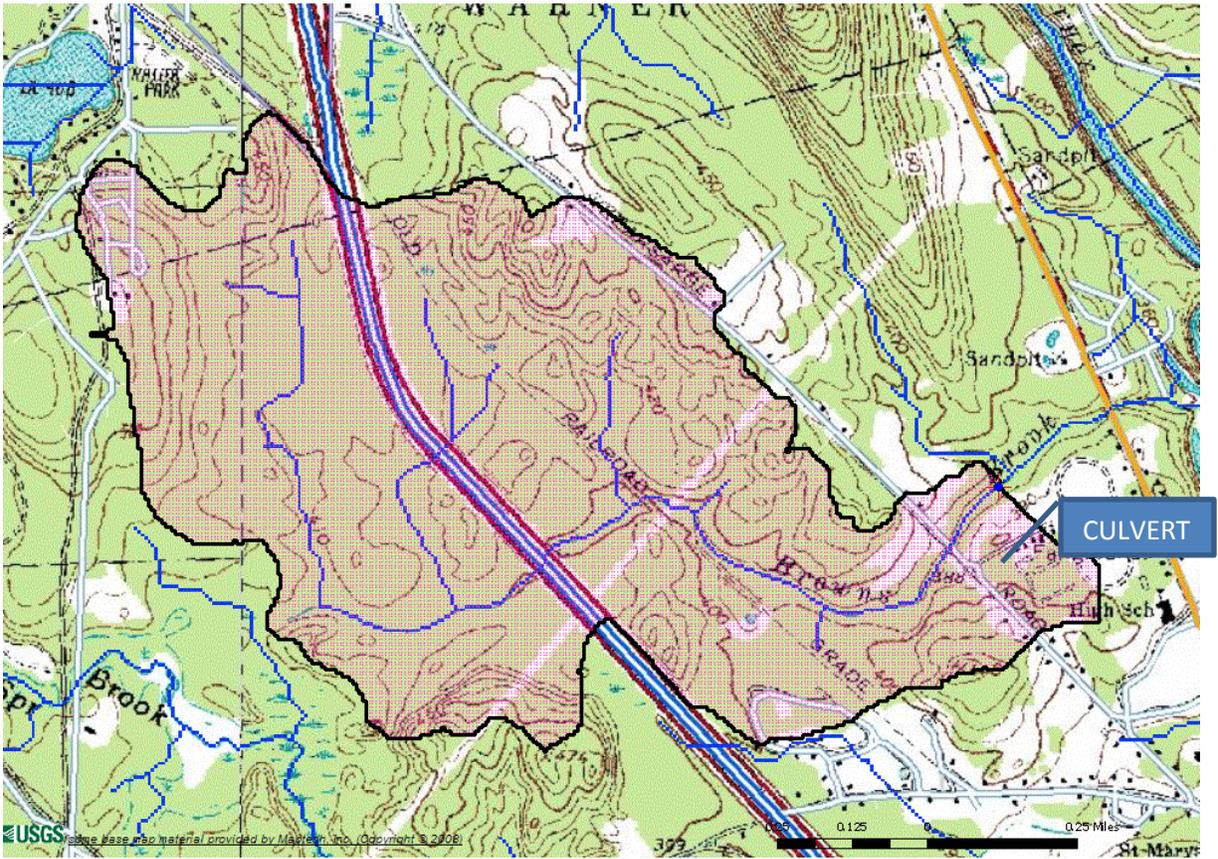
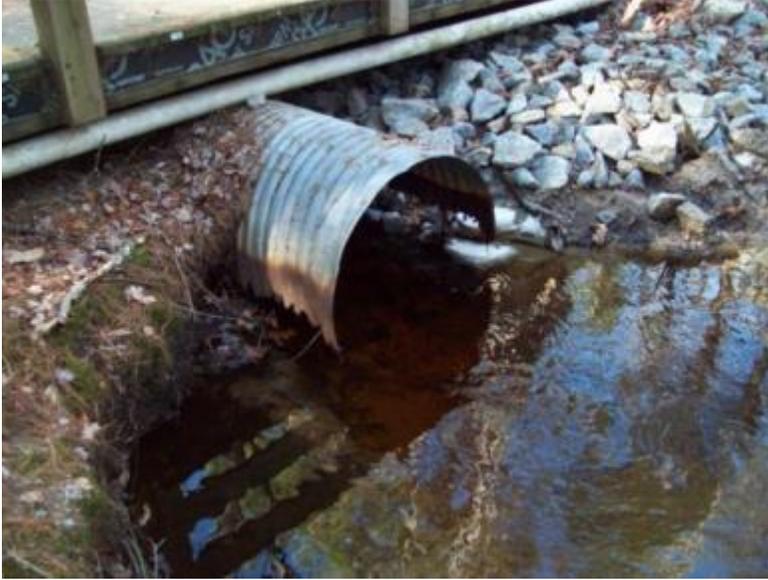
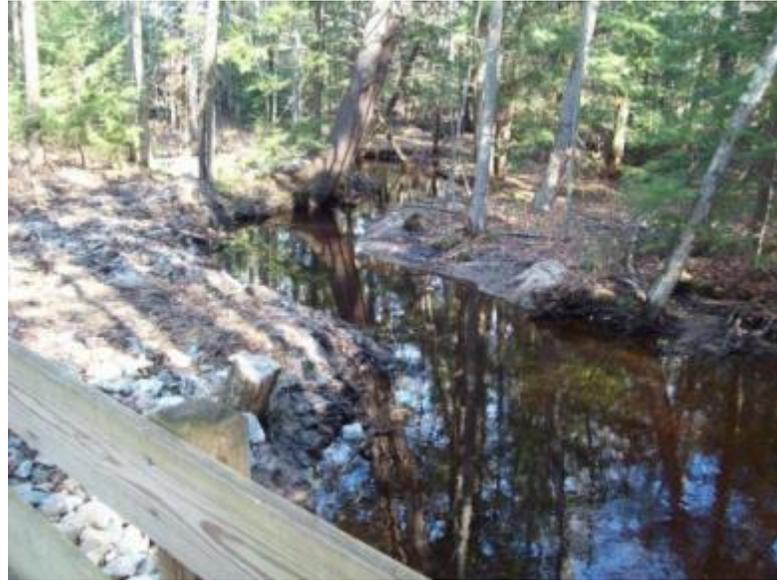
Browns Brook in Fairgrounds (East) (BB2)

This Browns Brook culvert is within the Fairgrounds under a parking lot entrance within the Fairgrounds. The culvert is a heavily rusted, 3-foot diameter, 20 feet long corrugated metal pipe under a relatively new wooden bridge. The bottom half of the culvert appears to be completely rusted away. The inlet is partially obstructed by sandbags and rip rap. There is a sharp, almost 90-degree bend in the brook on the upstream side, and it appears there had been some recent erosion and repairs, evidenced by the sandbags and riprap.

AQUATIC ORGANISM PASSAGE CONDITION: GOOD

RECOMMENDATION: REMOVE OLD CULVERT AND IMPROVE CHANNEL UNDER BRIDGE

The landowner may wish to remove the rusted metal pipe and allow the brook to flow freely under the new bridge. If this is done, a more natural channel should be constructed under the bridge.

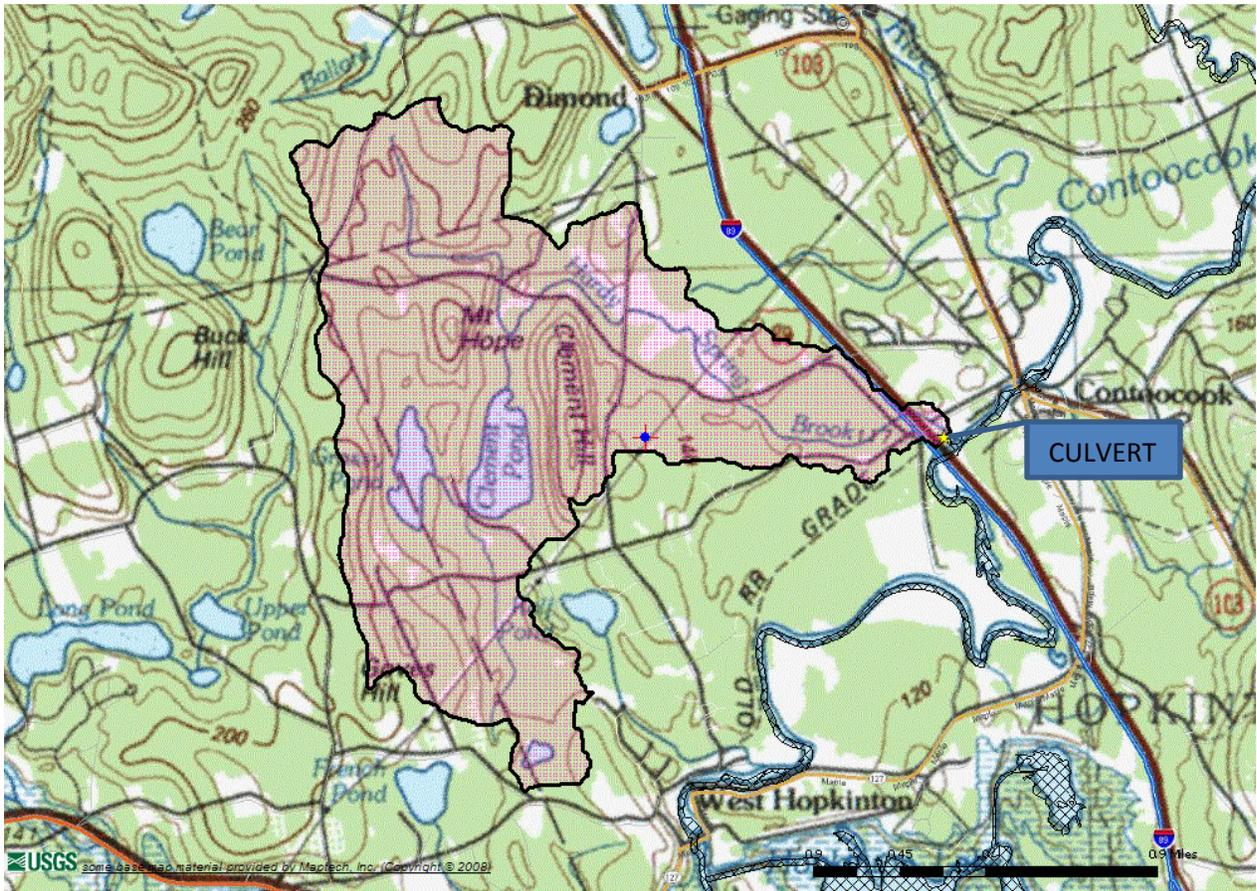
Hardy Spring Brook under Railroad Grade (HSB1)

This is an old stone structure under the former railroad line, between the Contoocook River and Pine Street. It is 3 feet wide and 5 feet high and approximately 40 feet long. It is in line with the stream channel and matches the stream slope and depth. However, it is failing in the downstream portion of the structure, with several of the culvert's large quarry stones collapsed into the stream channel. This appears to have caused some erosion and collapsing of the railroad grade's banks.

AQUATIC ORGANISM PASSAGE CONDITION: FAIR

The culvert appears to be failing and if it is not repaired may cause the collapse of the railroad grade. Collapse of the railroad grade would dam the brook, affecting fish passage and possibly flooding upstream properties and roadways.

RECOMMENDATION: REPAIR OR REPLACE

The structure appears close to completely failing. If this rail trail is no longer important, the structure could be removed altogether, or a bridge or substantially larger culvert could be installed in its place.

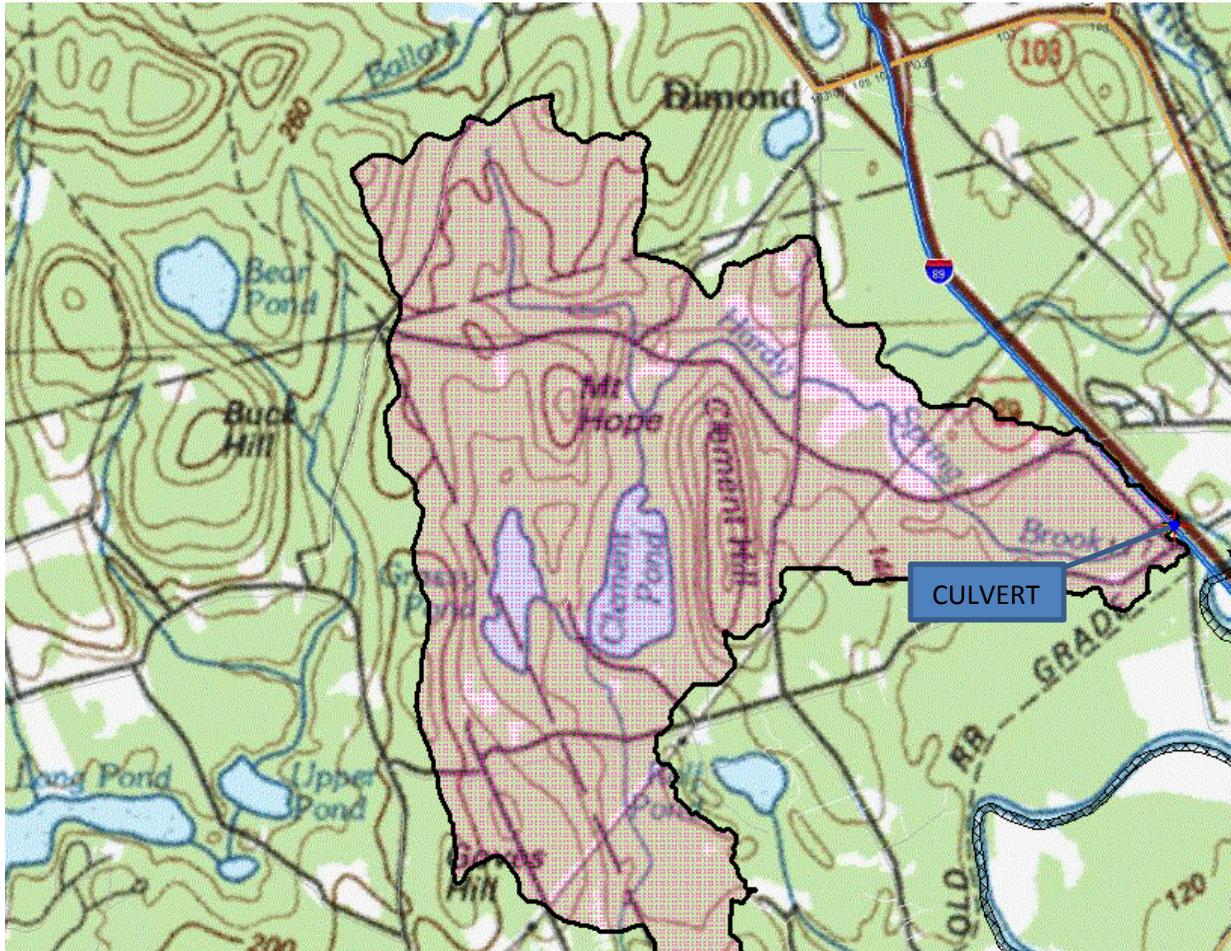
Hardy Spring Brook under I-89 Northbound (HSB3)

AQUATIC ORGANISM PASSAGE CONDITION: POOR

The structure is long and is narrower than the bankfull width (16 to 20 feet), but may be able to provide fish passage under appropriate water conditions.

RECOMMENDATION: REPLACE (LONG TERM)

Over the long term, a larger structure with a natural substrate should be installed, but the length and location under the interstate will make replacement expensive.

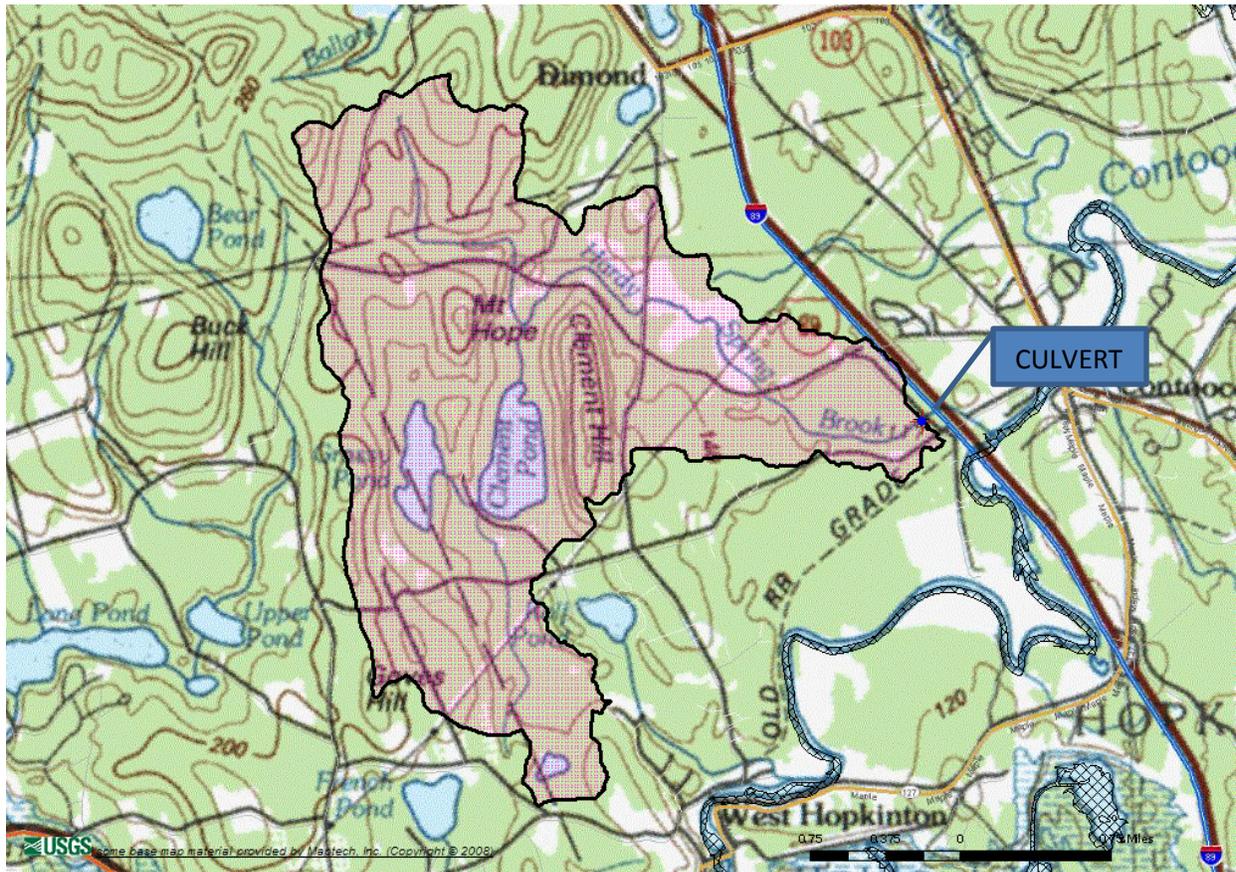
Hardy Spring Brook under I-89 Southbound (HSB4)

AQUATIC ORGANISM PASSAGE CONDITION: POOR

The structure is narrower than the bankfull width (14 feet), flat-bottomed and shallow, but may be able to provide fish passage under higher water conditions.

RECOMMENDATION: REPLACE (LONG TERM)

Over the long term, a larger structure with a natural substrate should be installed.

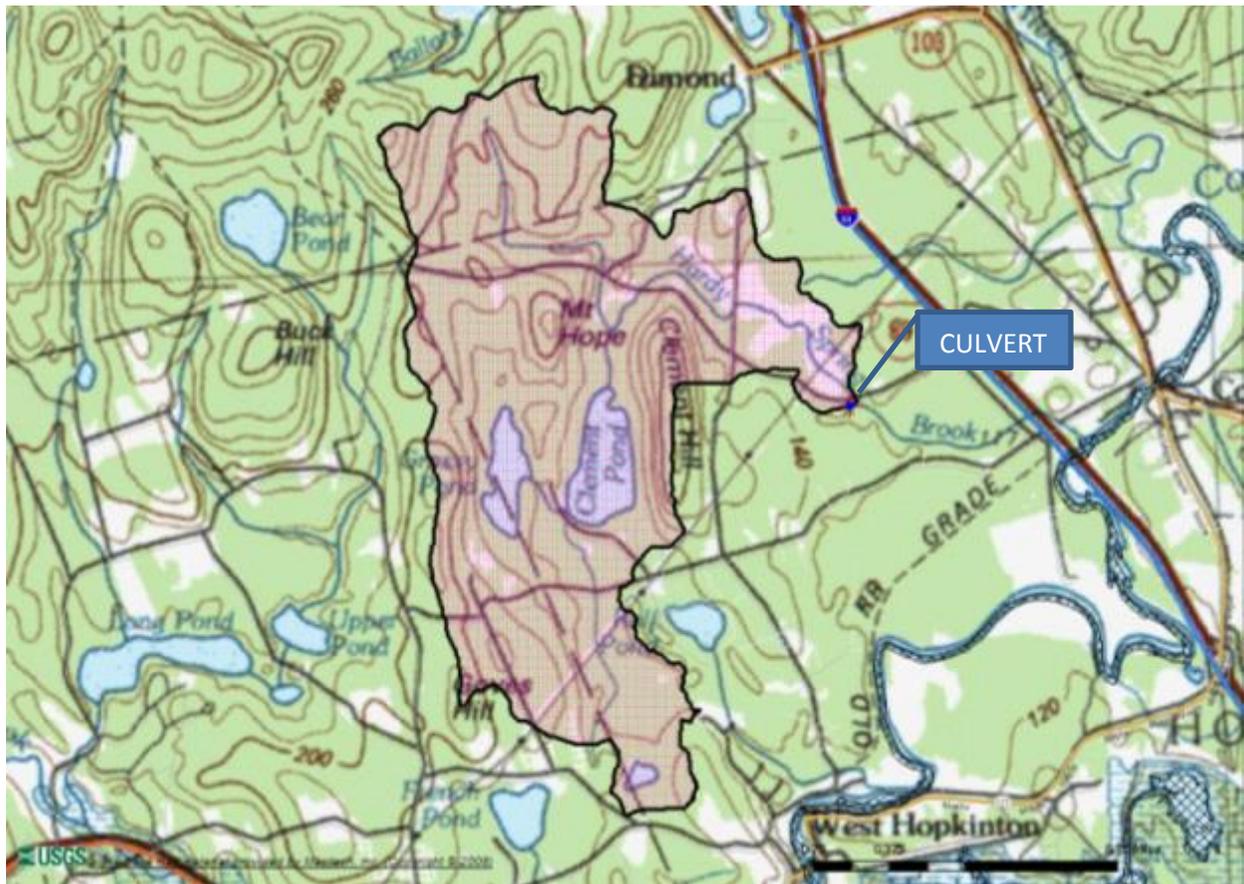
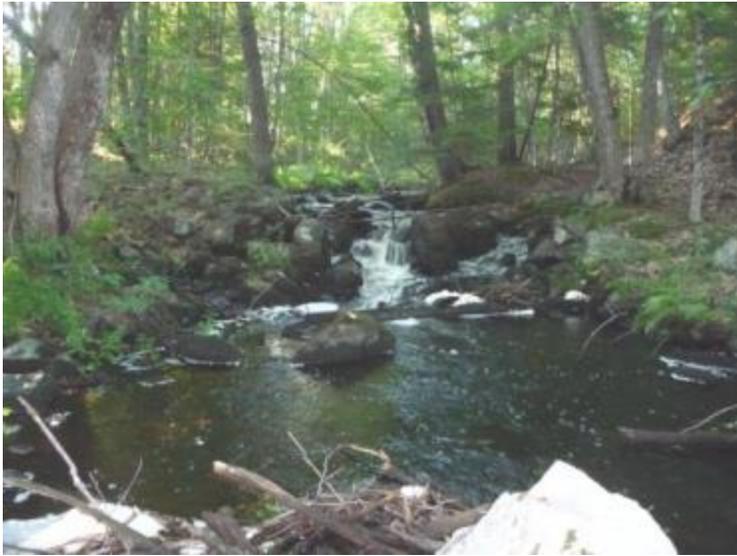
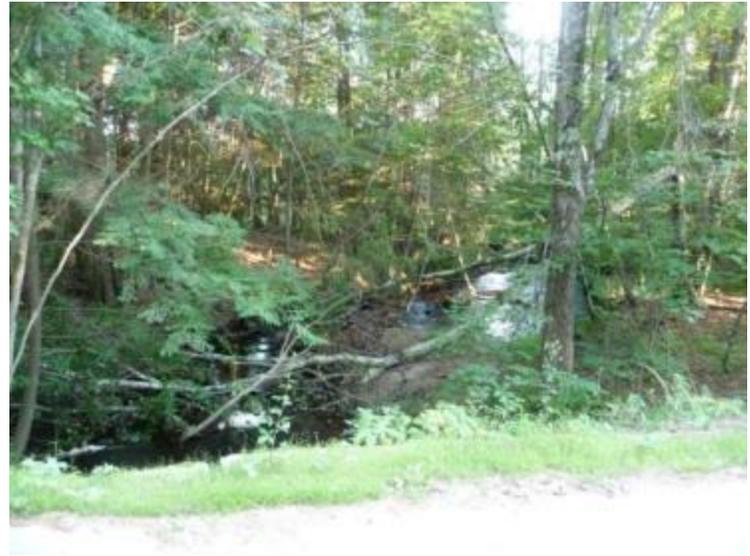
Hardy Spring Brook under Bound Tree Road #2 (HSB6)

AQUATIC ORGANISM PASSAGE CONDITION: FAIR

RECOMMENDATION: REPLACE (NEAR TERM)

A larger structure spanning the bankfull width should be installed.

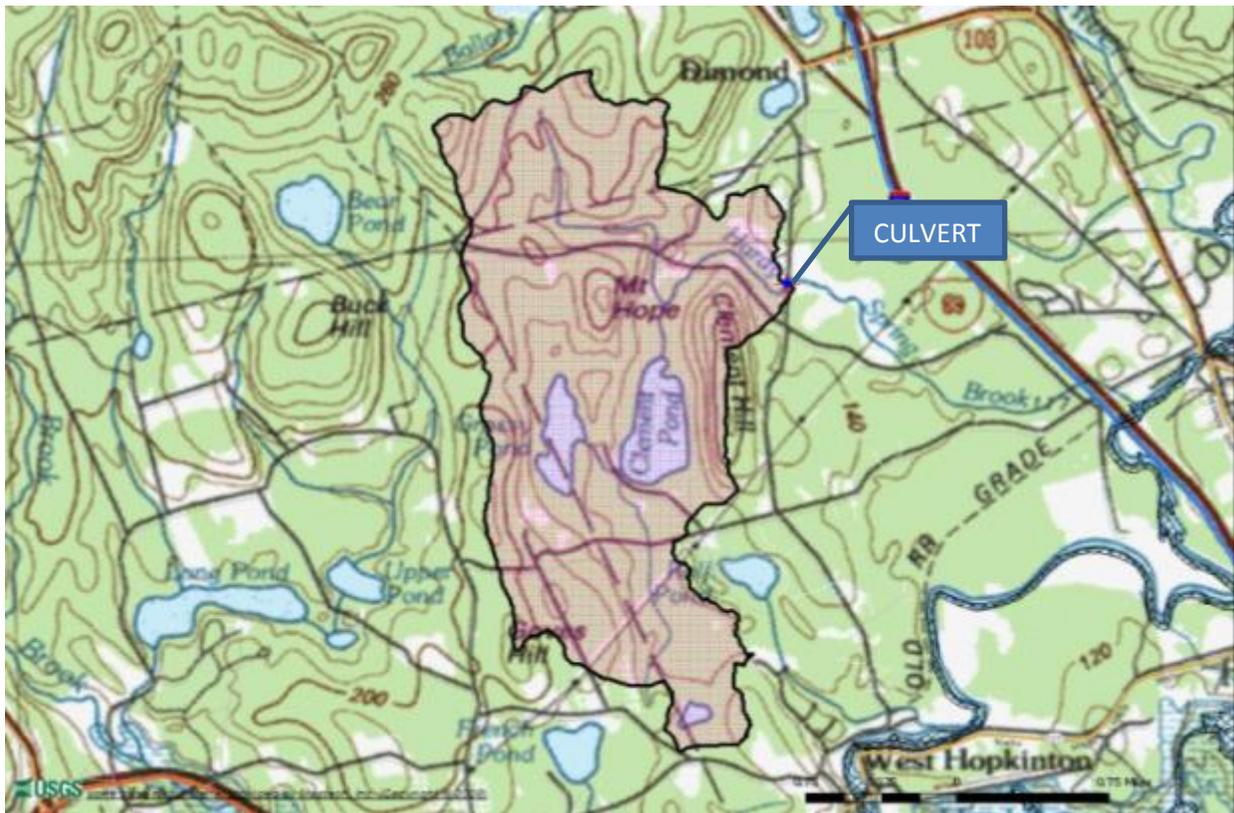
Hardy Spring Brook under Clement Hill Road (HSB7)

This is a 4 foot diameter, heavily rusted corrugated metal pipe, about 36 feet long, under Clement Hill Road. Part of the culvert has rusted through. There is a ponded shrub swamp on the upstream side but no pool on the downstream side. The culvert is generally in line with the stream channel and has a similar slope, water depth (15 inches) and water velocity. There is no natural substrate within the pipe, except where it has rusted through. There is a modest amount of erosion and aggradation downstream of the structure.

AQUATIC ORGANISM PASSAGE CONDITION: FAIR

The culvert is heavily rusted and is undersized, but has some aquatic organism passage capability.

RECOMMENDATION: REPLACE (NEAR TERM)

A larger structure spanning the bankfull width should be installed.

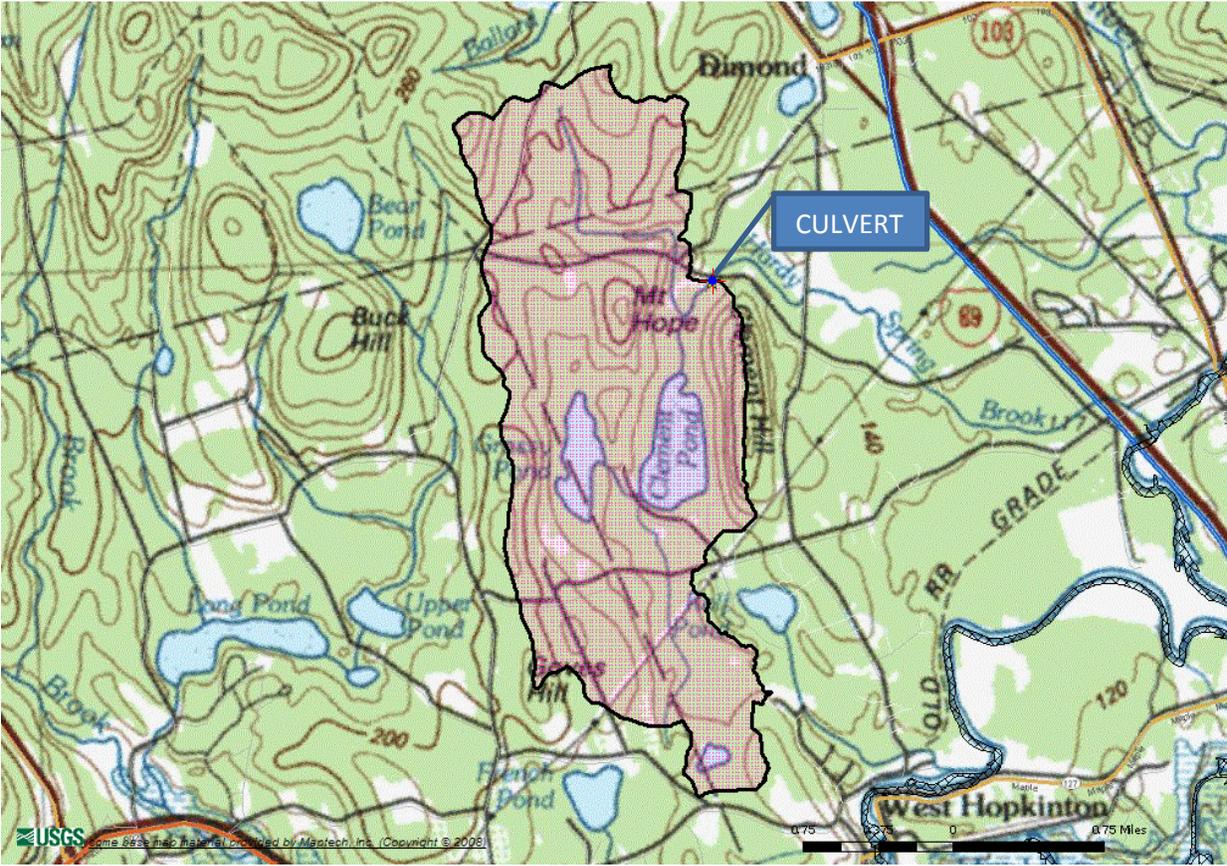
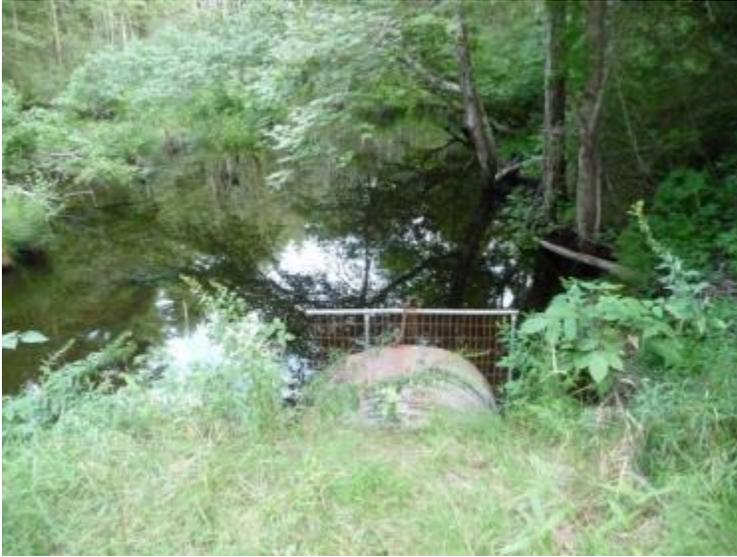
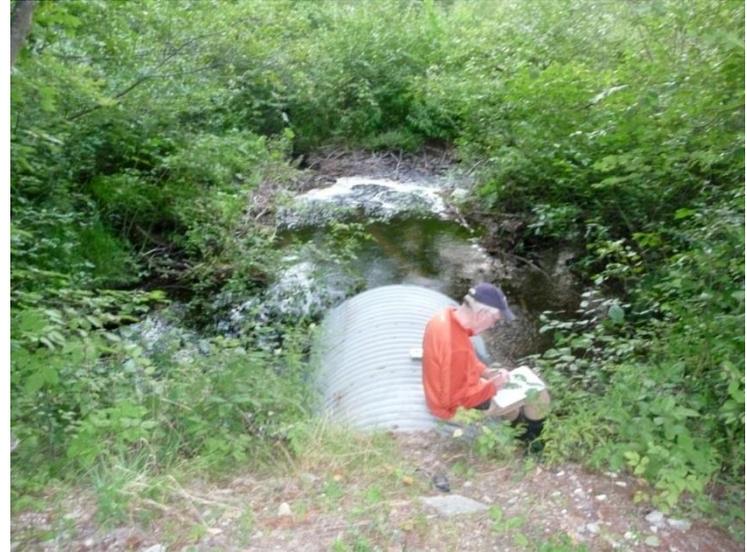
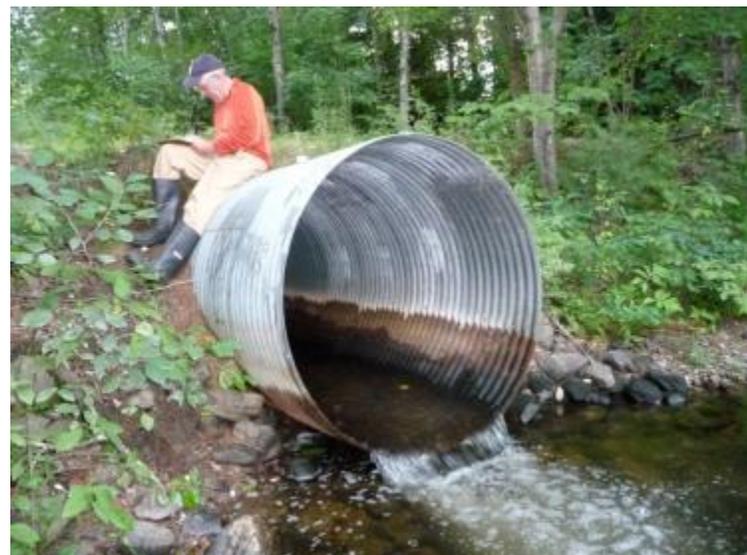
Hardy Spring Brook under Bound Tree Road (HSB8)

This is a 5 foot diameter corrugated metal pipe, about 60 feet long, under Bound Tree Road. The stream is ponded on the upstream side and there is a 3 foot deep pool on the downstream side. The outlet is perched above the stream surface, 3 inches at the time of the survey under relatively high flow conditions. The culvert is generally in line with the stream channel and has a similar slope, but velocity is faster within the culvert. There is no natural substrate within the pipe. The bank and bank armoring at the downstream end of the culvert has eroded away, resulting in the culvert end being exposed and perched. There is some erosion and aggradation downstream of the structure.

AQUATIC ORGANISM PASSAGE CONDITION: POOR

The perched condition of the outlet probably prevents many aquatic species from passing through the structure much of the year. The condition is probably worse in low water.

The culvert is showing rust, there is erosion around the outlet, and the outlet is perched.

RECOMMENDATION: REPLACE (NEAR TERM)

A larger structure should be installed, but the impact on water levels in the upstream ponded area and swamp should be taken into consideration in planning and design.

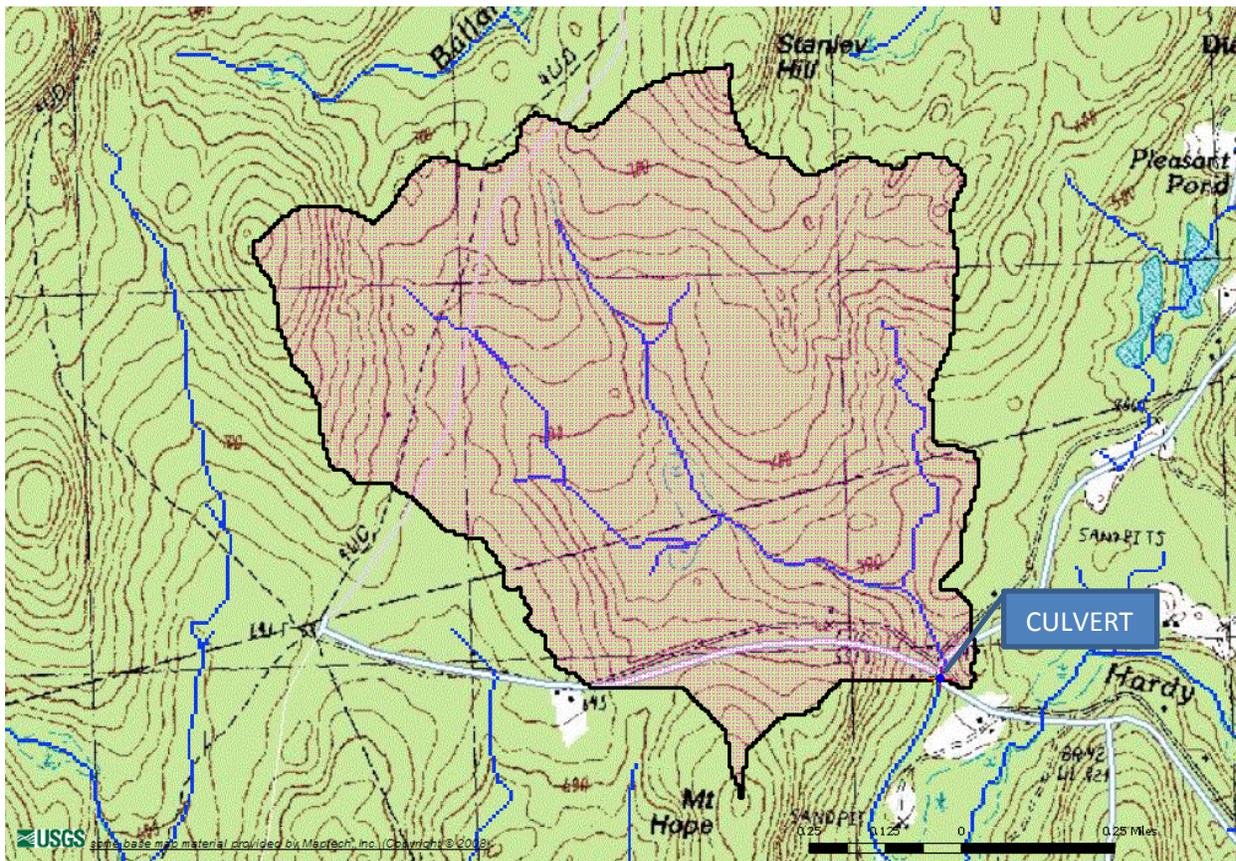
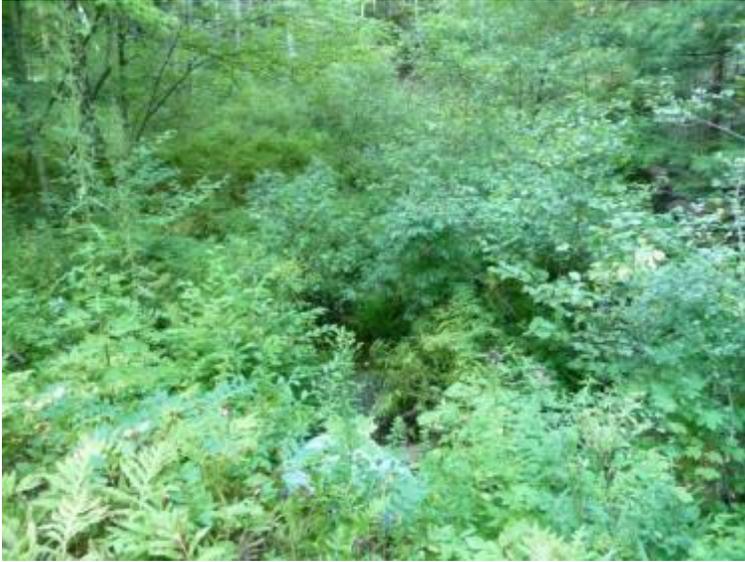
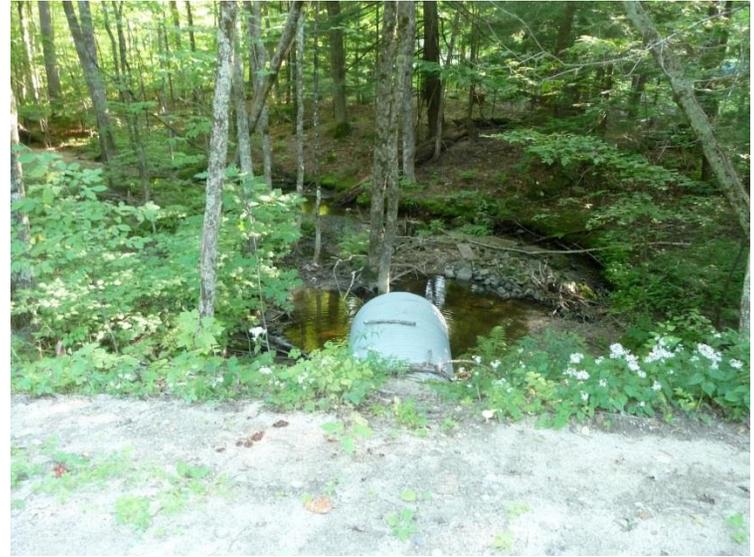
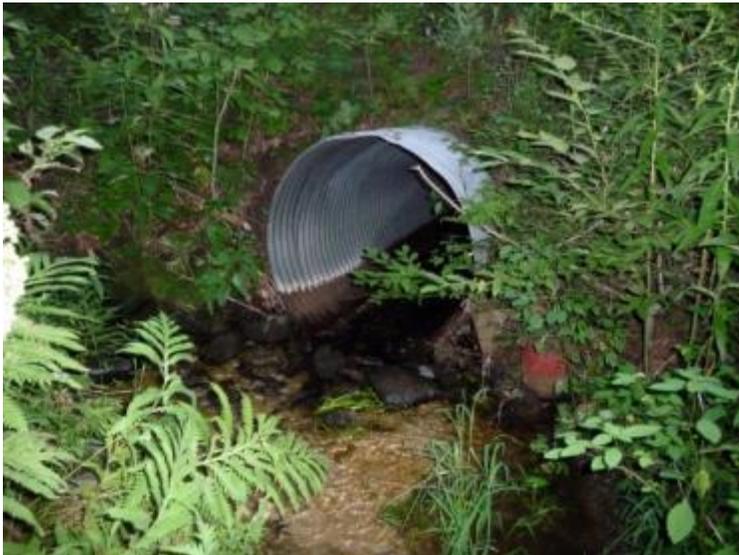
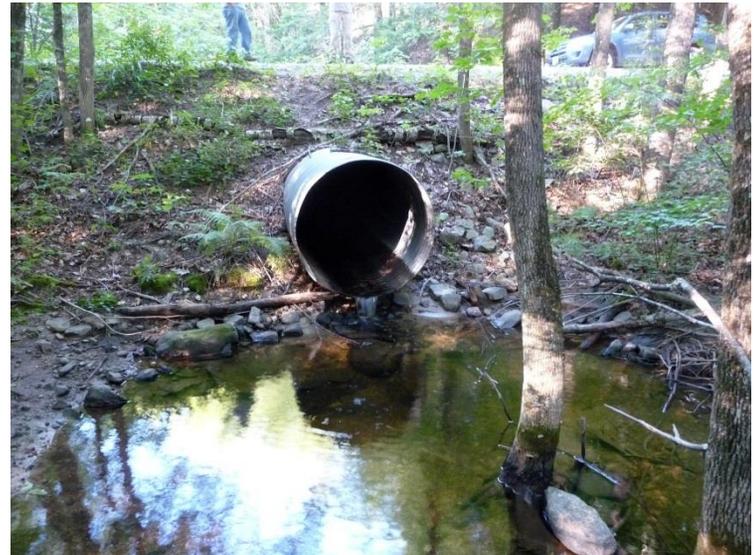
Unnamed Stream (Tributary of Hardy Spring Brook) under Bound Tree Road (US1)

AQUATIC ORGANISM PASSAGE CONDITION: POOR

The perched condition of the outlet may prevent most aquatic species from passing through the structure. The pipe is much smaller than the bankfull width (about 12 feet).

The culvert is showing rust, there is erosion around the outlet, and the outlet is perched.

RECOMMENDATION: REPLACE (LONG TERM)

When the culvert is due for replacement, a larger structure should be installed at stream grade.

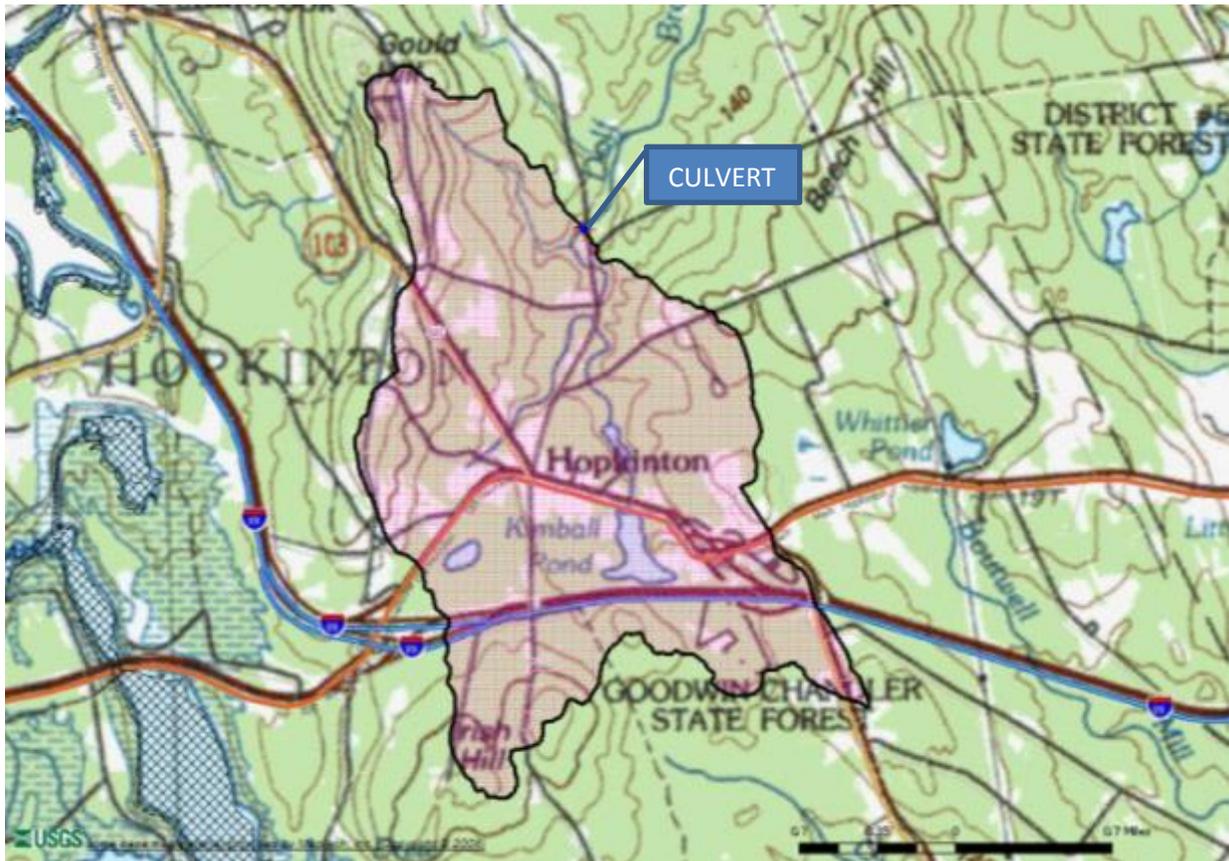
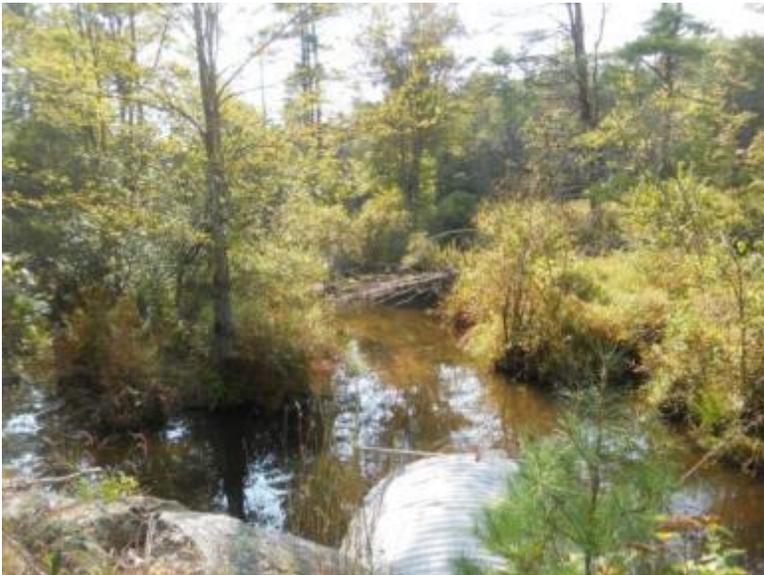
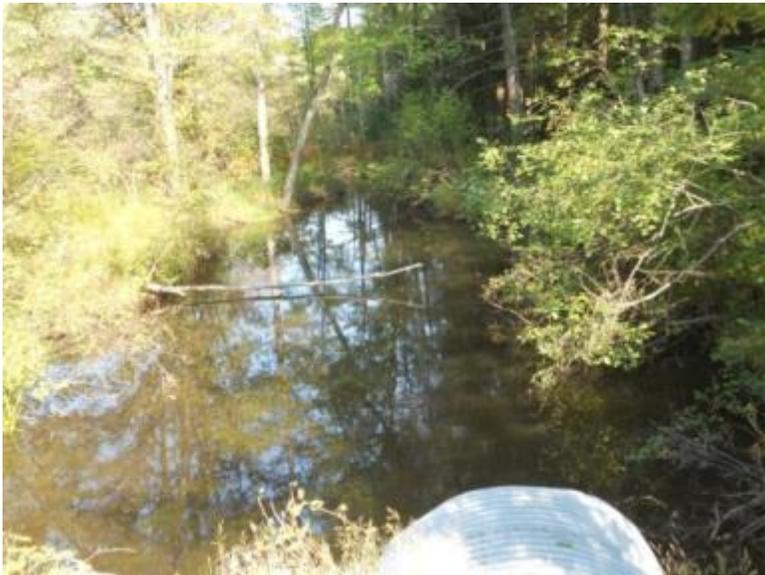
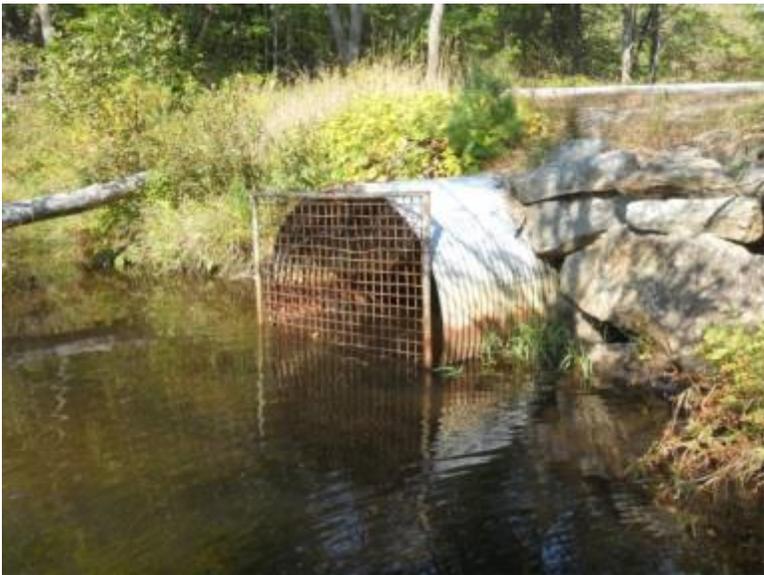
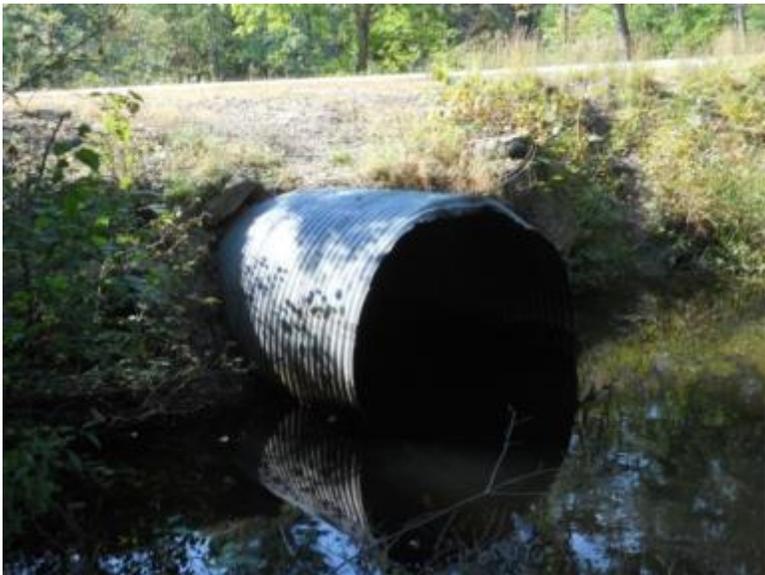
Dolf Brook under Briar Hill Road #1 (DB2)

This is a 6 foot diameter corrugated metal pipe, about 65 feet long, under Briar Hill Road north of Patch Road. The channel is sluggish here, with a sand and silt substrate. The culvert seems to have a similar slope, water depth and water velocity as the stream channel, and there was 2.2 feet of water and a sand/silt substrate within the pipe. There is rust on the lower half of the culvert. The bank and bank armoring at both ends of the culvert are intact. There is some sediment aggradation upstream and downstream.

AQUATIC ORGANISM PASSAGE CONDITION: MODERATE

RECOMMENDATION: REPLACE (LONG TERM)

When replacement is warranted, a larger structure should be installed at stream grade.
