TOWN OF HOPKINTON

CULVERT ASSESSMENT FOR

AQUATIC ORGANISM PASSAGE

HOPKINTON CONSERVATION COMMISSION

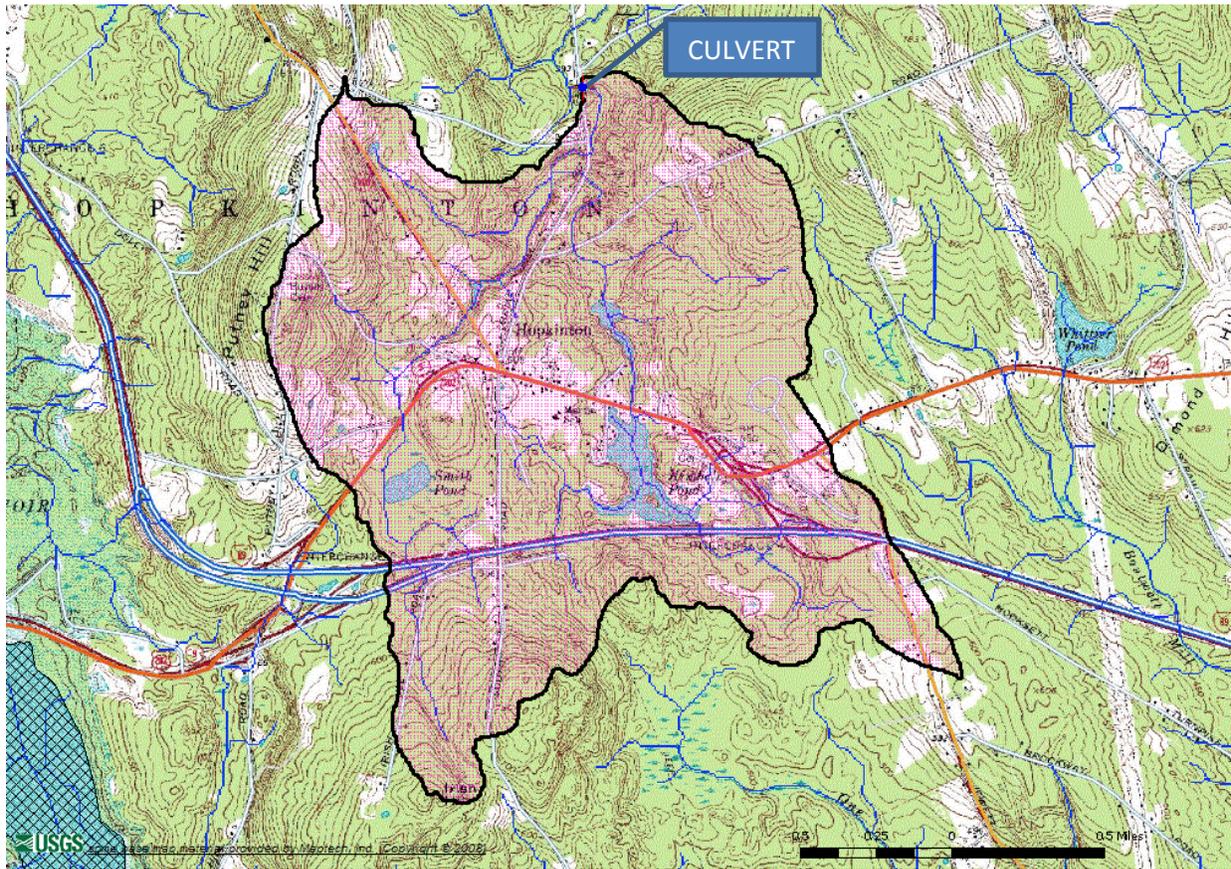
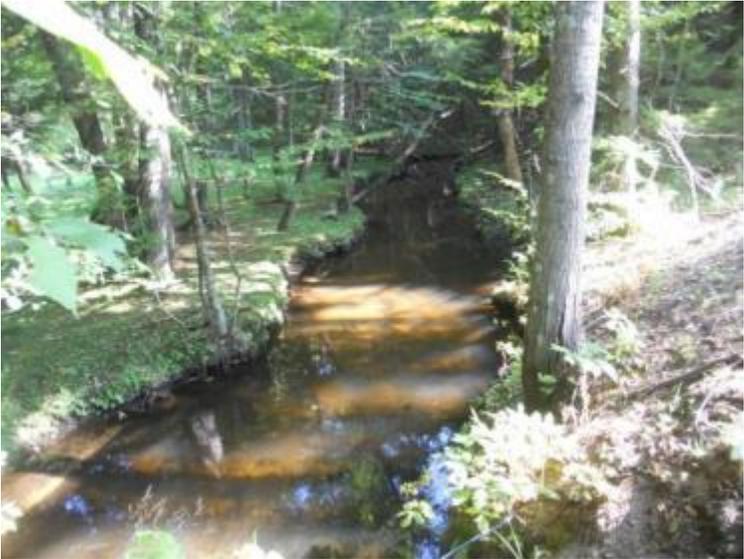
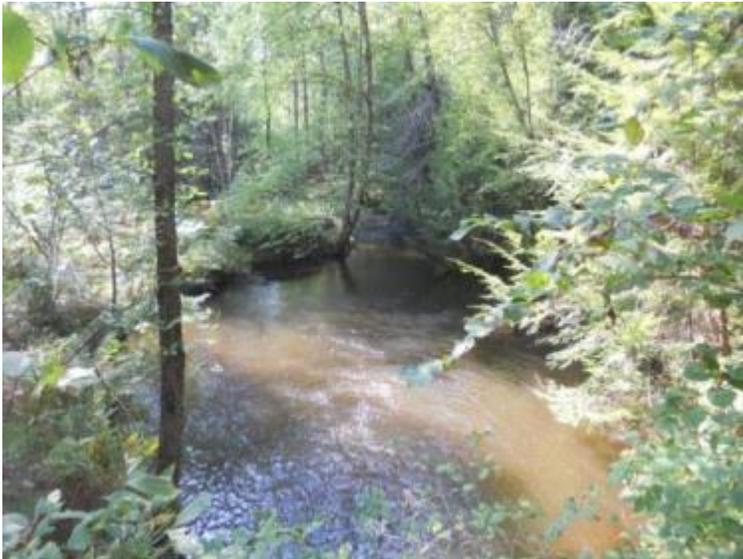
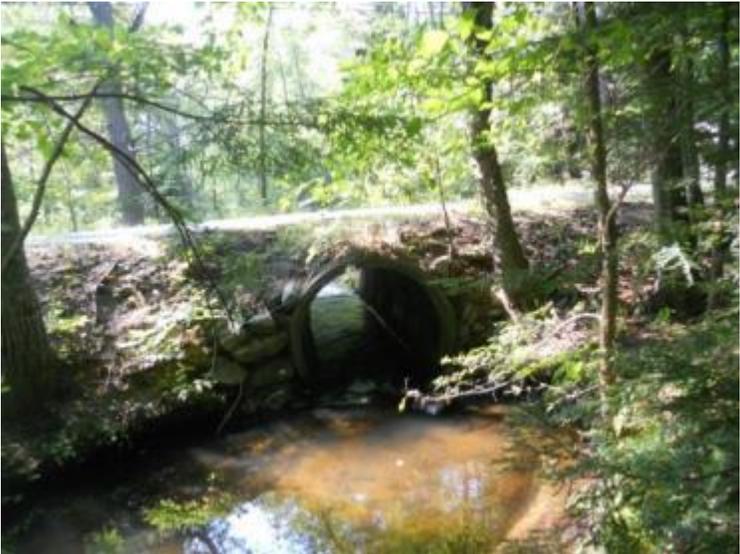
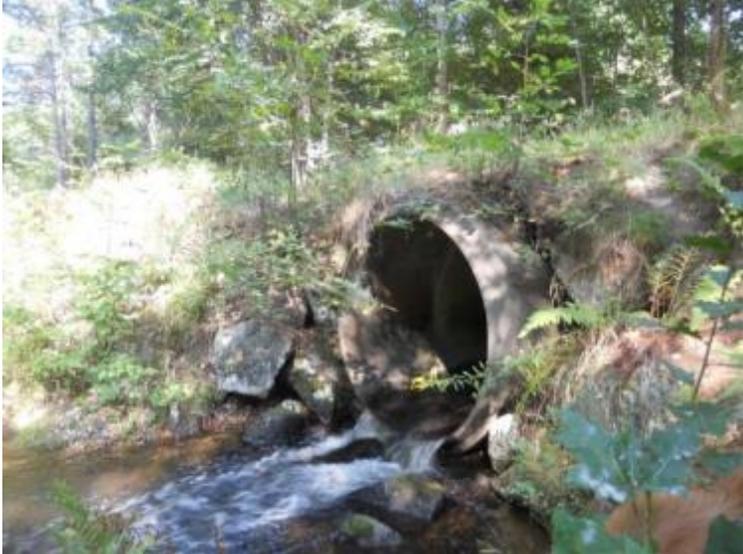
Dolf Brook under Briar Hill Road #2 (DB3)

AQUATIC ORGANISM PASSAGE CONDITION: POOR

A larger structure should be installed at stream grade.
