# The Houston Barn Committee Report

**December 20, 2021**

**Houston Barn Committee**  
**Report to the Hopkinton Select Board**  
**December 20, 2021**

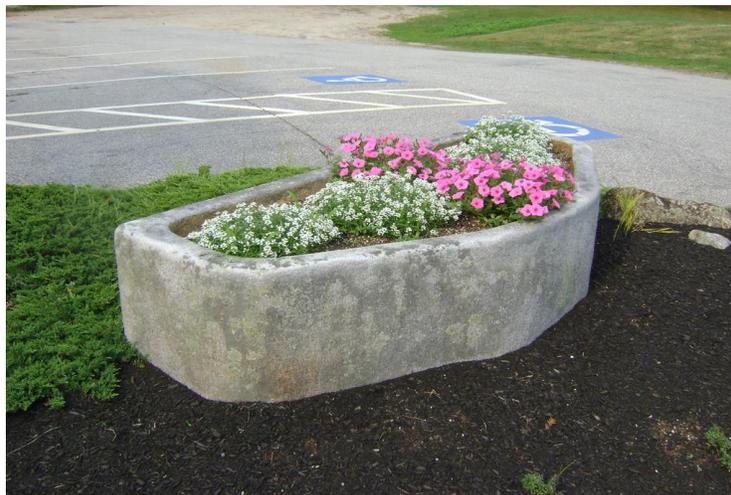
*Photo #1- Hewn granite water trough, previously located at Houston Barn.*

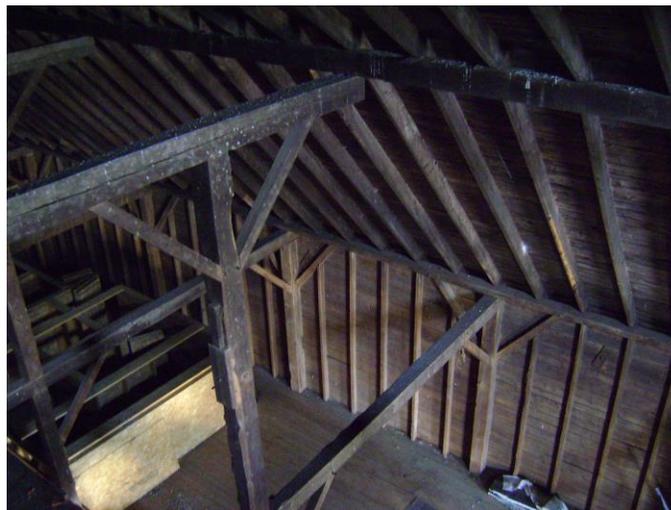
*Photo #2 - Typical view of barn frame showing heavy timber "bents" and "balloon" type wall studding.*

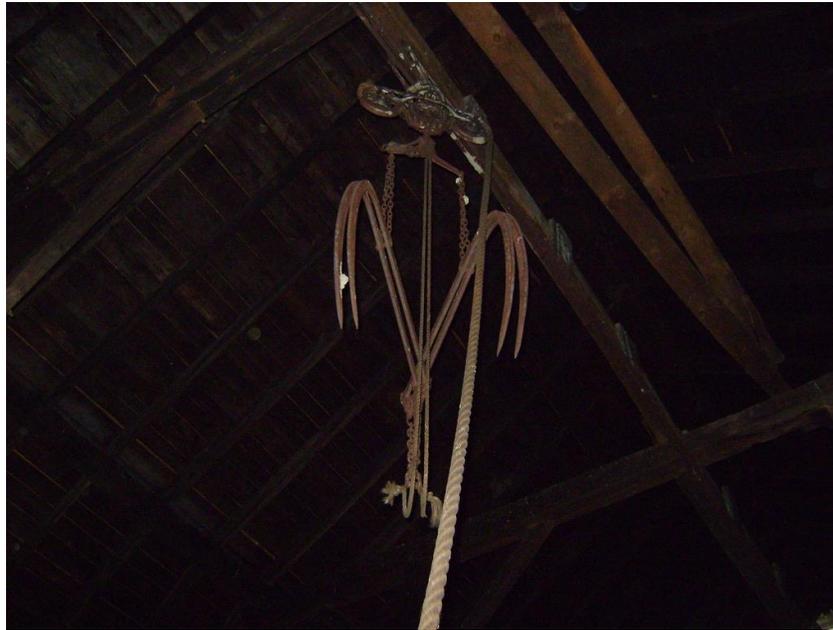
*Photo #3 - Meyers Clover Leaf Unloader hay forks and trolley in situ.*

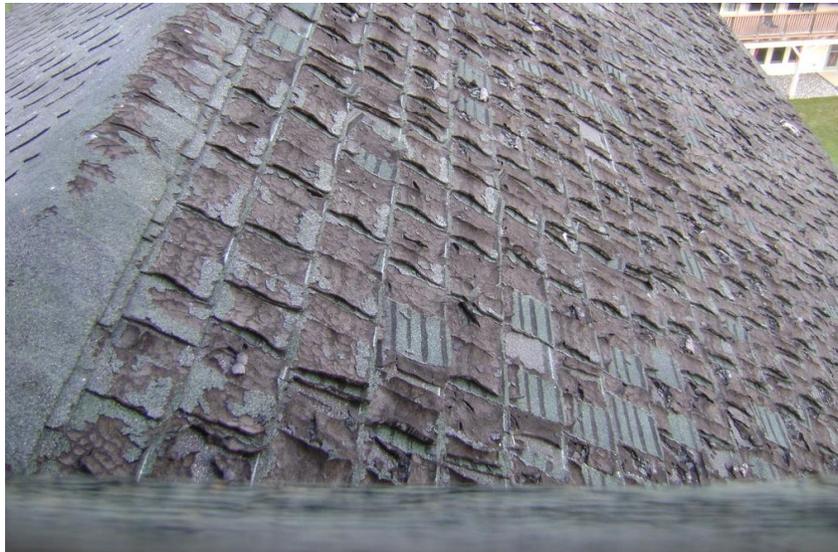
Barns live or die by their roofs. Vast numbers have been forever lost from this factor alone. Fortunately, the Houston barn was re-roofed in recent memory and this undoubtedly saved it. Unfortunately, as with many other buildings in recent decades, it has suffered the catastrophic premature failure of the asphalt shingles used. They are in very poor condition, especially on the west side. The east side is not as bad yet, but sure to follow.

*Photo #4 - Roof shingles in extreme failure, west side.*

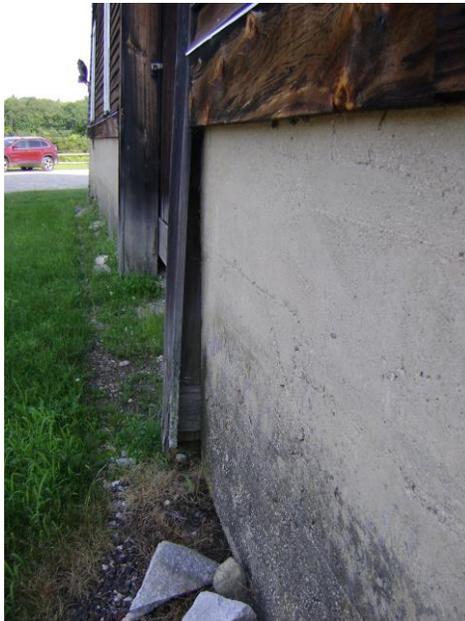
The stem-wall on the west side, however, does have more visible issues. Although the barn's elevations remain true, and no overall settling is evident, cracking and distortion of the (un-reinforced?) concrete is readily visible, especially at its north end. Also the several individual sections of concrete show some tilting outward to the west, and a departure from plumb by several inches as seen compared to the vertical wood trim-work.

*Photo #5 – West foundation, concrete stem-walls leaning out at top.*

This lean would seem to reduce and threaten its load-bearing capacity, although no larger harm is yet apparent. At the exterior base of the stem-wall sections, it seems various past efforts have been made to arrest the tilting, with fieldstone rubble, and/or concrete buttressing being added. It seems likely this was to counter the effects of water falling along this wall from the roof, and destabilizing the footings (if any).

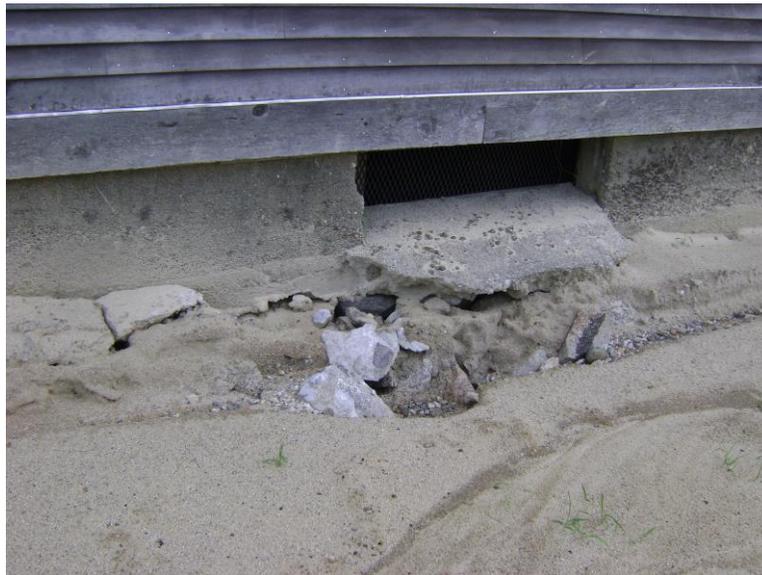
Significantly, water is also definitely a clear and present hazard on the east side. A combination of surface drainage, and large quantities of runoff from the barn roof, is eroding the fine sand fill against the eastern foundation.

*Photo #6 - East foundation, water infiltration and soil erosion.*

Seepage through the granite foundation wall is carrying away the subsoil, and conversely depositing it as large amounts of silt on the basement floor.

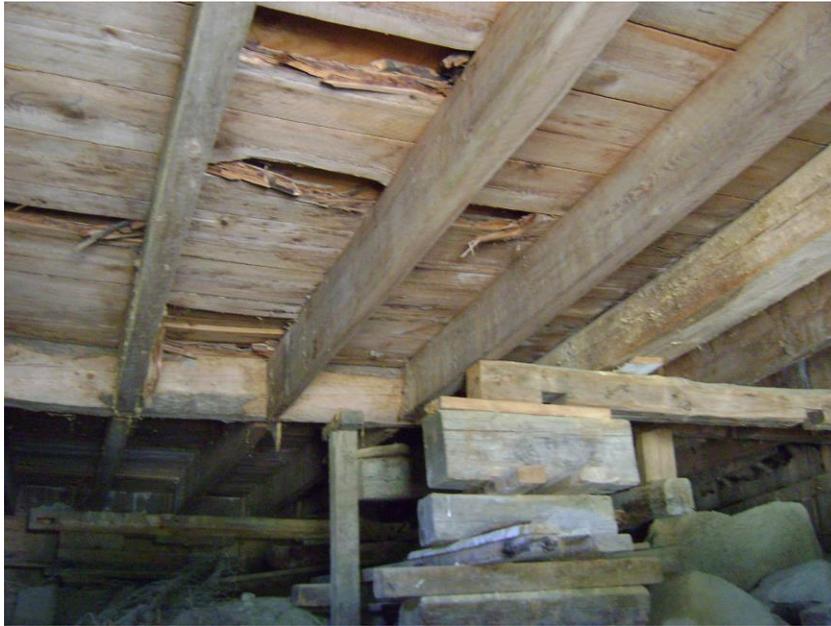
The main aisle floor (center "drive") and its major supporting beams are decayed in the first bays inside the large doors at both north and south ends of the barn, perhaps from snow and water entering at the open doorways over many years. Past partial repairs are visible, and ad-hoc cribbing and posts have been installed to support decayed or spliced beams.

*Photo #7 - Northwest section of undercarriage, damage to floor and sub-floor framing, temporary cribbing.*

These repairs are less than optimum and are themselves deteriorating. Examples are areas beneath posts 1C, 2C, 3C and near the basement stairway below posts 8B, 9B. (Refer to previous SFC Engineering Partnership Inc. report's first floor framing plan.) This includes important structural floor beams, but would be relatively straightforward to repair.

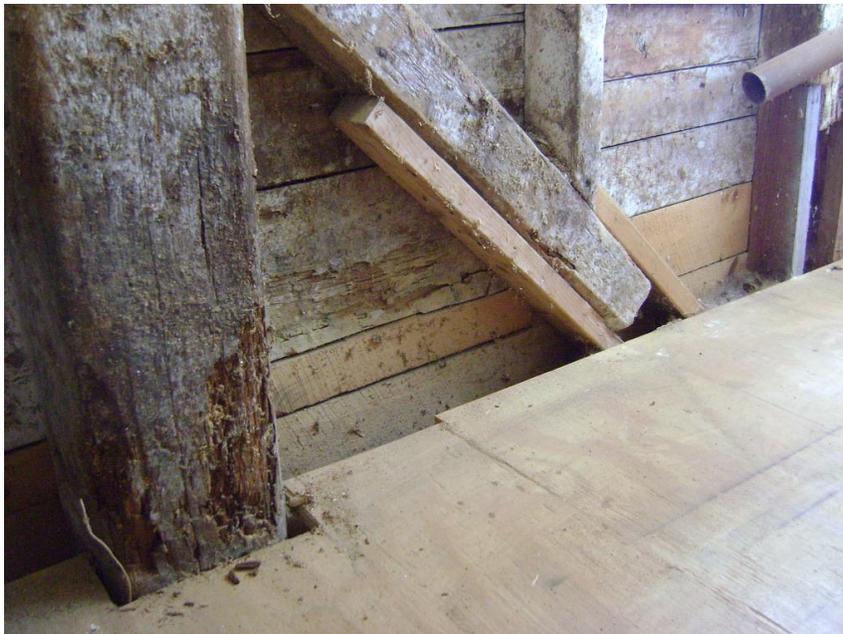
It was observed in some areas of the east wall interior, in the cattle tie-up area, that past decay has occurred at wall post feet and their knee type "up braces," likely from the effects of animal wastes.

*Photo #8 - Repairs indicating possible decay at sills from animal wastes.*

Past repairs have been made, but wall paneling, plywood floor overlay, and stored items made full assessment for this report impossible. The sill(s) beneath may or may not also be involved.

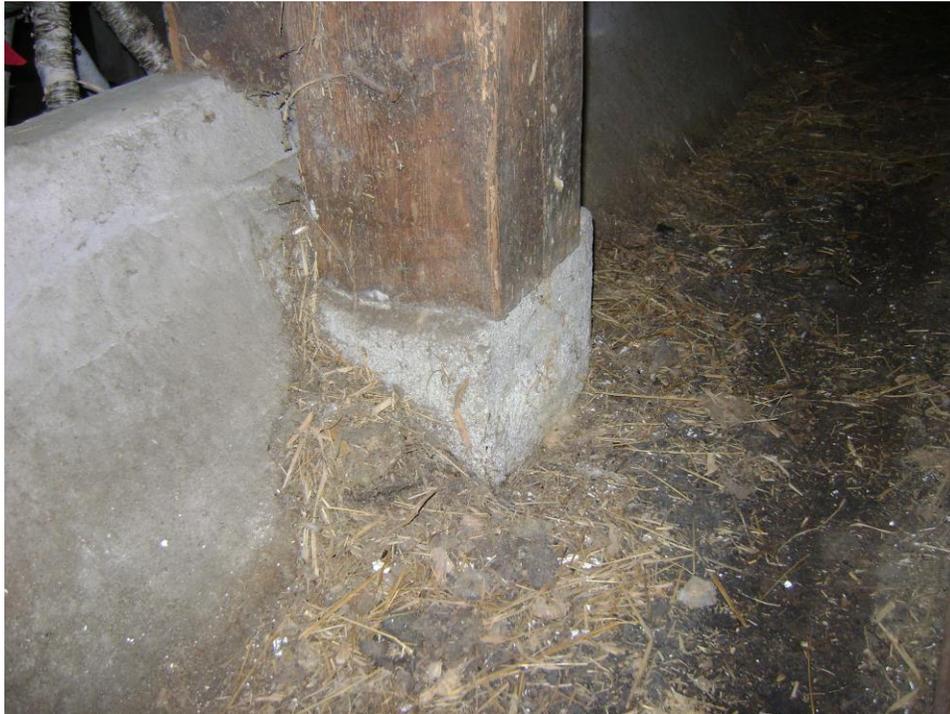
On the main floor, massive concrete feed troughs (bunks) were retro-fitted by cutting off the feet of the primary timber posts on each side of the main drive. These fore-shortened posts now sit supported upon cast concrete steps.

*Photo #9 - Concrete feed trough with step for shortened primary post. (Typical)*

Two concerns arise. Firstly, concrete can conduct moisture into the wood, engendering decay or insect infestation, and indeed powder post beetles appear to be active at a number of these locations. Secondly, if it is contemplated to ever remove the concrete bunks, the posts will need extending or other supporting measures installed to fill the gap and maintain the load-path to the basement posts below.

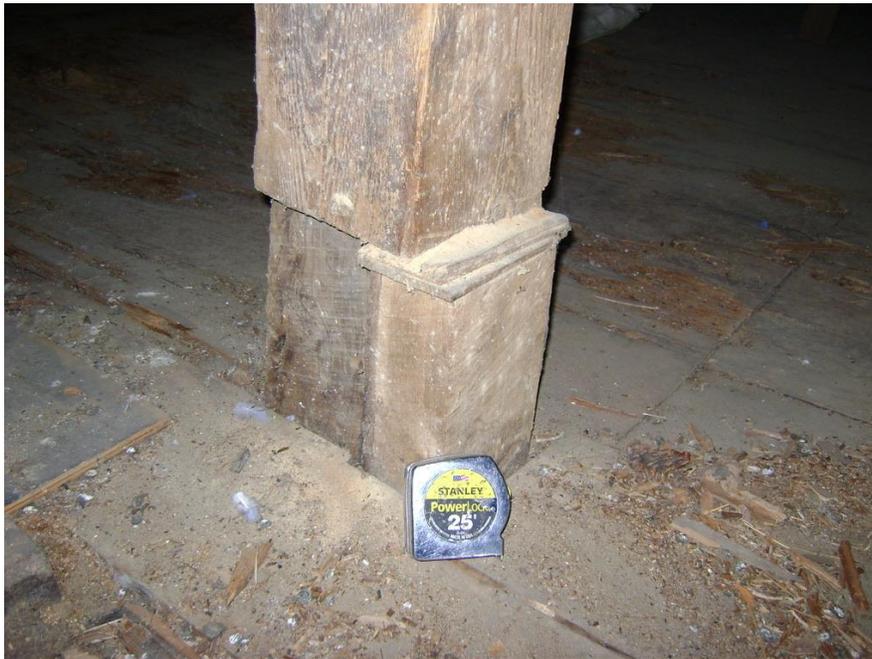
In the remaining area not perched on concrete (at the northwest of the main drive) there has been a shortening and downward displacement of the major post(s), centered in the area of Posts 2C, 3C. This may have been rot resulting from a roof leak in the past, accumulating in hay or bedding materials. A decayed section of the 3C Post foot has been sawed off and blocked up, but inadequately. Again insect damage seems to be active at that location.

*Photo #10 - Post 3C, cut off and shimmed, also active insect boreholes and frass evident.*

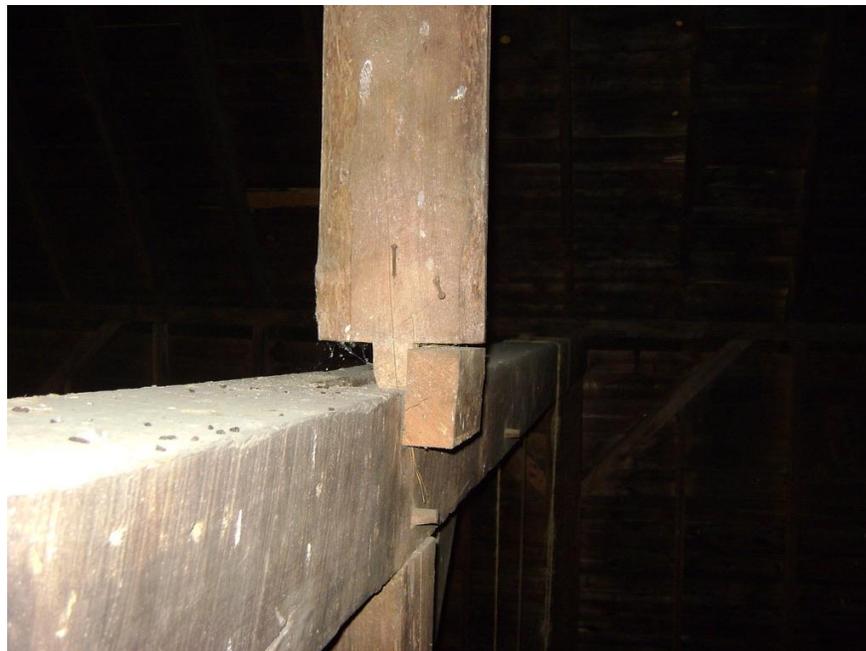
Importantly, at the attic loft level, it can be observed that the same Post 3C has sunk enough (3") to detach the higher queenpost's foot tenon from its mortise in the tie-beam and allow the tie-beam itself to sag notably.

*Photo #11 - Displaced tenon at tie beam above post 3C. Vital roof support is potentially compromised.*

A scab block has been nailed to restrain the tenon but that is inadequate for such a critical connection - one that carries the load of the roof. If it fully detached, the roof area above could be at risk of partial collapse.

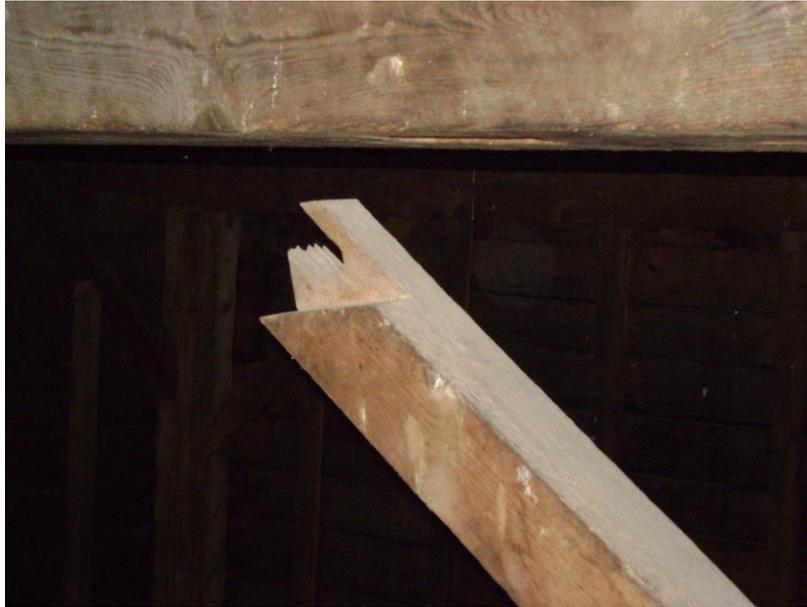
Even ignoring that worst-case scenario, uneven post elevations induce unhealthy tensions and stresses on a frame. That slumping or sagging has the secondary effect of inducing some lean in other posts. The frame though-out is strengthened by knee braces mortised into the major timbers, and some are displaced or missing as a result of the main posts settling unevenly. This weakens the frame resistance against wind loads, etcetera.

*Photo #12 - Disconnected knee-brace, indication of settling and distortion of major frame timbers such as Post 3C.*

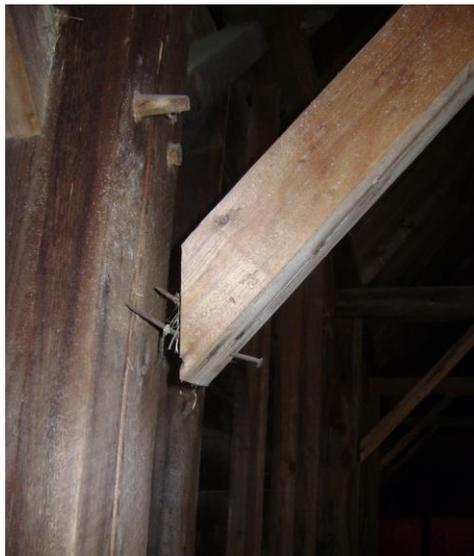
Also, for reasons possibly associated with the necessary sequence of operations during the original barn-raising, the knees from tie beams to wall posts are not mortised at their heels, but only nailed. A number of these points are loosened or detached.

*Photo #13 - Nailed knee-brace connection at wall post separated. (Typical)*

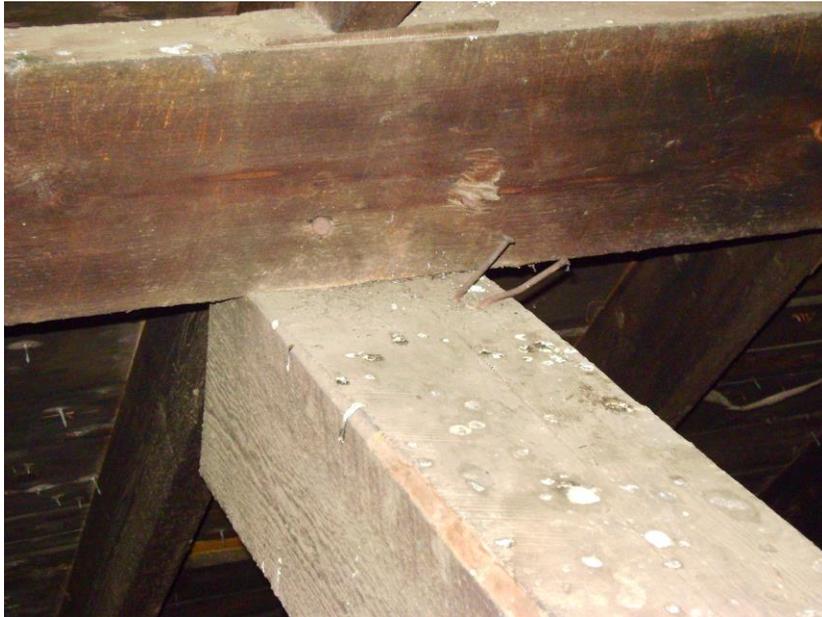
While considering windstorms, it can also be noted that the structural purlin beams, supporting the rafters at the break angle of the roof, are connected to their cantilevered horizontal support beams only by gravity and a very few toe-nails.

*Photo #14 - Structural major roof purlin attached to bent by toe-nails only.*

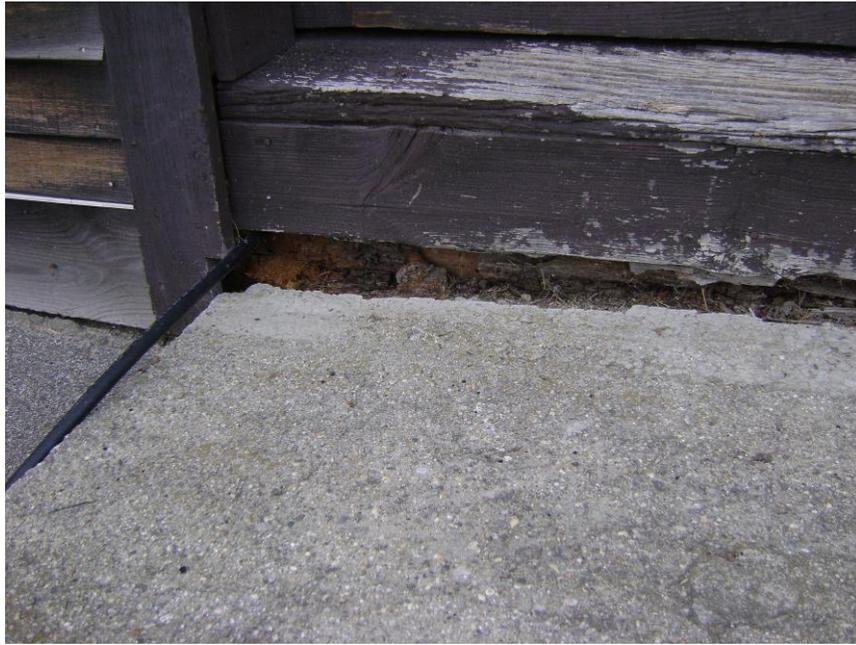
The barn generally has the considerable benefit of 'high and dry' siting. However at the south door concrete steps, blacktop, and landscaping details are in close contact with the barn frame at ground level, and likely directing rainwater into sill timber areas.

*Photos #15 - Entry step fostering sill decay under southeast doorway.*

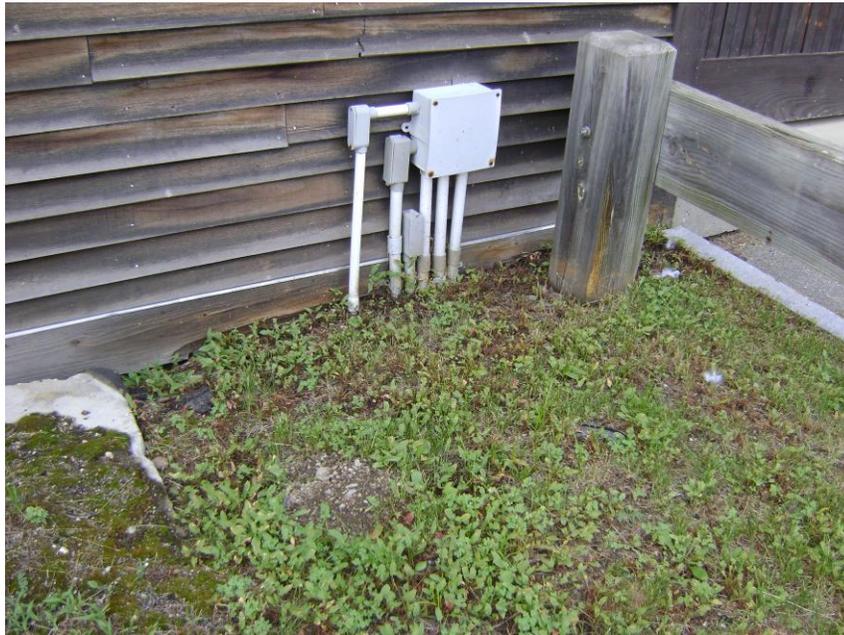
*Photos #16 - Landscaping details (grade too high) fostering sill decay, south wall.*

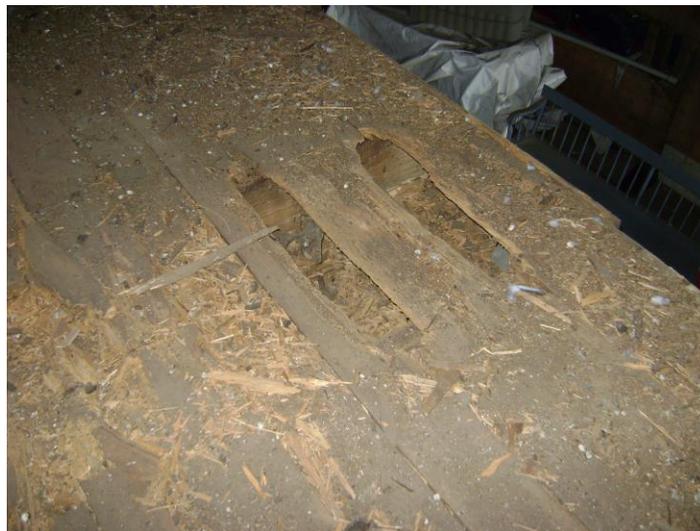
The primary loft floors are two layers of nominal one-inch boards, and generally sound. Limited areas, especially in the west side, are rotted and hazardous, probably from roof leaks in the past.

*Photo #17- East loft, floor decay.*

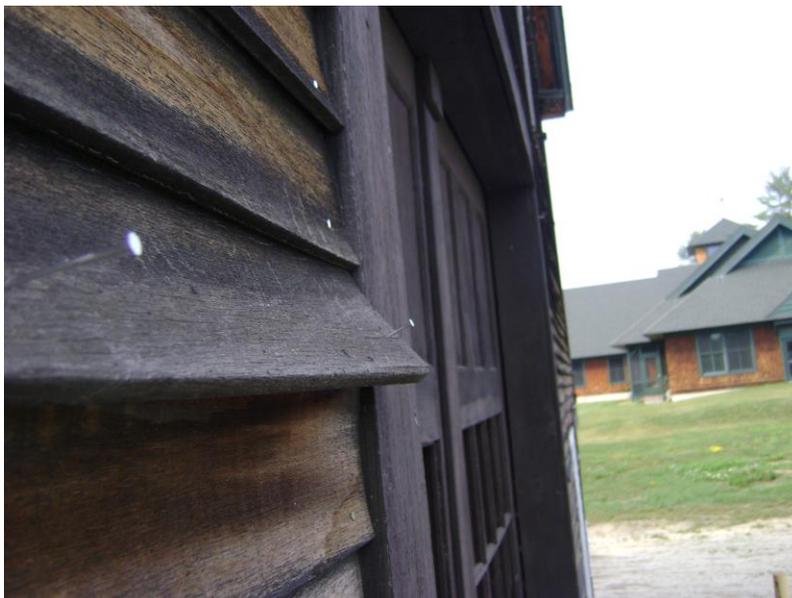
The modern clapboarding was obviously a great, even heroic, investment towards saving the Huston Barn and is aesthetically attractive. Very regrettably it is displaying some cupping and detachment in various widespread places, and the nails are pulling loose from the sheathing over large areas, the result of cyclical wood movement as weather acts upon the clapboards.

*Photo #18 - Clapboards warped and detached, with nails pulled. Typical of many.*

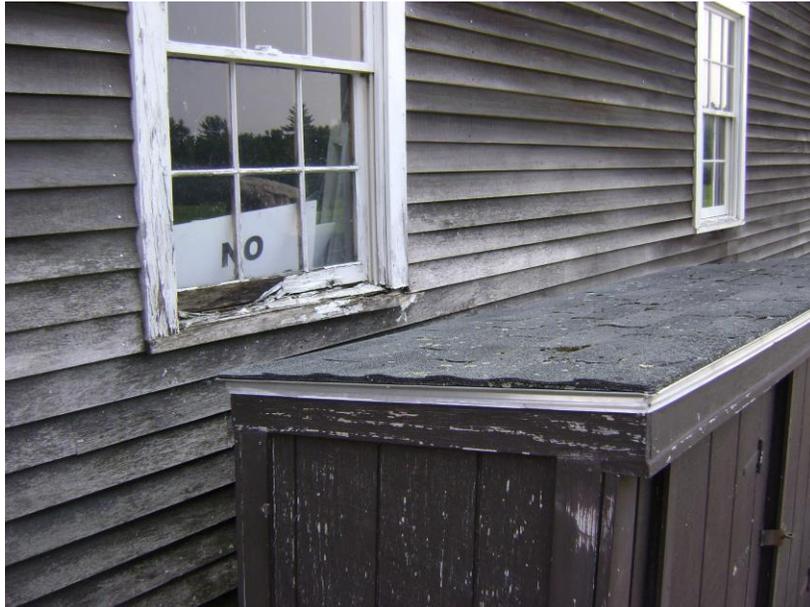
*Photo #19 - Water damage to window resulting from proximity of bin assembly.*

Trim can be repaired as needed in limited areas, such as the corner board by the southeast cow door. A carpenter-built set of bins at the south end of the east wall is splashing roof water back onto the siding and skirt-board, causing decay, and has ruined the window casing there. The bins should be re-located and the casing replaced.

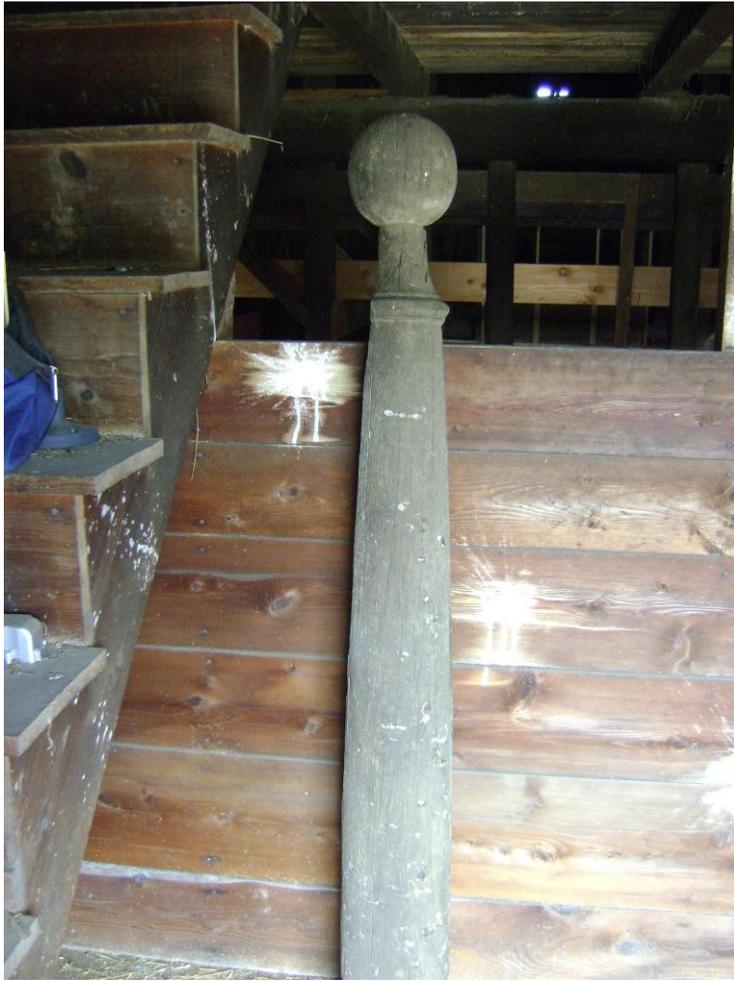
Cupolas served to ventilate the barn for the benefit of both hay and livestock, but also as a strong statement of style and pride. Older photos show this cupola to have been much taller, but it was deliberately and carefully reduced in height, a task interesting to imagine. It almost certainly was topped with a mast. A turned wooden post found in the loft stairway, may have been the original mast.

*Photo #20 - Possibly original mast from Cupola. Could be used as pattern for replication.*

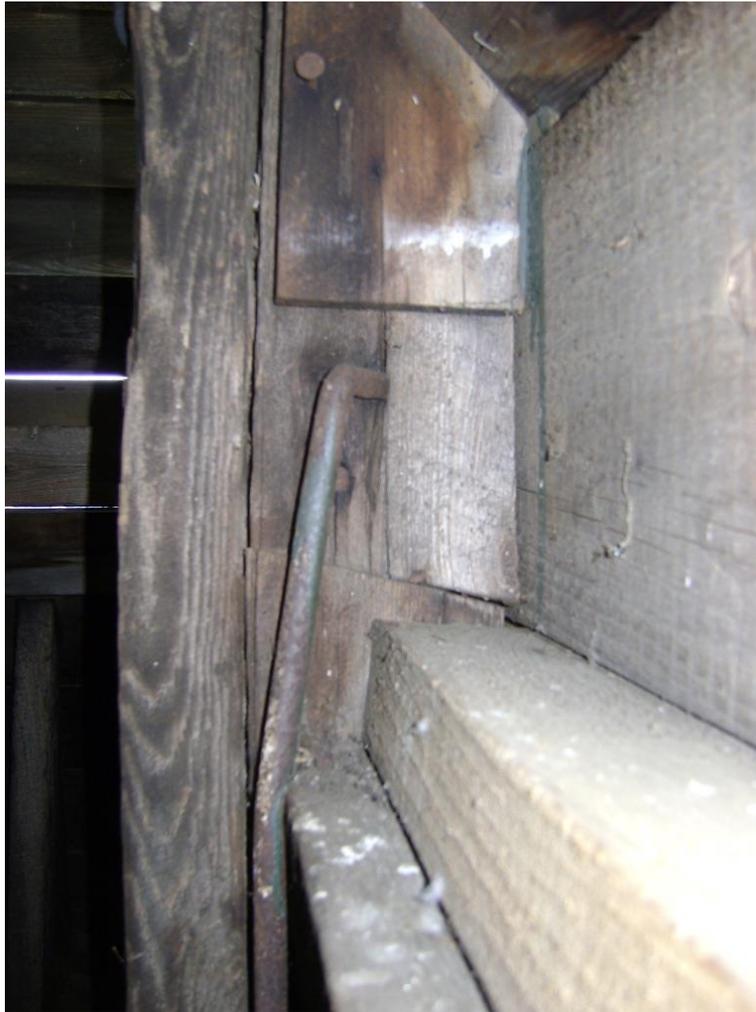
When it was reduced in height, long iron staples were driven to secure the sawed off posts at roof level, and they have served. But their performance in an extreme weather event might be pondered.

*Photo #21 - Interior of Cupola, showing iron staple anchoring cut post. (Typical)*

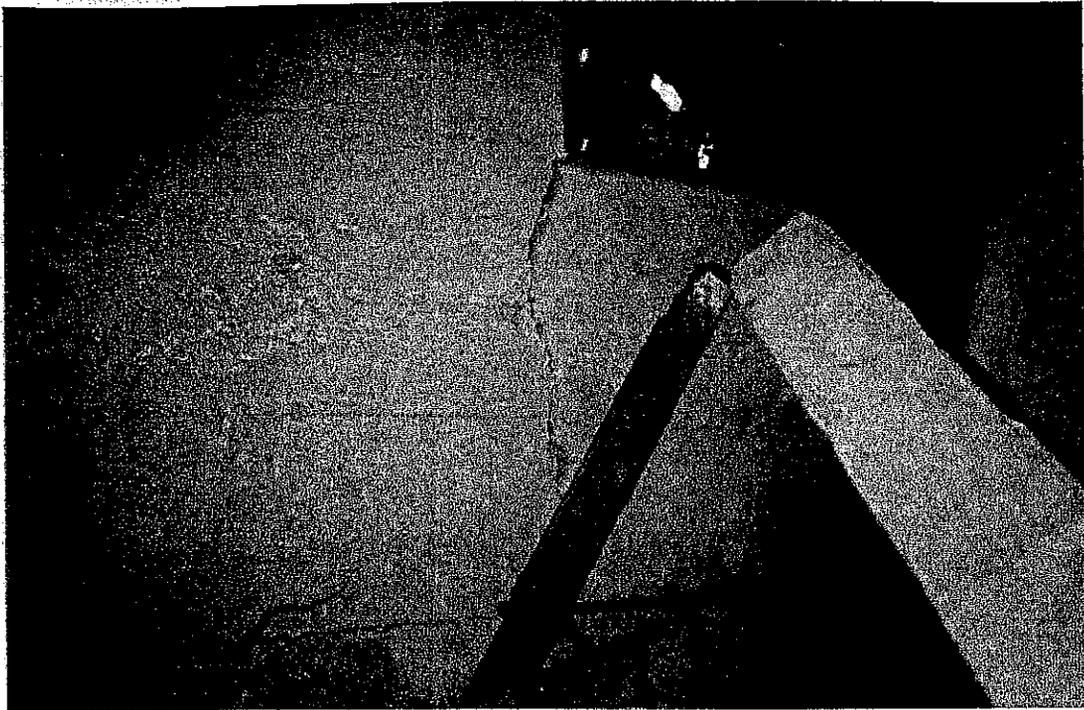
Large crack in north foundation wall

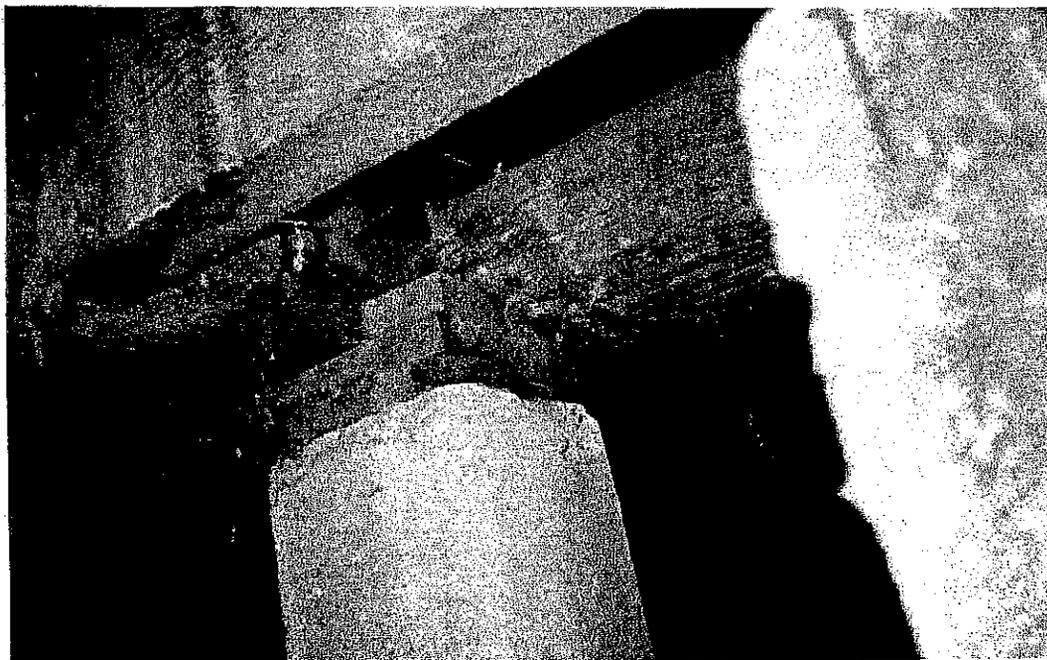
Damaged beam along 2 between C & D

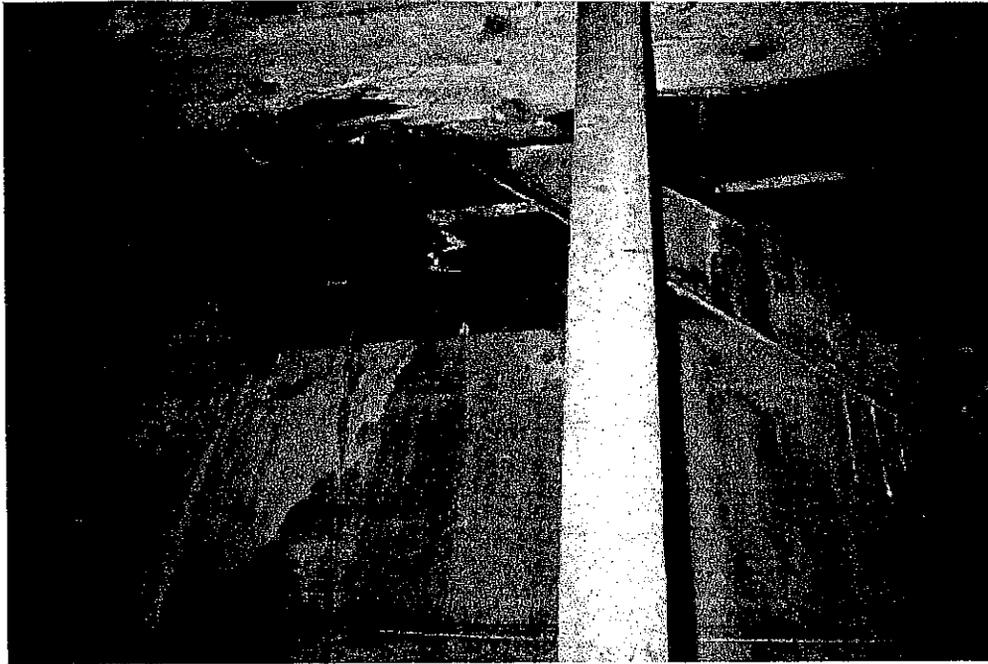
Water damage to floor along C (4-5)

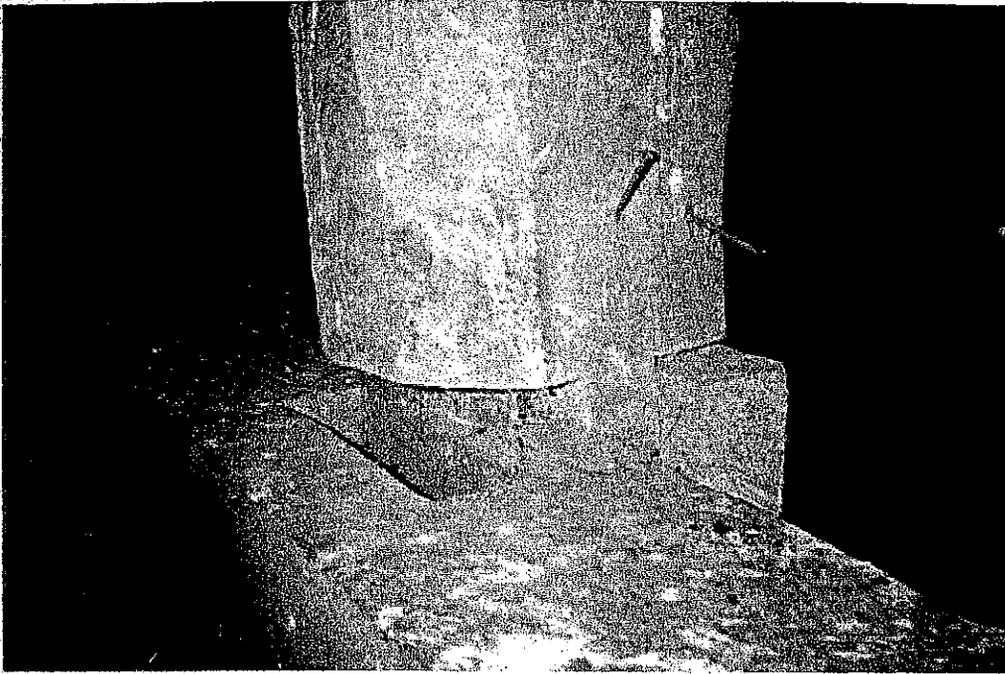
Connection @ 3 & C has pulled apart

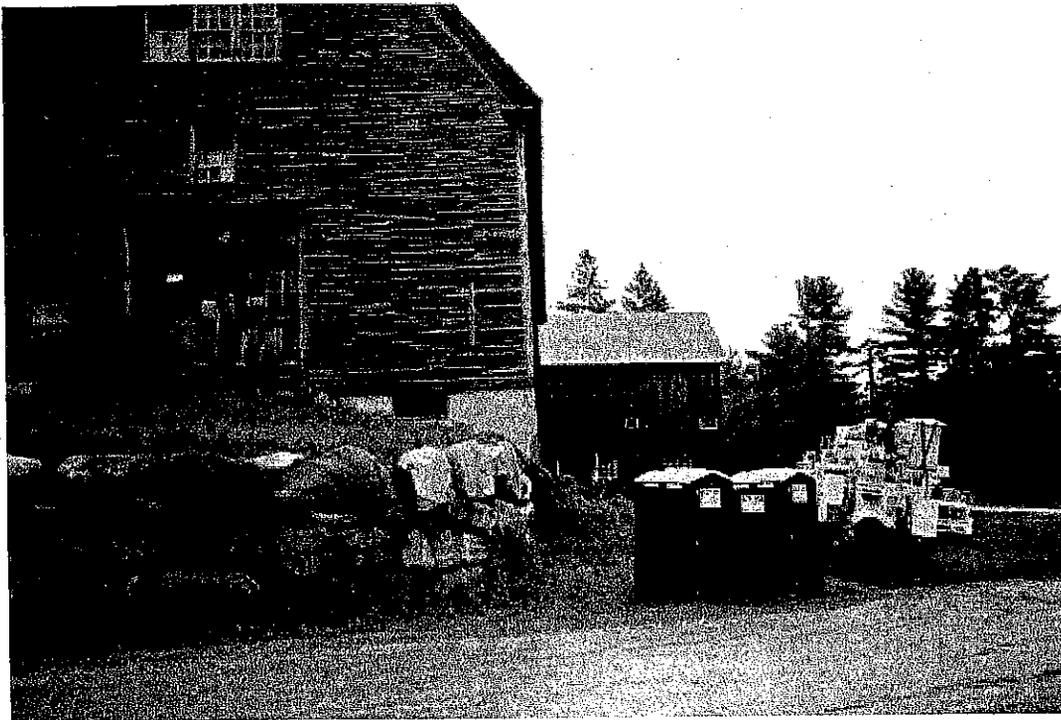
View along west wall showing slight pitch to east
