RE: Septage Facility – Field Inspection Report #21-30 and **Facility Requirements**  
Hopkinton Septage Lagoons, 491 East Pembroke Road Hopkinton, NH  
NHDES Permit #: **SEF-00-001**; Groundwater Permit #: **GWP-198705021-H-006**.

## FACILITY INSPECTION REPORT

### Inspection Report #: 21-30

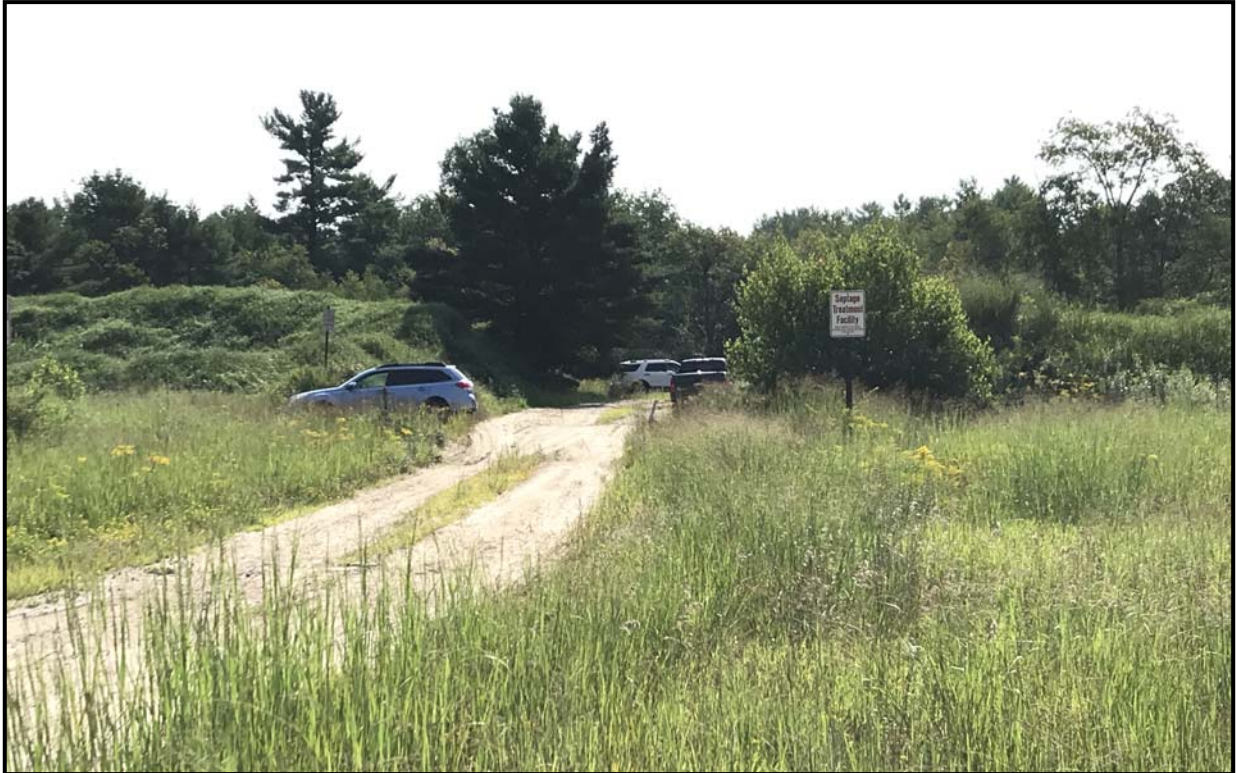
The SEF entrance indicates tall, heavily vegetated lagoon berms/stockpiles on either side of the entrance driveway, with no observed gate across the entrance. A 3-foot wire fence is visible around the facility. A sign "Septage Treatment Facility..." including the Town's name, address and telephone number, was observed adjacent to the south side of the entrance; and a "Danger-Septic Lagoons-Keep Out" sign on the north side of the entrance. (Refer to attached **Photo #1.**) No spill control equipment or materials were noted anywhere within or outside the west or south sides of the fenced facility. A preponderance of mosquitoes was also noted by the RMS inspectors in and around the facility during the inspection.

Photo #1 – Entrance to Septage Facility (Looking Southeast)

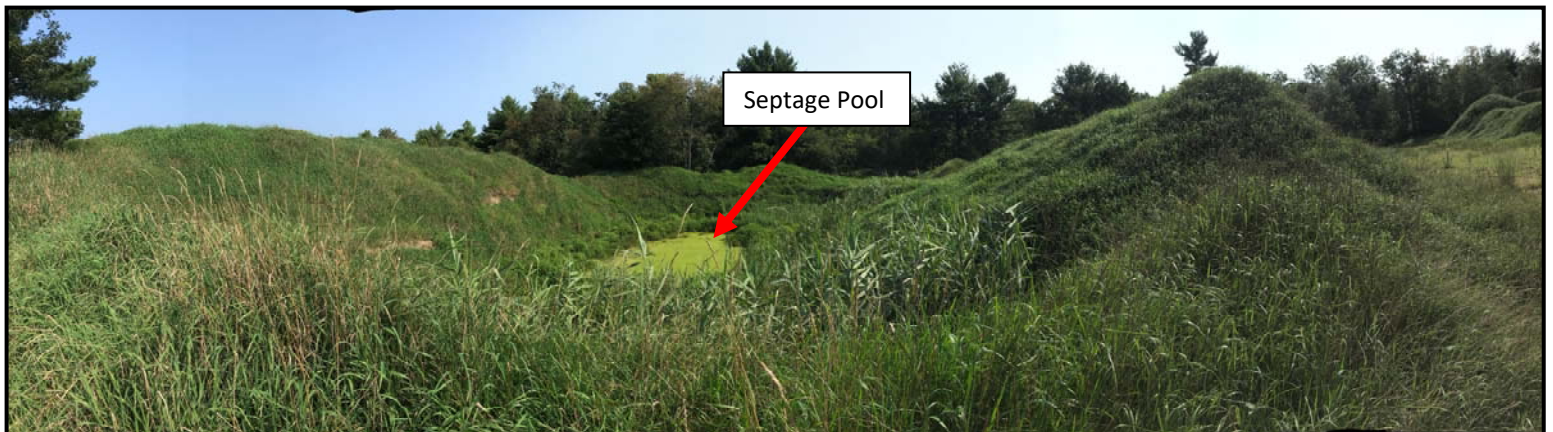
- Lagoon 1 is located in the northwest corner of the fenced facility, on the north side of the entrance. (See **Photo #2**, attached.) It is currently active with a hauler quick-disconnect coupling and hose noted in-place within a PVC culvert through the southerly lagoon berm (**Photo #3**). A puddle of water was noted in the gravel access road in front of the hauler discharge location (**Photo #4**). All berms are steep, heavily vegetated with very tall grass/weeds, with irregular crests – more like stockpiles side-by-side. The south berm is approximately 8 feet tall above the gravel access drive elevation; the other berms are approximately 25 to 40 feet high above the gravel access drive elevation.

The interior lagoon contained a pool of liquid septage with a green algae surface. The water surface of this pool is approximately 20 feet below the access drive elevation. All interior berms and around the contained septage pool, are heavily vegetated. Some areas of the interior berm/slopes appeared to have sloughed off, exposing bare material. (Refer to attached **Photo #5.**) A 40-gallon plastic trash barrel was noted adjacent to the hauler discharge hose location, for disposal of any trash by the hauler.

Photo #2 – Lagoon 1 (Looking Northeast)

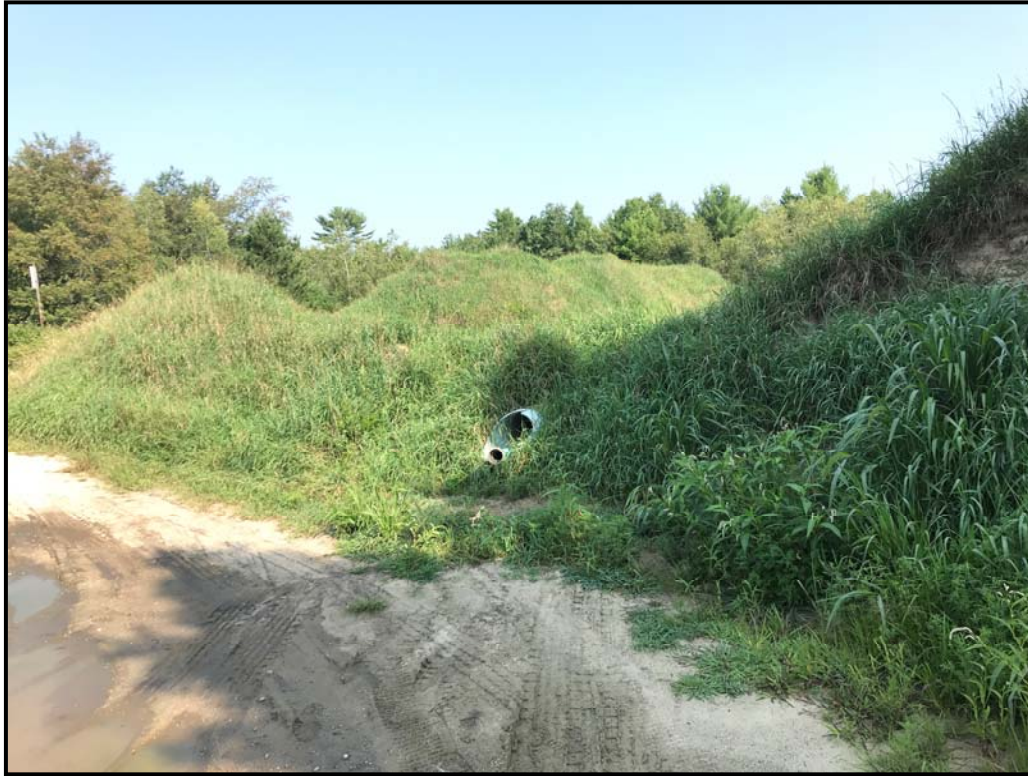
Photo #3 – Lagoon 1 Hauler Discharge Location  
(Looking North)

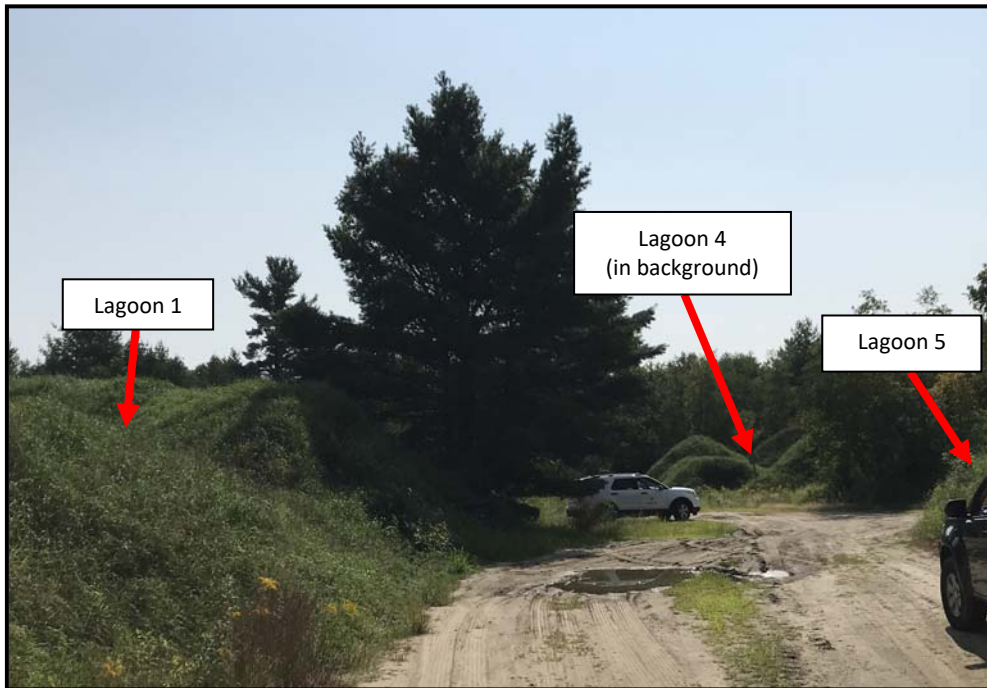
Photo #4 – Puddle in Front of Lagoon 1  
Hauler Discharge Location (Looking Southeast)

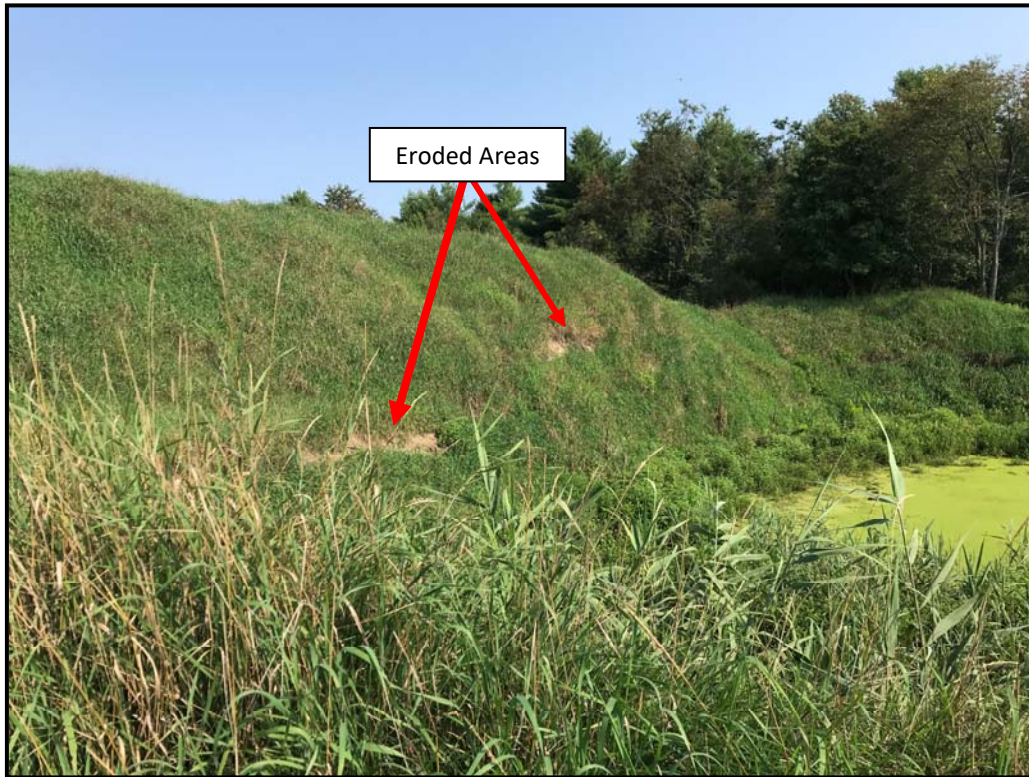
Photo #5 – Lagoon 1 Example of Eroded Interior Berm  
(Looking North)

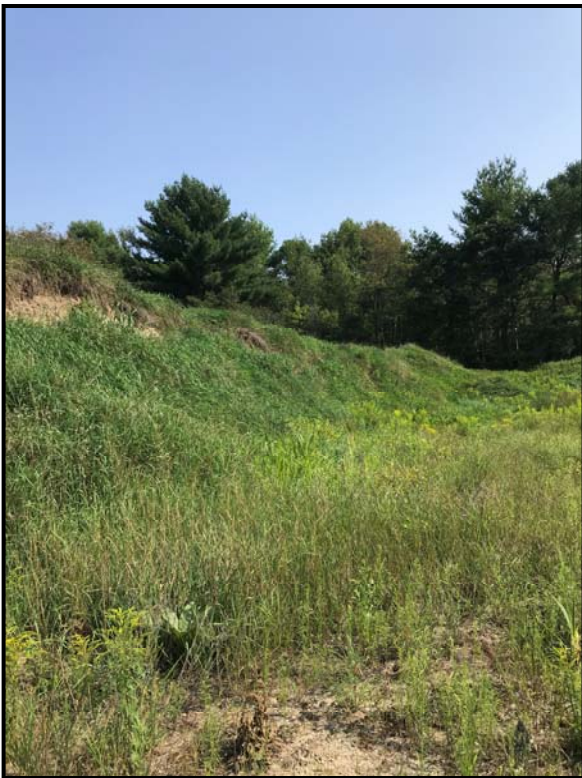
- Lagoon 2 is located in the north-center part of the facility and is currently inactive and "temporarily filled in" (**Photo #6** and **#7**). The lagoon area and all of the steep side berms are heavily vegetated with tall grass/weeds, with irregular crests – appearing more like stockpiles of material set side-by-side. Lagoon 1's east berm is also Lagoon 2's west berm. The filled in, center of the lagoon, is relatively flat, also vegetated, although not as heavy as the side berms. Some sparsely vegetated areas were noted. There was no south berm remaining for this lagoon, and the north berm is only about 8 feet in height above the gravel access drive elevation - presumably this material was used to fill the lagoon in. There was no evidence of any piping/hose, or operational equipment for this lagoon.

Photo #6 – Lagoon 2 (Looking Northwesterly)

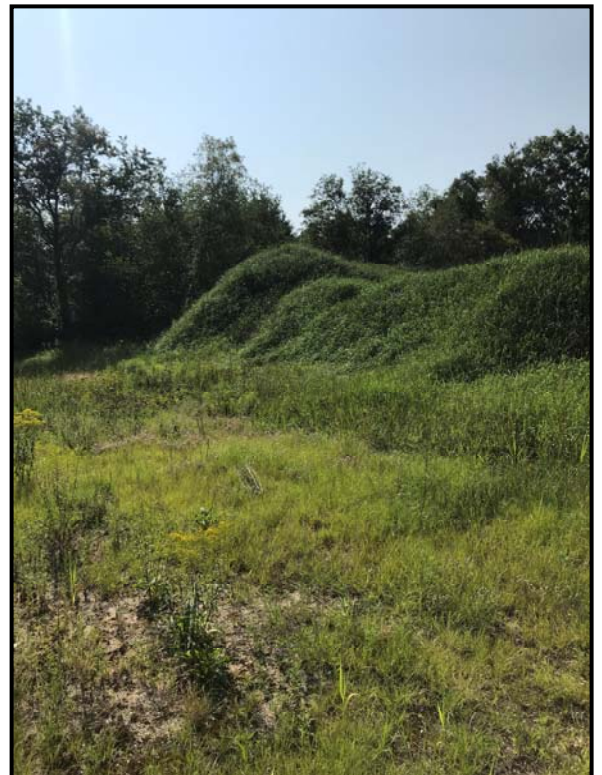
Photo #7 – Lagoon 2 (Looking Northeasterly)

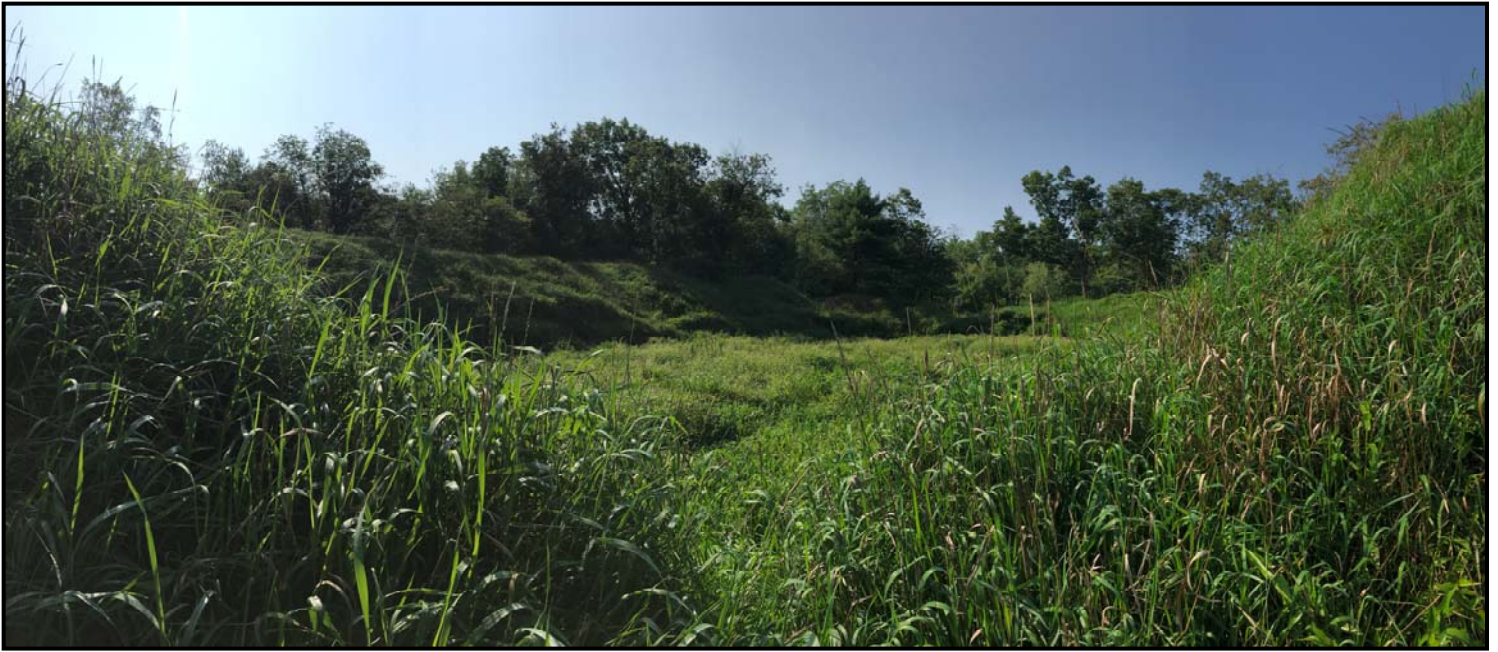
- Lagoon 3 is located in the northeast corner of the SEF, and is inactive (**Photo #8**). According to Ms. Cochrane it is "drying out", and will be eventually filled-in using the material piled around it. All berms are steep, heavily vegetated with very tall grass/weeds, with irregular crests – like stockpiles side-by-side; approximately 8 feet to 25-30 feet high above the access drive elevation. (Refer to **Photo #9**.) No liquid septage pool was noted in the bottom of this lagoon from the inspector's available access point. Lagoon 2's east berm is the same as Lagoon 3's west berm. The back of a sign and the wire fence is visible on the north side of the lagoon. No piping/hose or operational equipment was noted near this lagoon.

Photo #8 – Lagoon 3 (Looking North)

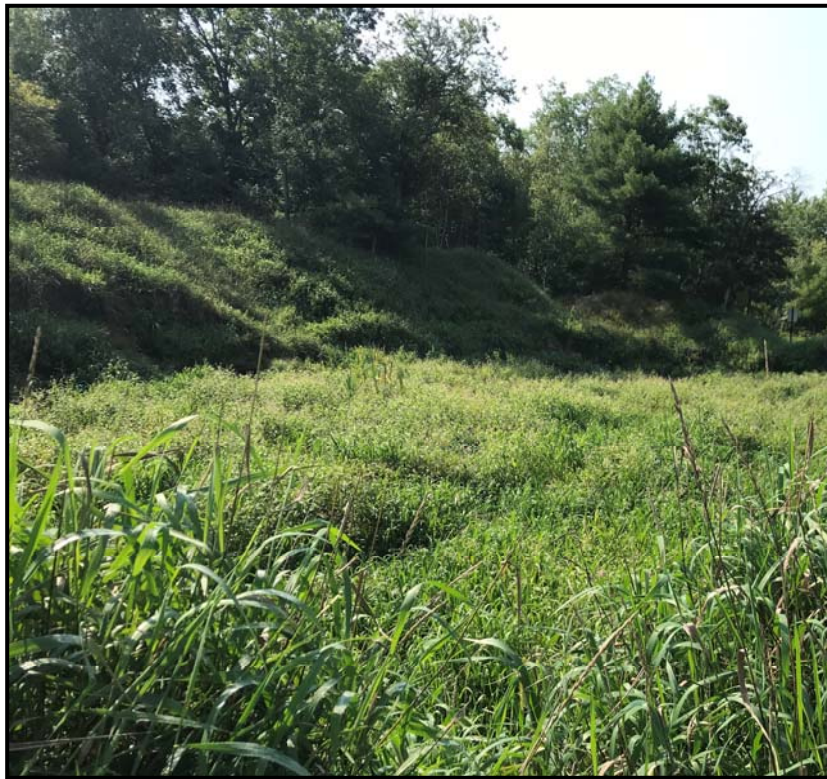
Photo #9 – Lagoon 3 (Looking Northwesterly)

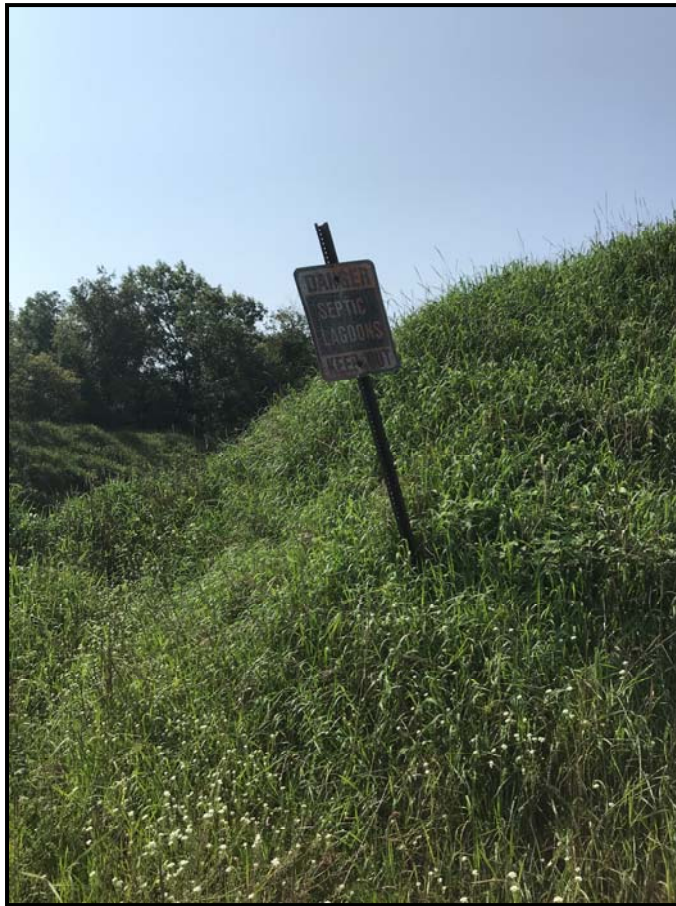
- Lagoon 4 was essentially inaccessible by the RMS inspectors, due to steep, heavily vegetated berms/stockpiles. It is located in the south corner of the facility. It is assumed that this lagoon is currently inactive, as there did not appear to be available hauler access to it. A sign "Danger-Septic Lagoons – Keep Out" was found on the outside slope of the southwest berm/stockpile. These berms appeared to be approximately 5 to 30 feet in height, above the access drive elevation, also with irregular crests. The east berm has grown trees on it. (See **Photo #10**.)

Photo #10 – Lagoon 4 (Behind Sign & Stockpile)  
(Looking Southeasterly)

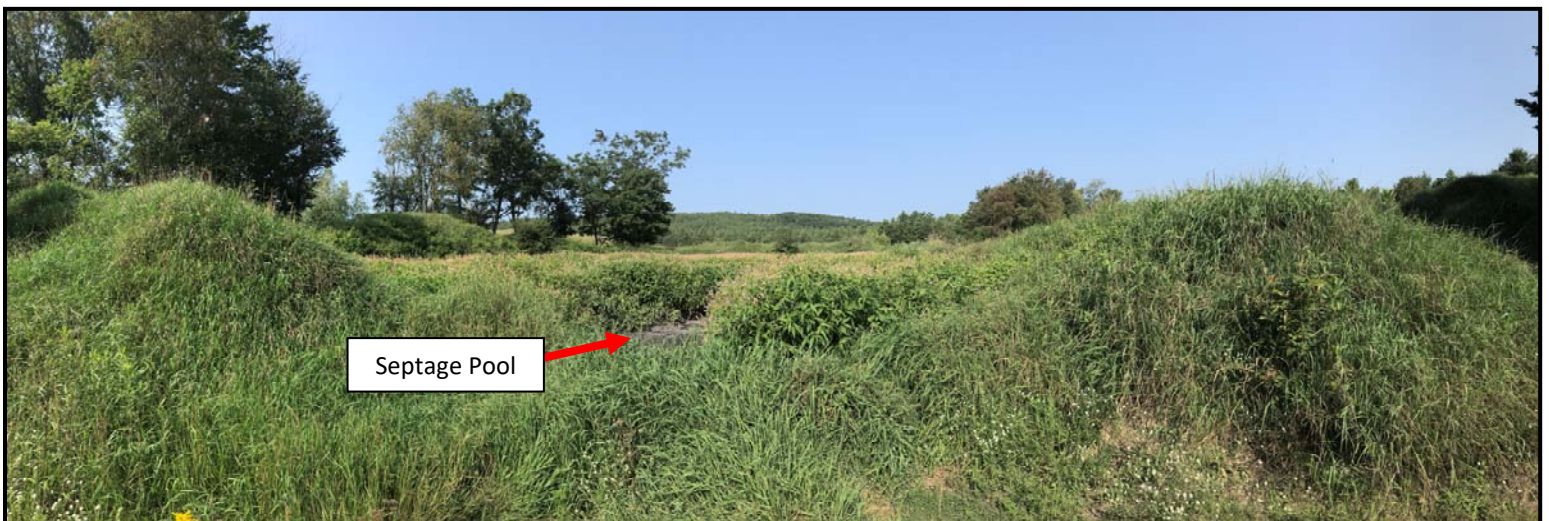
- Lagoon 5 is located at the southwest corner of the SEF, near the south side of the entrance, and is active. Ms. Cochrane relayed that she thinks only one hauler discharges to this location. This lagoon did not appear to have a complete east berm, to allow placement of the hauler's hose on the ground in the northeast corner of the lagoon, for gravity discharge into the lagoon. (Refer to **Photo #11**.) There was no piping/hose or operational equipment noted near this lagoon. The berms for this lagoon are lower in height than the other lagoons, ranging from approximately 8 to 15 feet above the access drive elevation. All berms and the lagoon bottom are heavily vegetated with tall grass/weeds. A small pool of liquid septage was noted in the bottom of the lagoon with a "scum layer" evident on the surface. The pool surface appeared about 3 feet below the access drive elevation. No piping/hose or operational equipment was noted near this lagoon.

Photo #11 – Lagoon 5 (Looking Southeasterly)

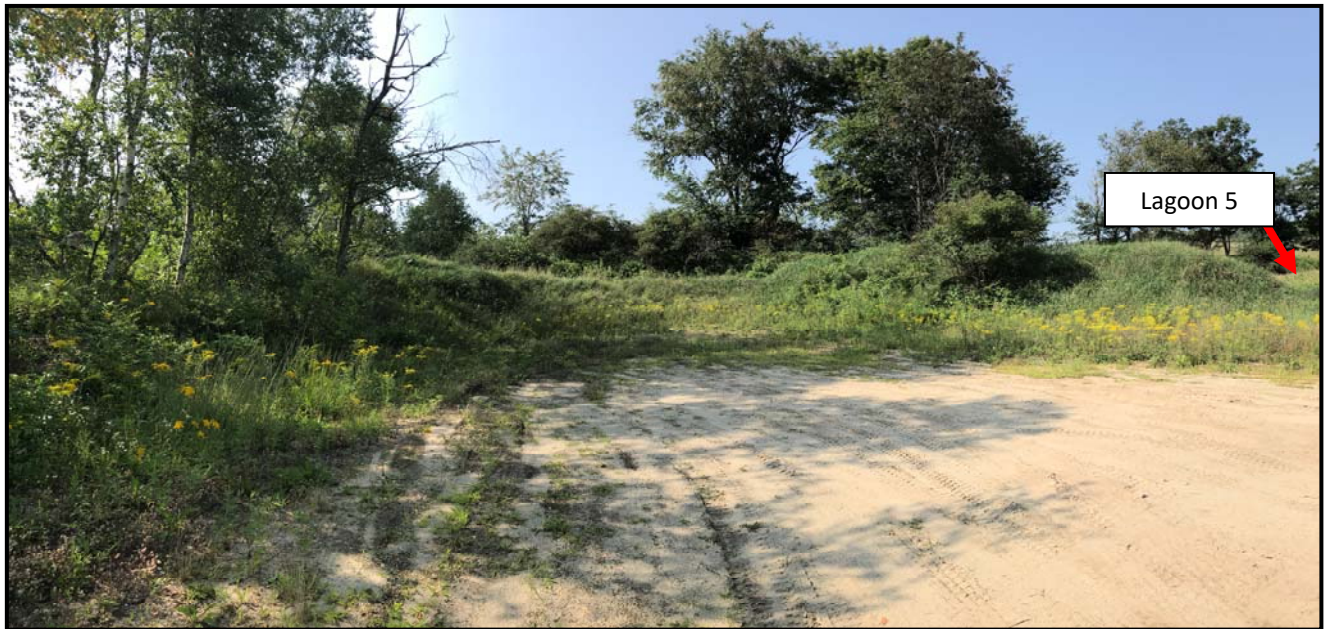
A relatively flat gravel area is located between Lagoons 4 and 5, in the south-central part of the facility, with an approximate 8-foot high grass-covered berm on the south end (**Photo #12**). The east berm of this gravel areas is also the west berm/stockpiles of Lagoon 4. The west berm of this area is also part of the east berm of Lagoon 5, and contains large bushes. Ms. Cochrane stated that this area had been used by the former operator for "clean fill" if needed, when lagoons were temporarily filled in.

Photo #12 – Gravel Area (Looking South)

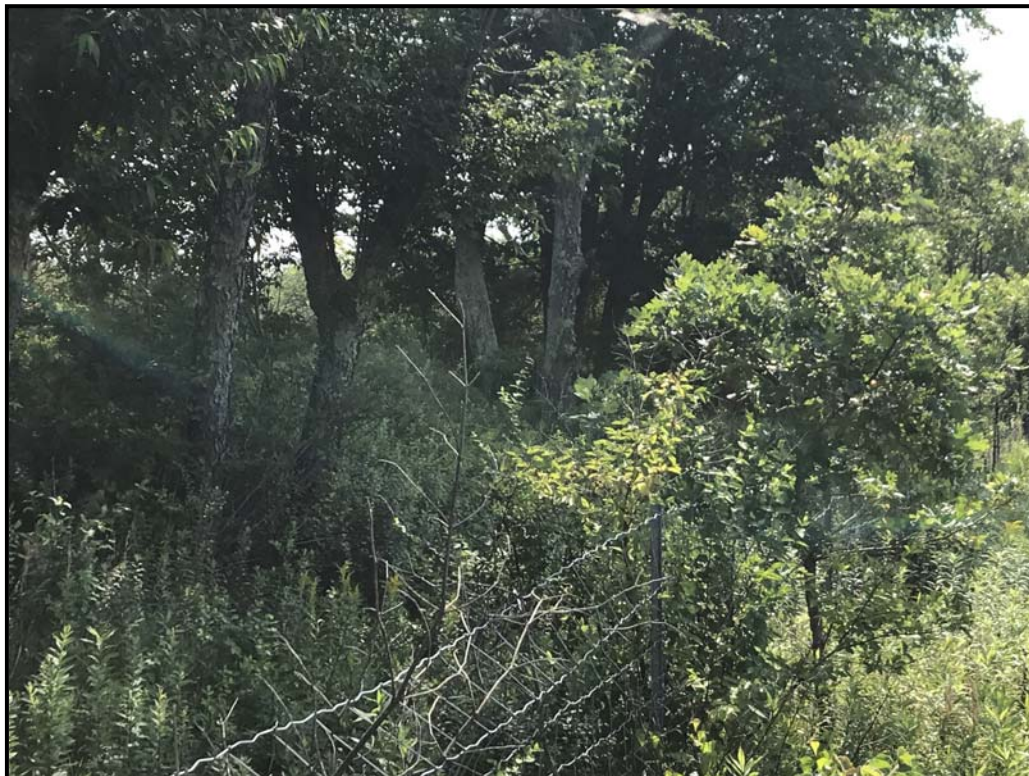
RMS also inspected the exterior of the facility, along the southerly gravel access road. A grass and tree covered windrow-type berm about 8 to 10 feet in height above the access road elevation, is located along the south side of the facility, just within the wire fence line. (See **Photo #13**.) Mr. Talvy estimated that the cherry tree growth on this berm is about 20 years old, and stated that cherry trees require soil with a high nutrient content; therefore, it is assumed that this external windrow berm is also dewatered septage solids. Three groundwater monitoring wells are located between the fence and this berm, but were not visible to the RMS inspectors due to high grass/weeds, and were not inspected during this field visit.

Photo #13 – Example of Facility – South Fence Line  
Note: Windrow berm behind trees. (Looking Southeast)
