TOWN OF HOPKINTON

CULVERT ASSESSMENT FOR

AQUATIC ORGANISM PASSAGE

HOPKINTON CONSERVATION COMMISSION

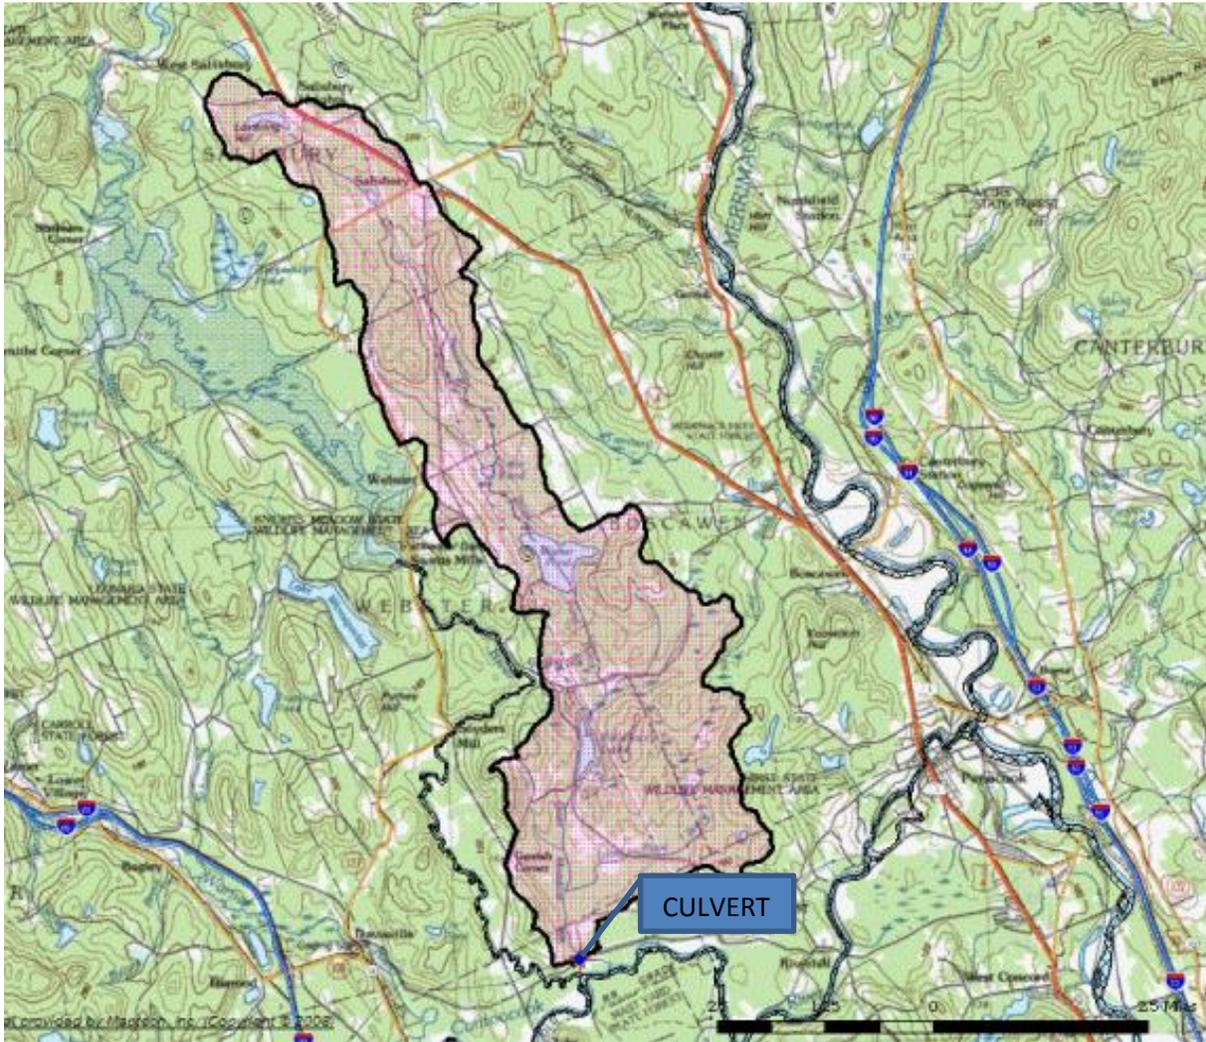
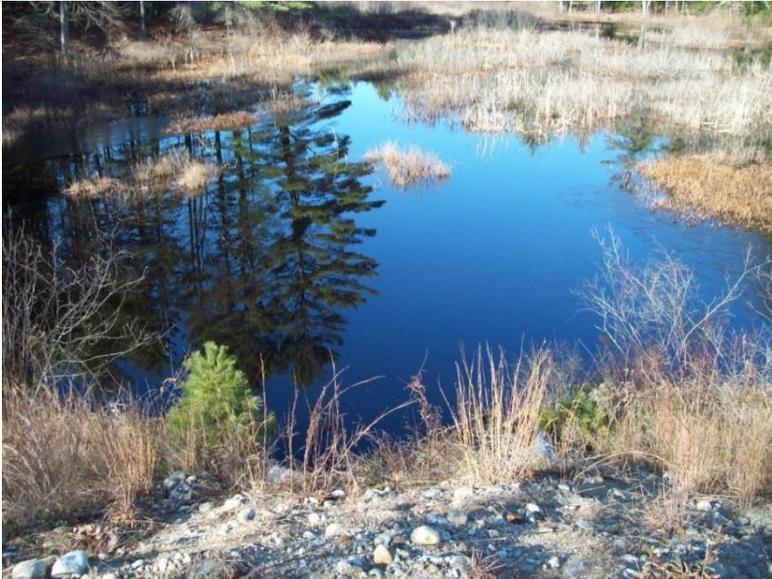
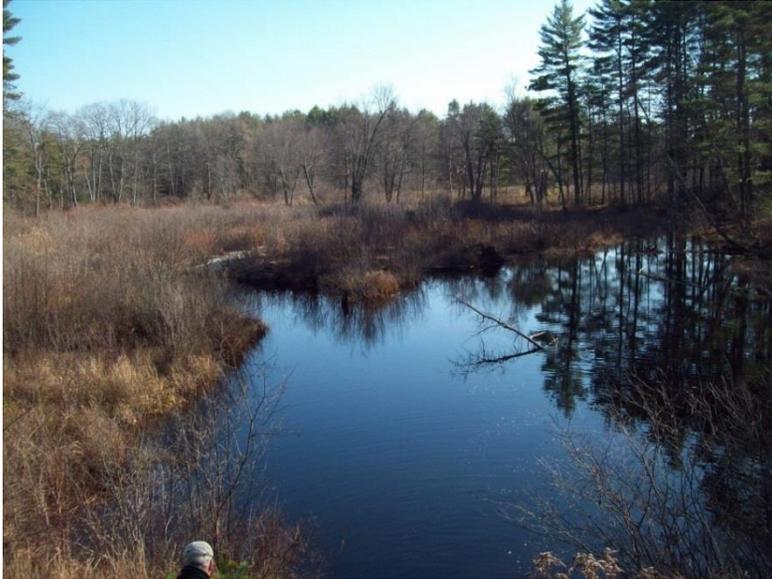
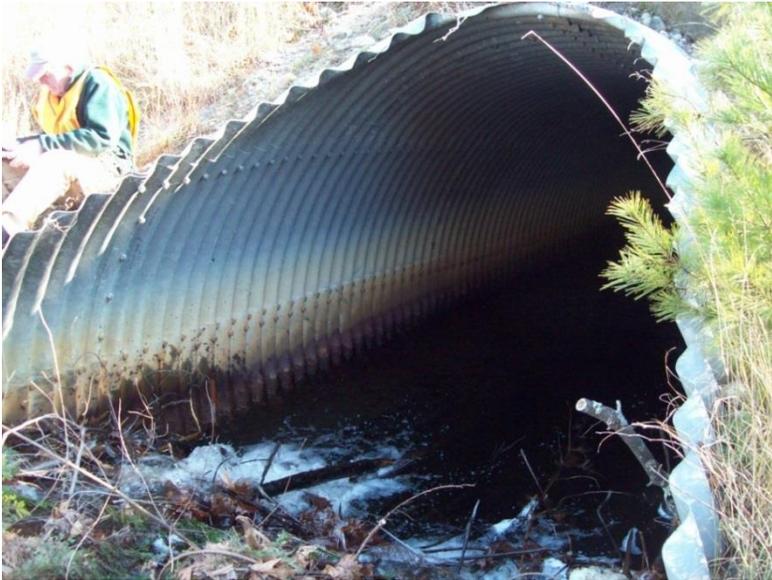
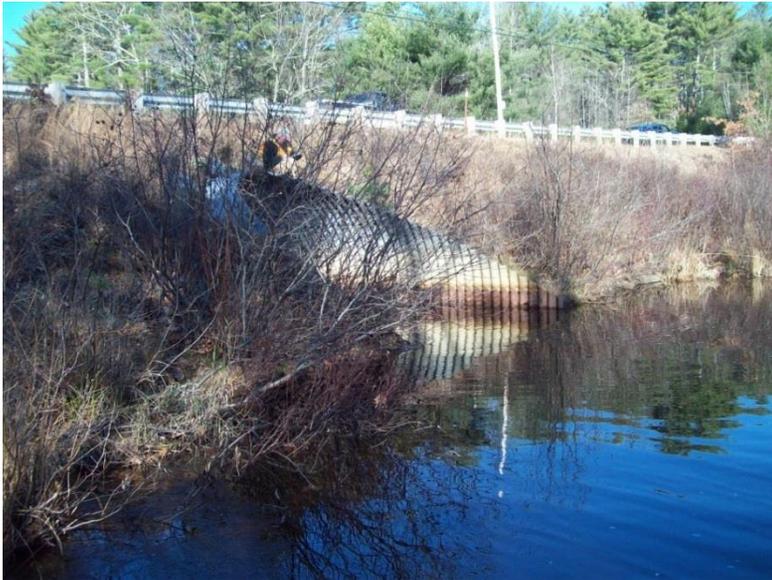
Deer Meadow Brook under East Penacook Road (DMB)

AQUATIC ORGANISM PASSAGE CONDITION: GOOD

No action is recommended at this time.

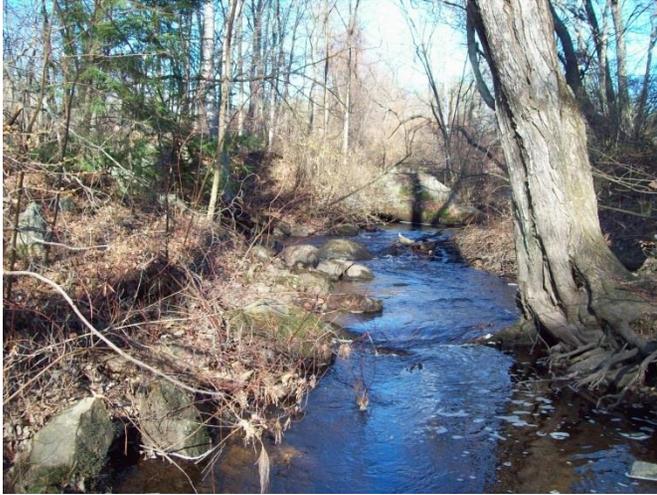
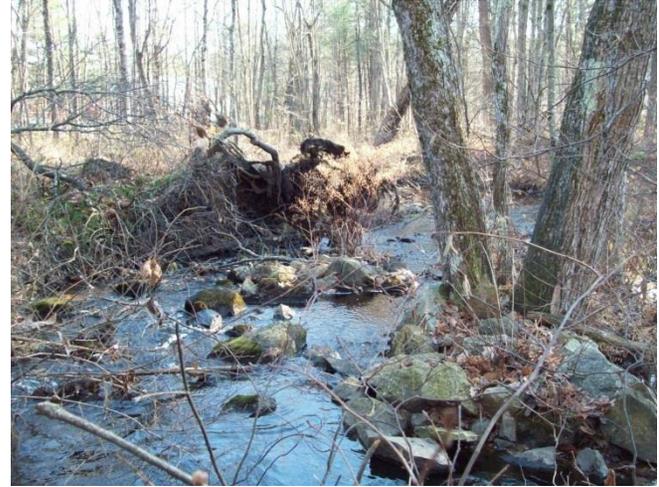
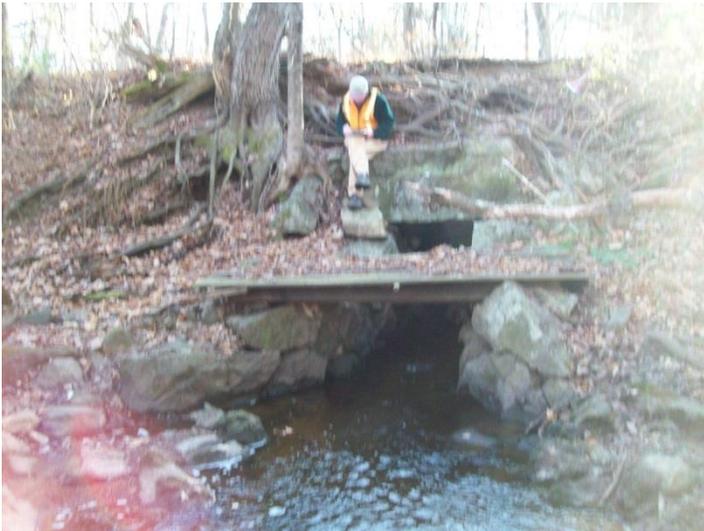
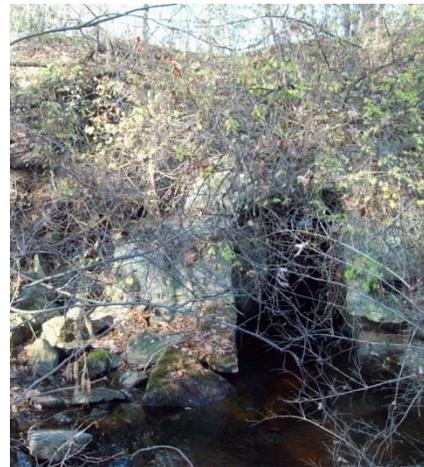
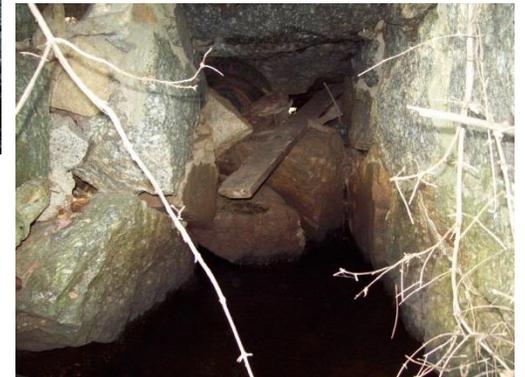
Hardy Spring Brook under Railroad Grade (HSB1)

Hardy Spring Brook under Railroad Grade (HSB1): This is an old stone structure under the former railroad line, between the Contoocook River and Pine Street. It appears to be on private property. Hardy Spring Brook is in generally good condition and has high quality fish and wildlife habitat along much of its length. The structure is much narrower (3 feet) than the bankfull width (18 to 25 feet) and is collapsing. If the structure is not repaired it may cause the collapse of the railroad grade, which would not only affect fish passage, but also could dam the stream flow. If this rail trail is no longer important, the structure could be removed altogether or repaired. A bridge or substantially larger culvert could be installed in its place.

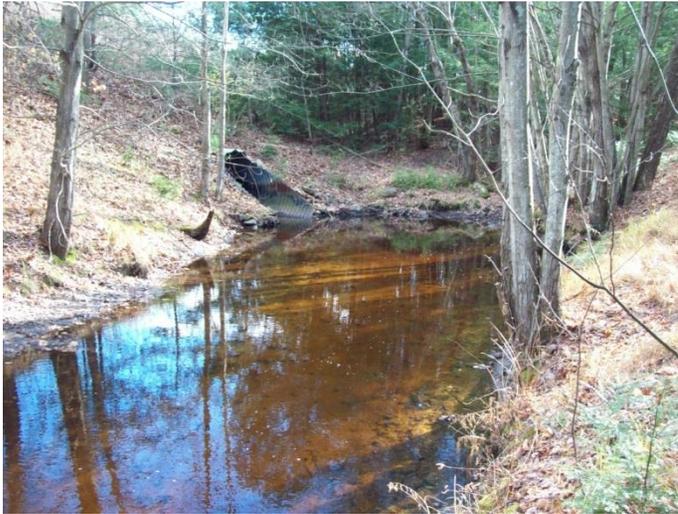
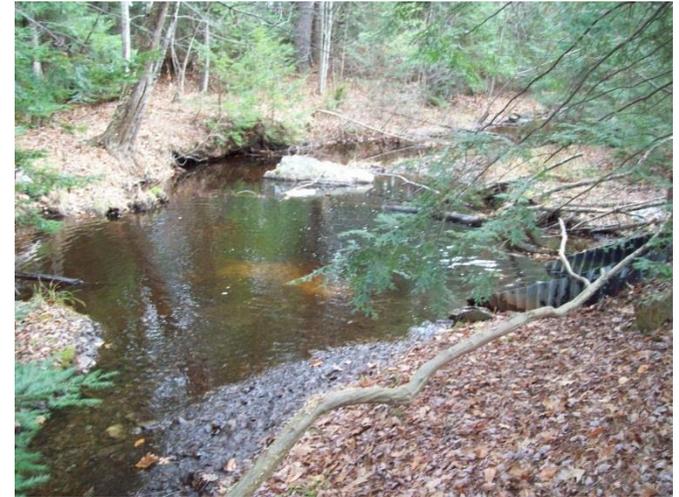
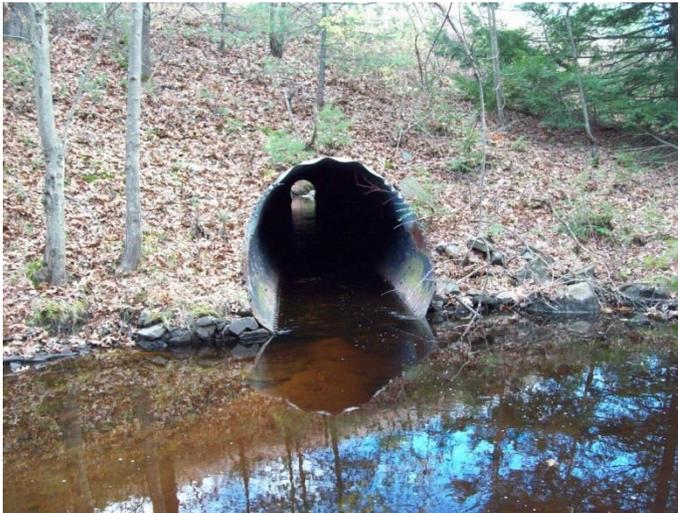
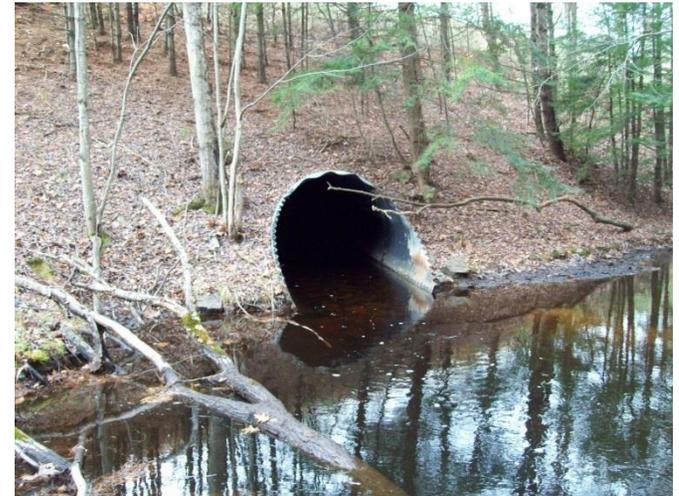
Hardy Spring Brook under I-89 Northbound (HSB3) and Southbound (HSB4): HSB3 is a long, 7-foot diameter corrugated metal pipe under I-89 northbound and a large fill slope. It is 7 feet in diameter and. HSB4 is a concrete 6 by 6 foot box culvert under I-89 southbound. Both culverts are long, narrower than the bankfull width, and lack a natural substrate. Over the long term, larger structures with natural substrates should be installed, but the length and location under the interstate will make replacement expensive. Both of these culverts are the state's responsibility.

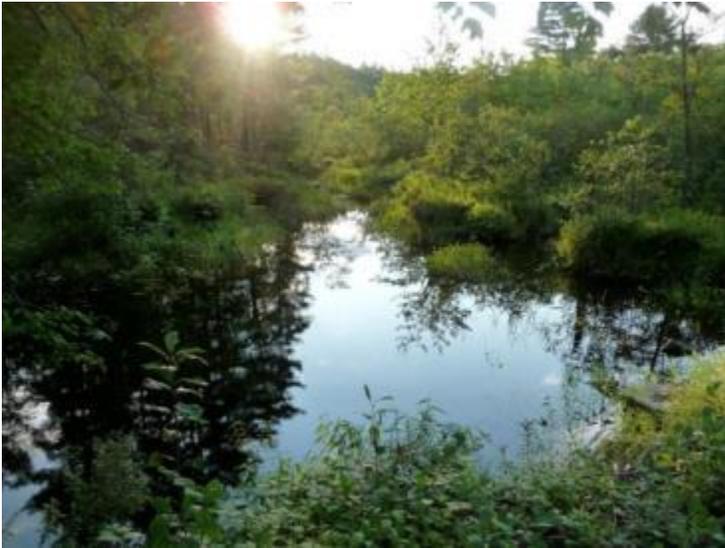
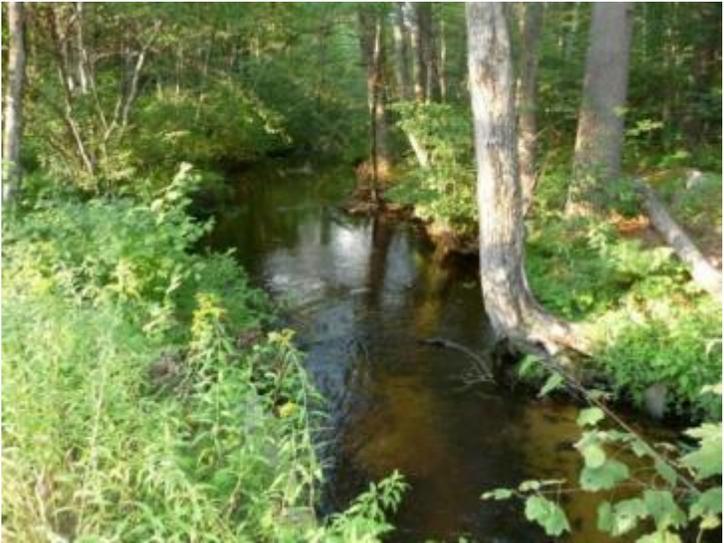
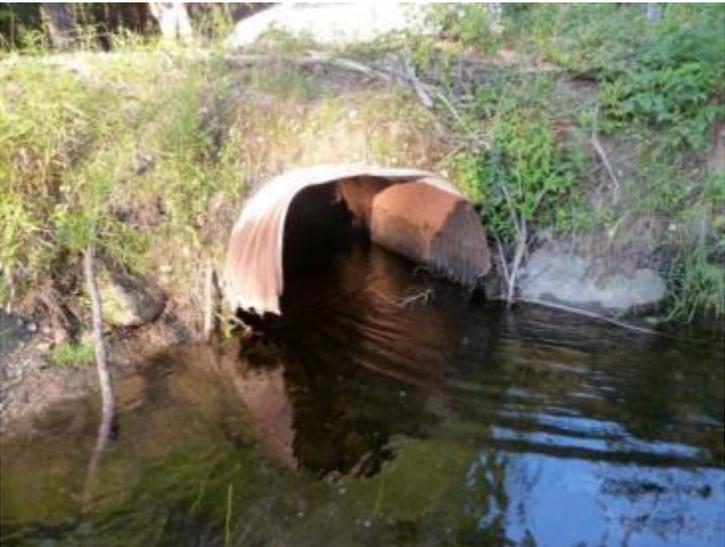
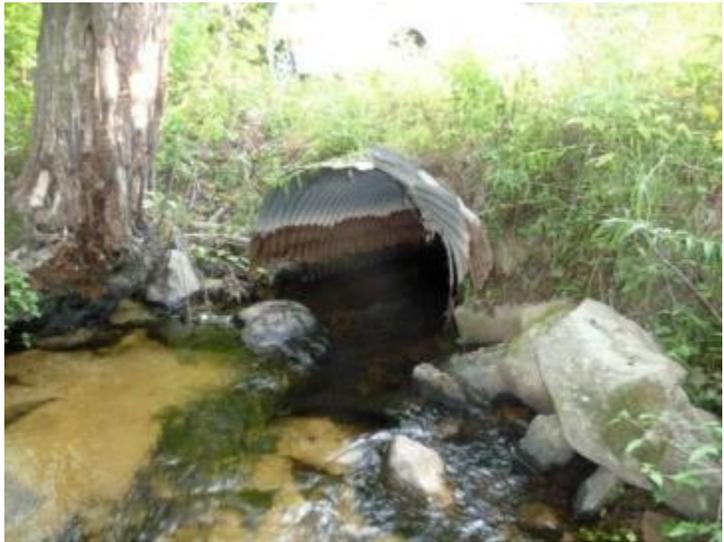
Hardy Spring Brook under Clement Hill Road (HSB7)

Hardy Spring Brook under Clement Hill Road (HSB7): This is a 4 foot diameter, heavily rusted corrugated metal pipe, about 36 feet long, under Clement Hill Road. The structure is much narrower than the bankfull width and lacks a natural substrate, but has water within the structure and is not perched, so fish may find it passable much of the year. A larger structure spanning the bankfull width should be installed. The town is currently considering replacing this pipe.

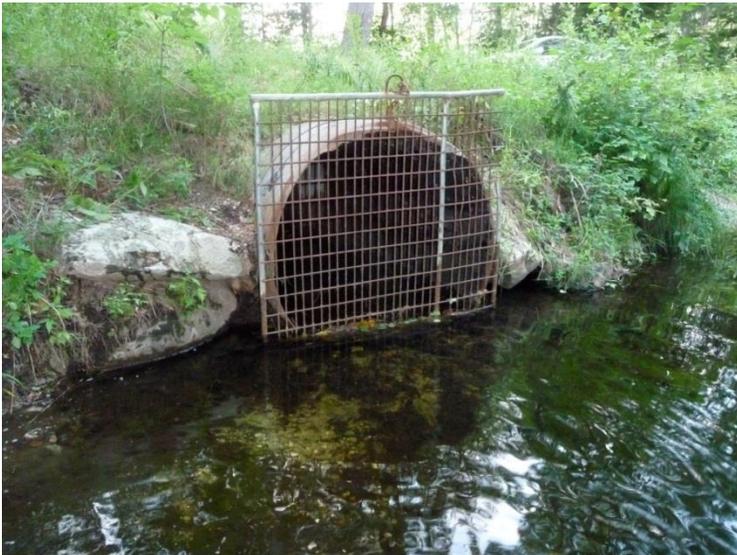
Inlet

Hardy Spring Brook under Bound Tree Road (HSB8): This is a 5 foot diameter corrugated metal pipe, about 60 feet long, under Bound Tree Road. The outlet is perched above the stream surface, which may prevent many aquatic species from passing through the structure. The culvert is also showing rust and there is erosion around the outlet. A larger structure should be installed at the low water flow elevation. The impact on water levels in the upstream ponded area and swamp should be taken into consideration in planning and design.

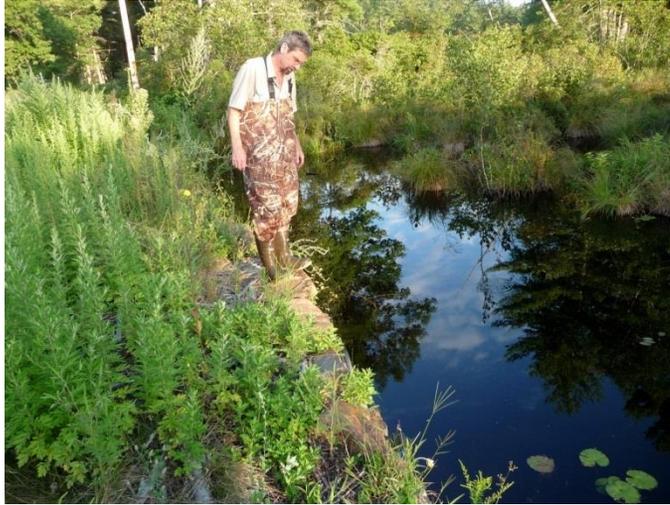
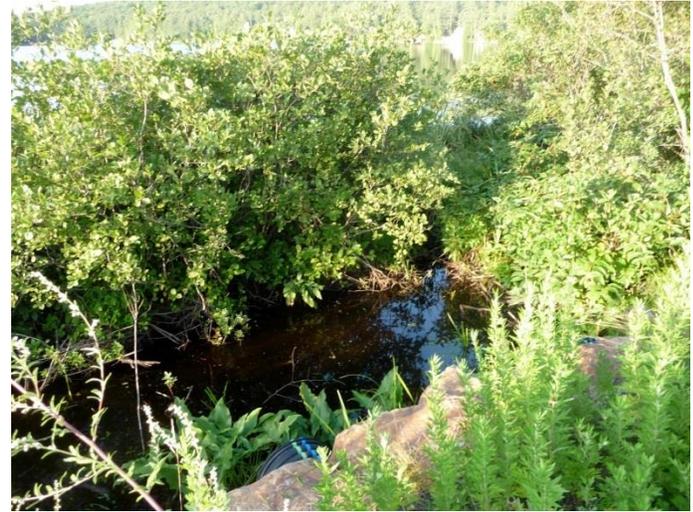
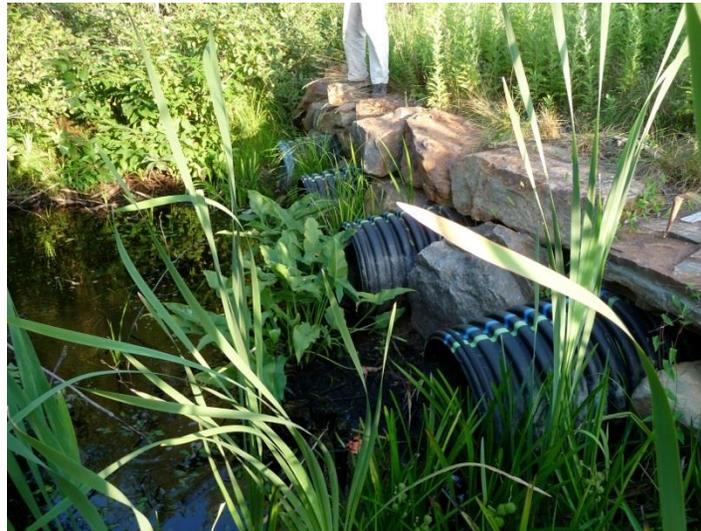
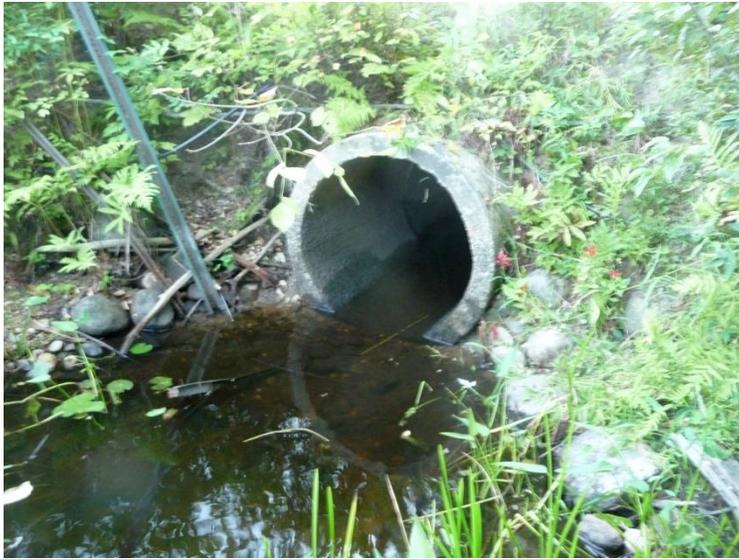
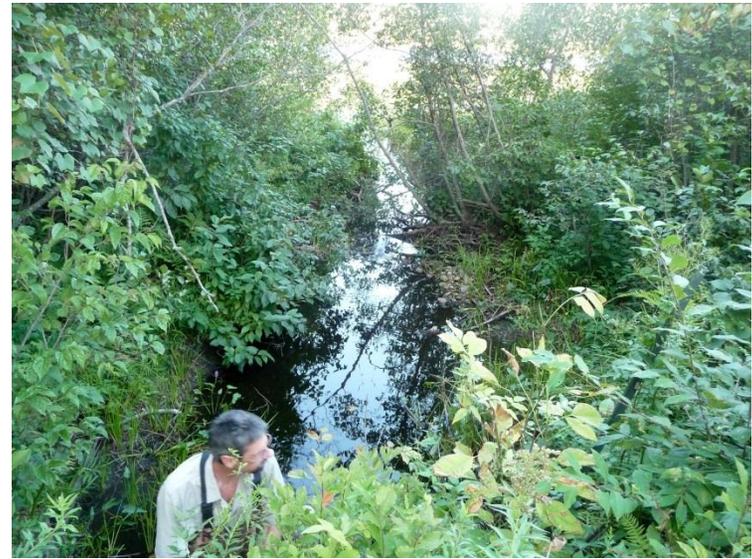
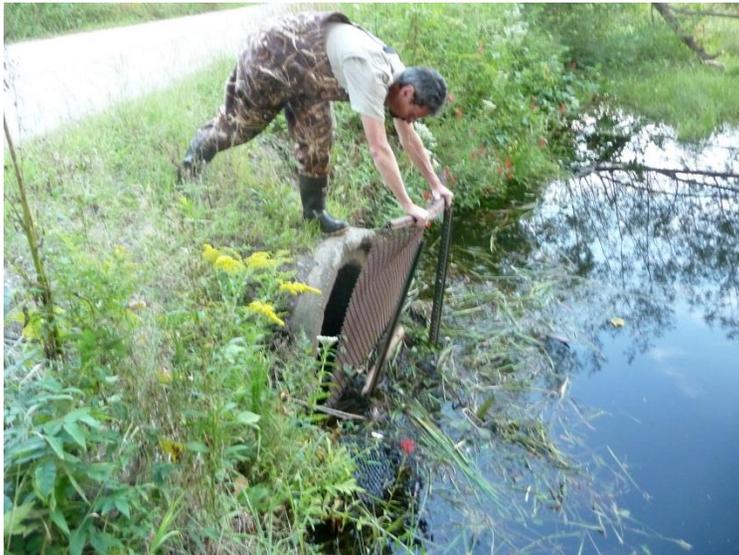
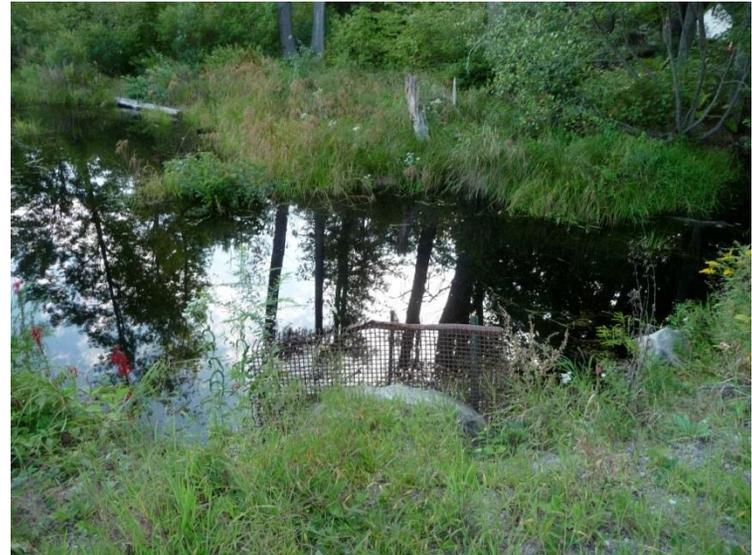
Hardy Spring Brook Tributary under Camp Merrimac Road (HSB9)

AQUATIC ORGANISM PASSAGE CONDITION: GOOD

The submerged condition of most inverts (pipe bottoms) suggests fish can pass through the culverts. The road is not heavily traveled so wildlife can presumably cross the road unimpeded.

RECOMMENDATION: NO ACTION AT THIS TIME

When replacement of the structures is warranted in the future, particularly if the road becomes more heavily traveled, ways to accommodate wildlife under the road could be considered.

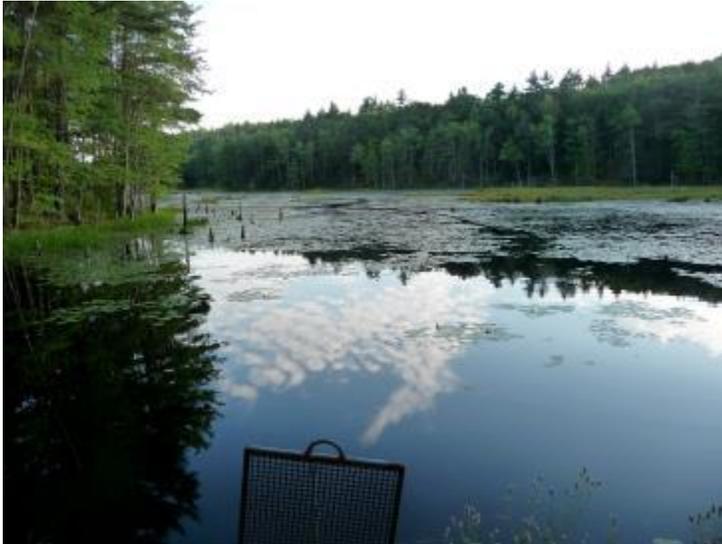
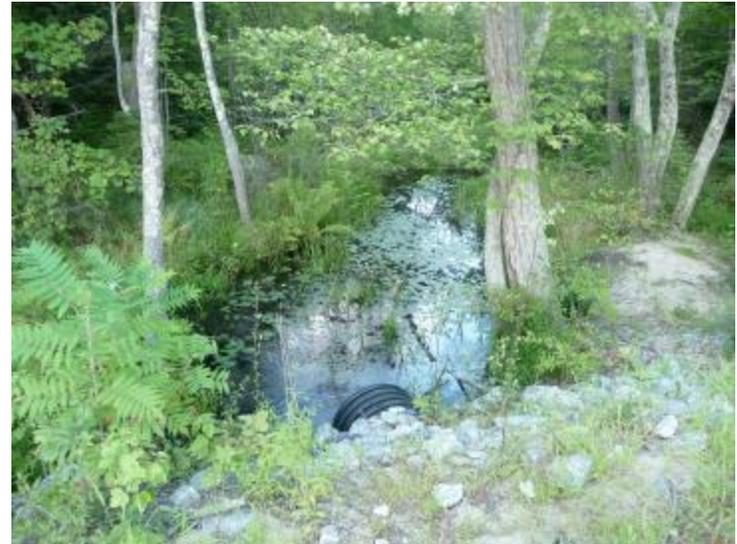
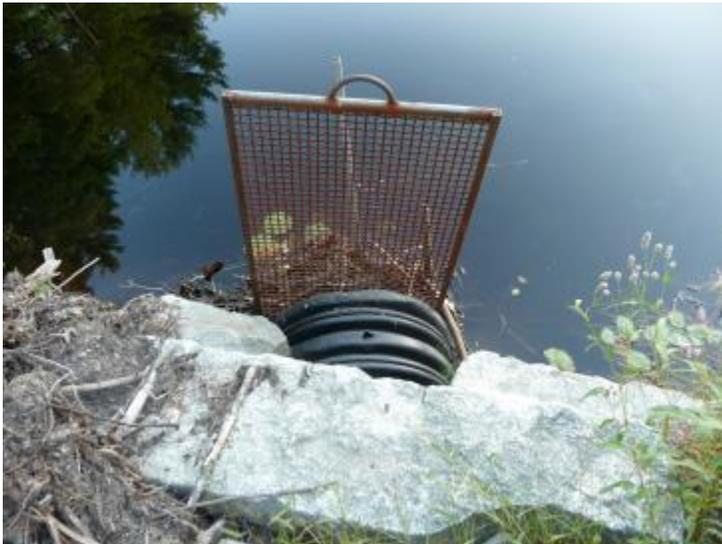
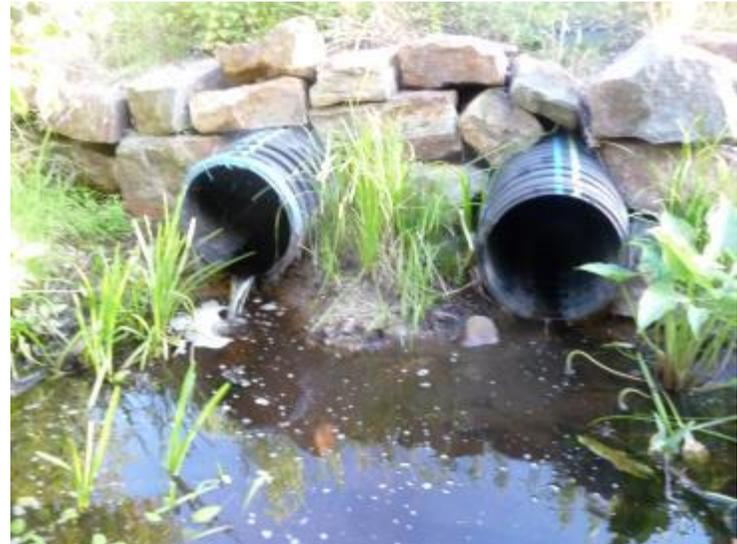
Hardy Spring Brook Tributary under Pine Street (HSB10)

AQUATIC ORGANISM PASSAGE CONDITION: POOR

The perched condition of the outlets prevents most if not all aquatic species from passing through the structures.

RECOMMENDATION: NO ACTION AT THIS TIME

When replacement of the structures is warranted in the future, ways to accommodate fish and wildlife under the road should be considered, but it may be difficult to improve on the existing structure.

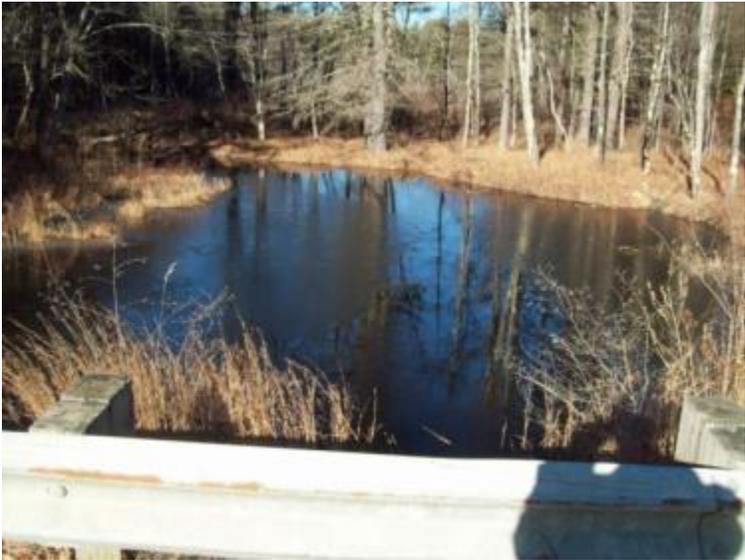
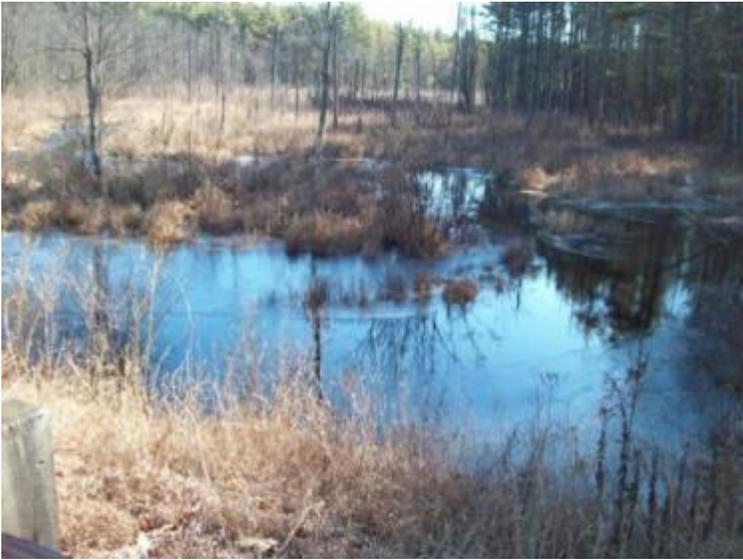
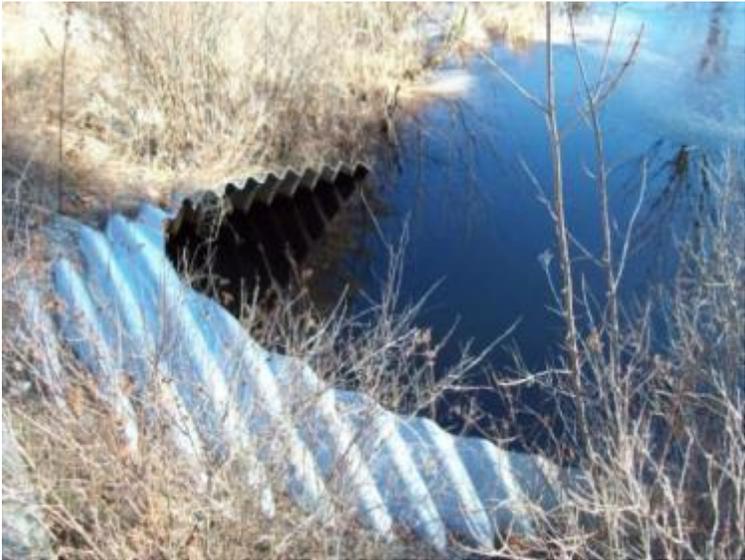
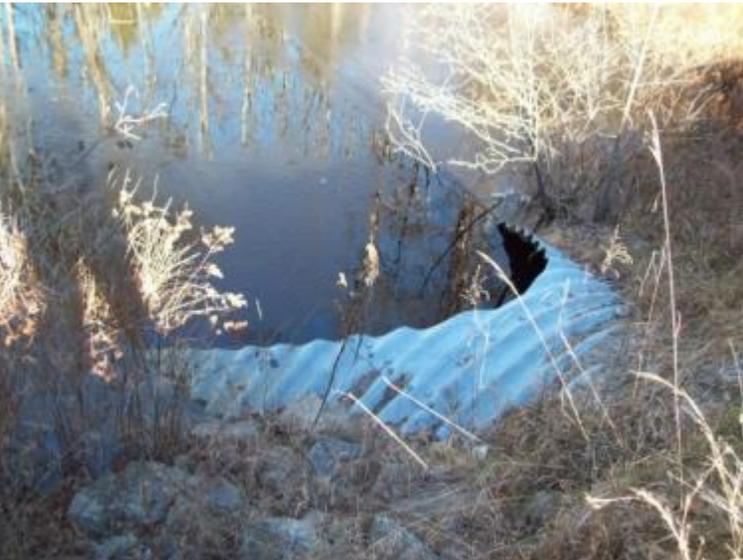
Dolf Brook under Broad Cove Road (DB1)

AQUATIC ORGANISM PASSAGE CONDITION: GOOD

RECOMMENDATION: NO ACTION

No improvements for aquatic organism passage are recommended at this time.

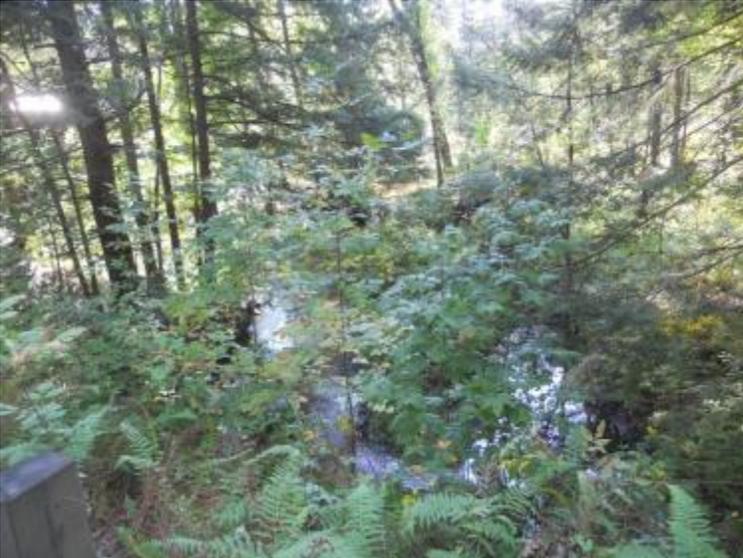
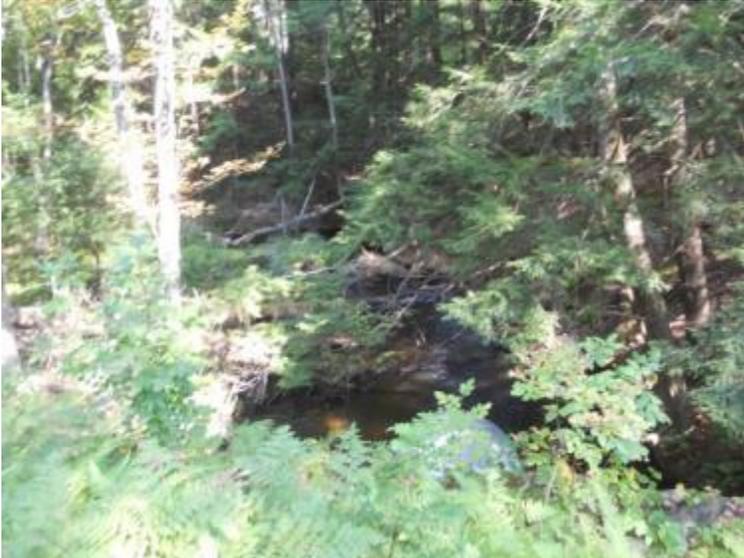
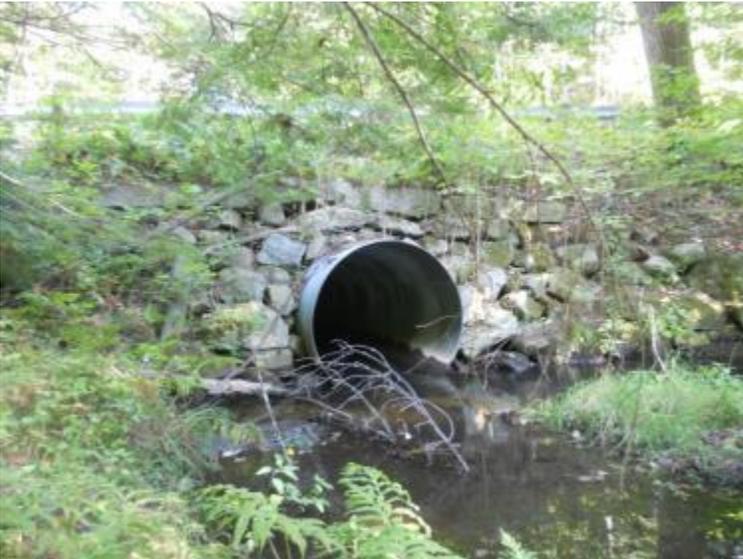
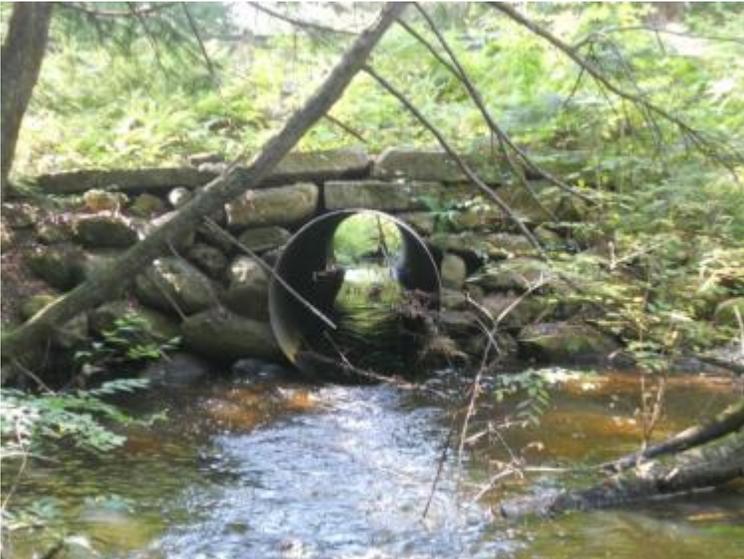
Dolf Brook under Briar Hill Road #3 (DB4)

AQUATIC ORGANISM PASSAGE CONDITION: POOR

The culvert has high potential but is currently in poor condition for aquatic organism passage.

RECOMMENDATION: REPLACE (NEAR TERM)

A larger structure should be installed at stream grade.

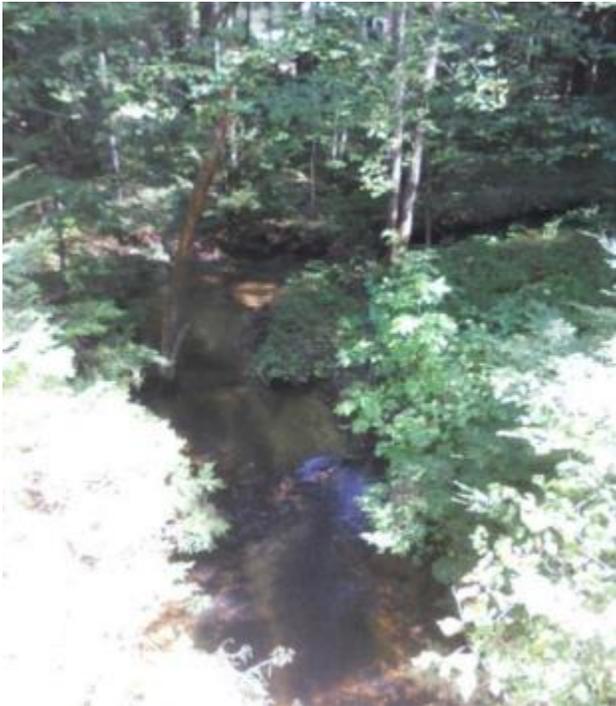
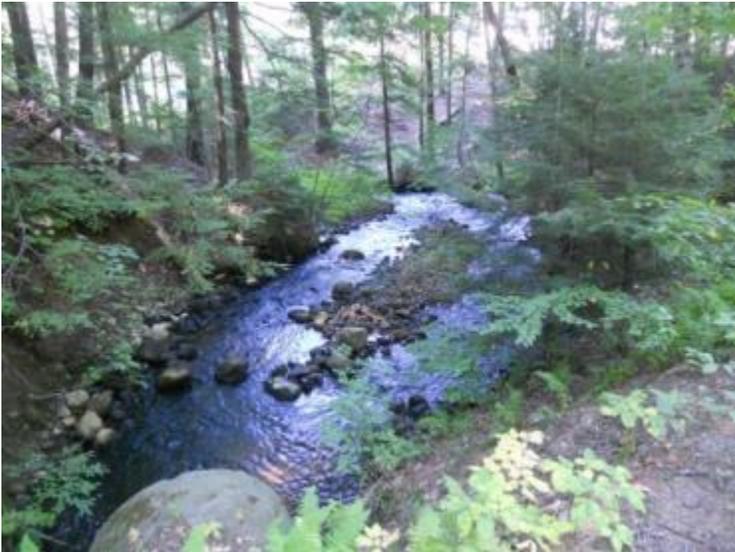
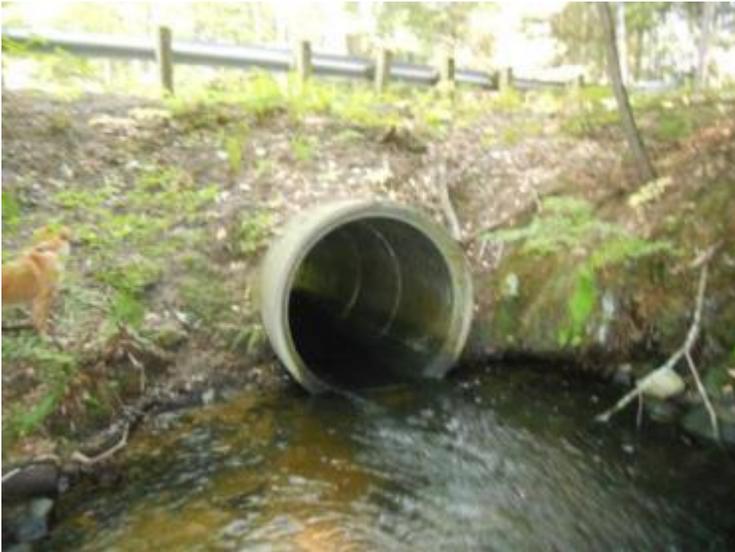
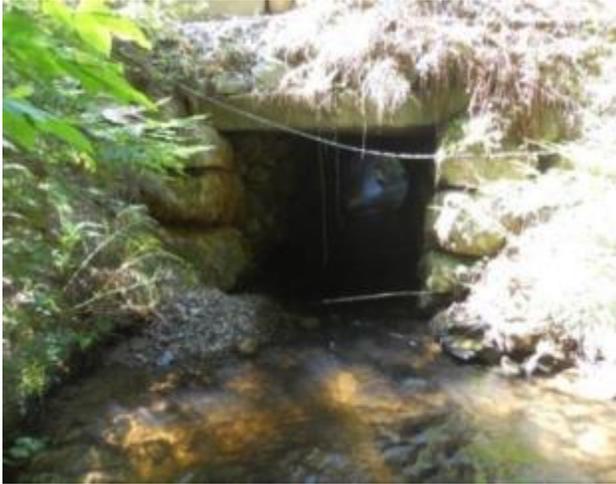
Dolf Brook under Briar Hill Road #4 (DB5)

AQUATIC ORGANISM PASSAGE CONDITION: POOR

RECOMMENDATION: REPLACE (LONG TERM)

A larger structure should be installed at stream grade when the structure is due for replacement.

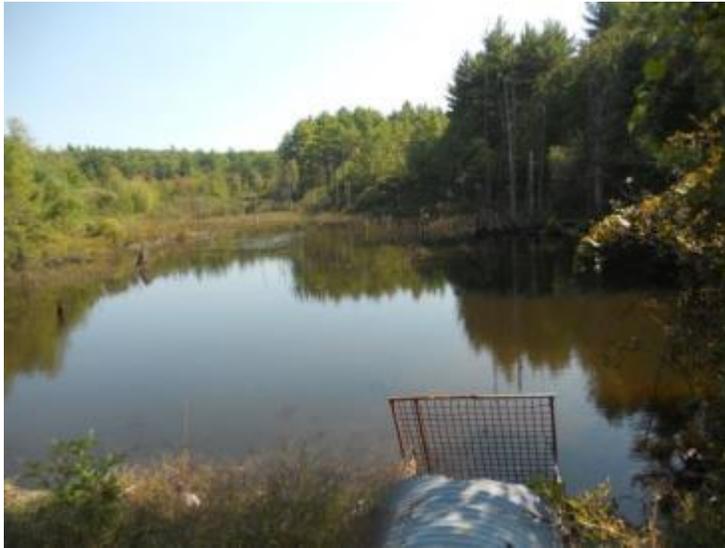
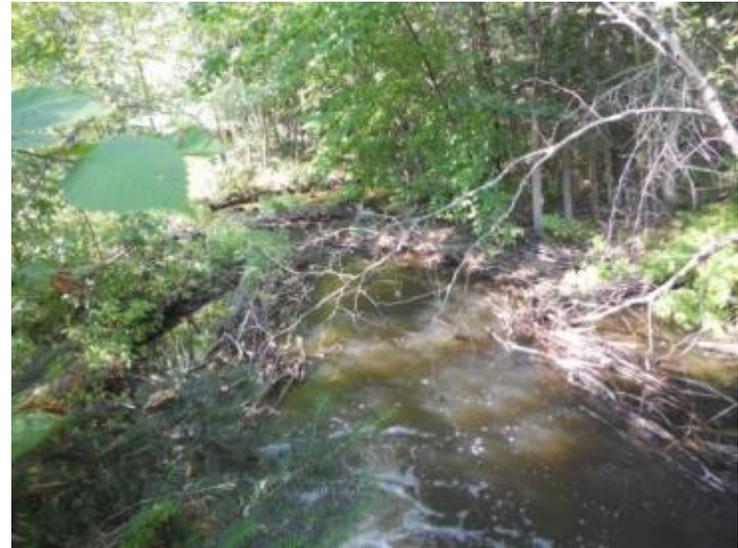
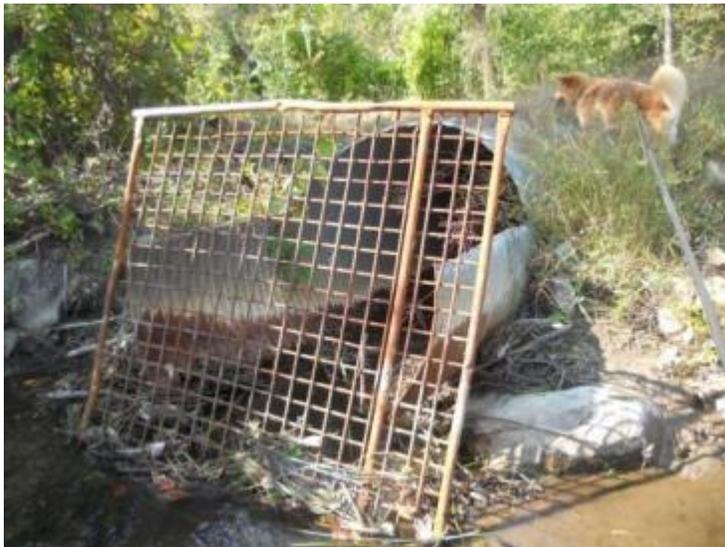
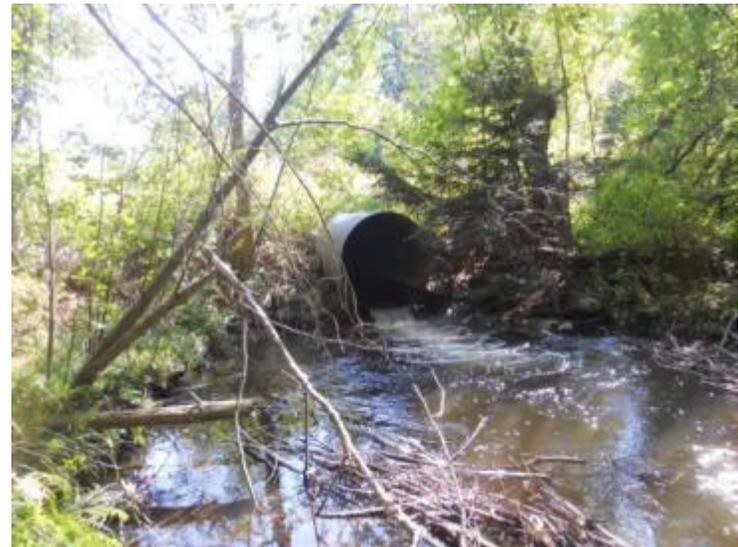
Dolf Brook under Rollins Road (DB6)

AQUATIC ORGANISM PASSAGE CONDITION: POOR

RECOMMENDATION: REPLACE (LONG TERM)

A larger structure could be installed at stream grade when the structure is due for replacement, but any changes should take effects on the upstream ponded area into consideration.

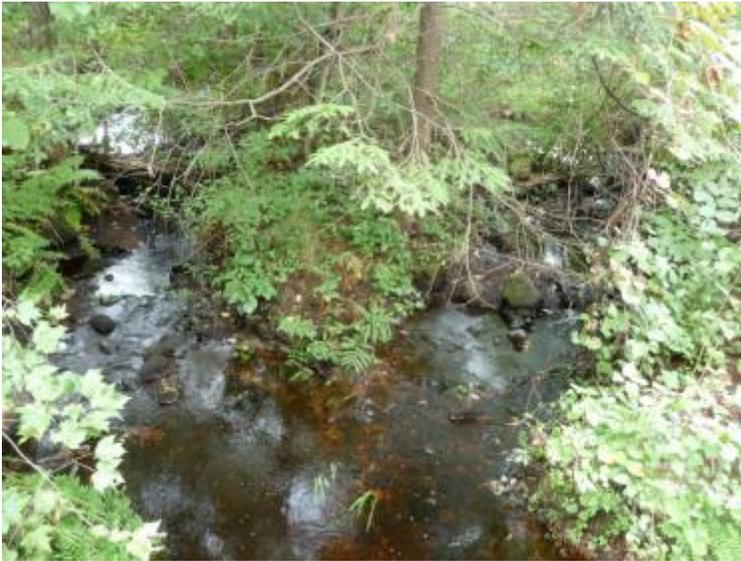
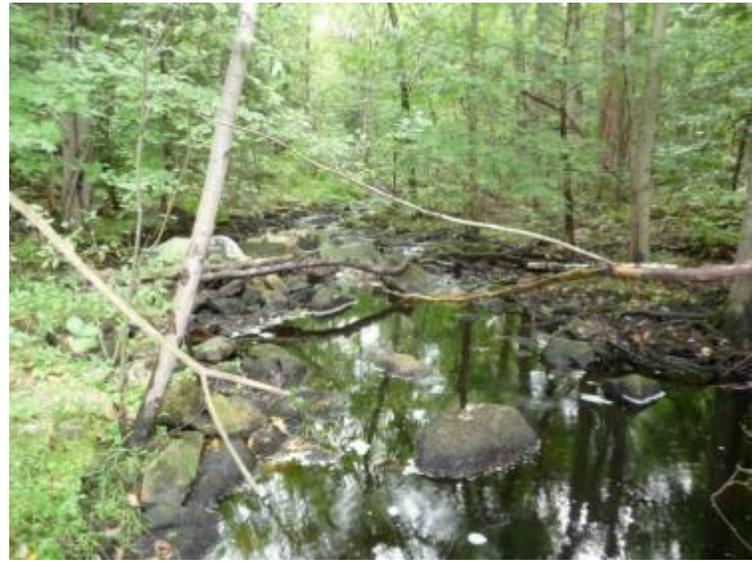
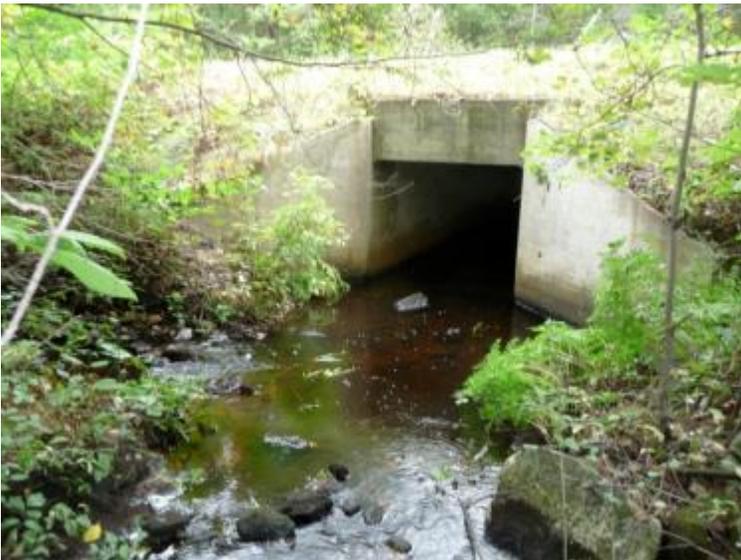
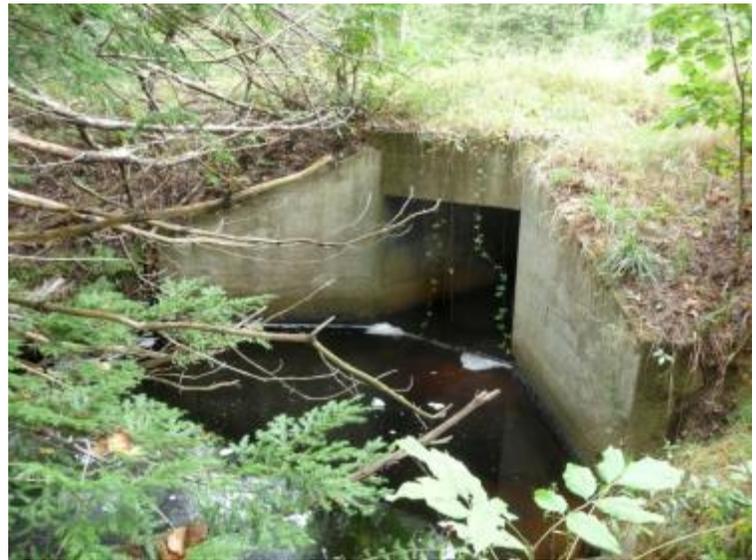
One Stack Brook under Jewett Road (OSB)

AQUATIC ORGANISM PASSAGE CONDITION: POOR

RECOMMENDATION: REPLACE (NEAR TERM)

A larger structure should be installed at stream grade as opportunities arise.

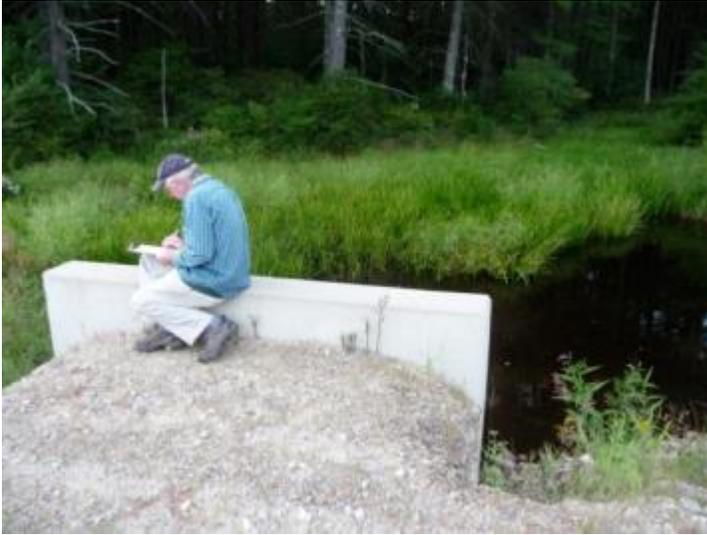
Boutwell Mill Brook under Hooksett Turnpike (BMB1)

This concrete box culvert is a new structure that is 8 feet wide by 4 feet tall and approximately 35 feet long. It is under Hooksett Turnpike a short way downstream of the culvert under Stickney Road (BMB2). The structure is in new condition, is in line with the stream channel, and matches the stream slope and depth. It has a sand substrate. There is a small amount of erosion upstream, and a pool and aggradation (sediment deposition) downstream.

AQUATIC ORGANISM PASSAGE CONDITION: EXCELLENT

There is no impediment to aquatic organism passage, although the crossing was not observed in unusually low water conditions.

RECOMMENDATION: NO ACTION

No action is recommended except for maintenance of existing conditions.
