TOWN OF HOPKINTON

CULVERT ASSESSMENT FOR

AQUATIC ORGANISM PASSAGE

HOPKINTON CONSERVATION COMMISSION

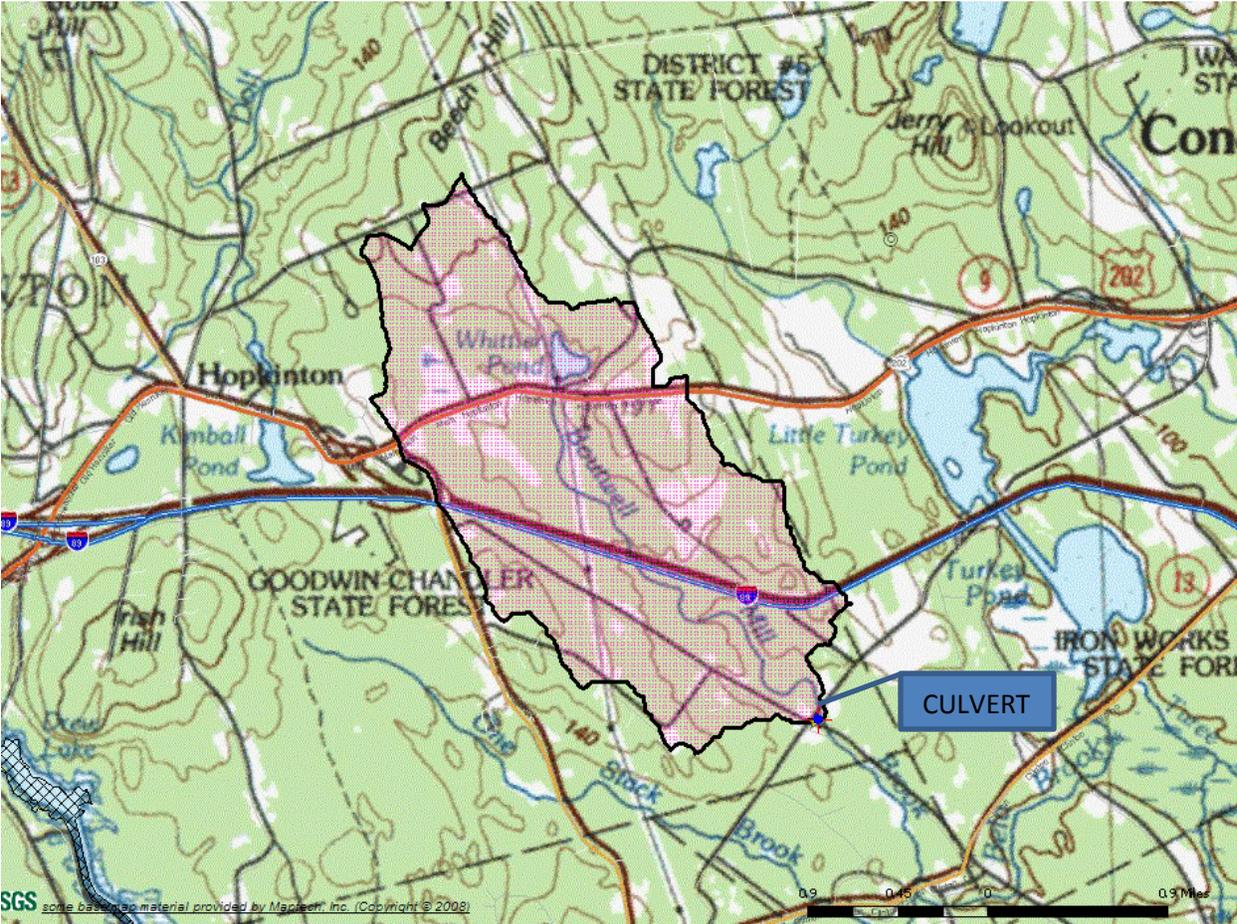
Boutwell Mill Brook under Stickney Road (BMB2)

This corrugated metal pipe is 10 feet wide by 7.5 feet high and approximately 70 feet long. It is under Stickney Road a short way upstream of the culvert under Hooksett Turnpike. The structure appears to be in good condition and has a sand and gravel substrate. It is in line with the stream channel and matches the stream slope and depth. There is some bank undercutting upstream and some sediment deposition downstream.

There is no impediment to aquatic organism passage, although the crossing was not observed in unusually low water conditions.

No action is recommended except for maintenance of existing conditions.
