# The Houston Barn Committee Report

**December 20, 2021**

**Houston Barn Committee**  
**Report to the Hopkinton Select Board**  
**December 20, 2021**

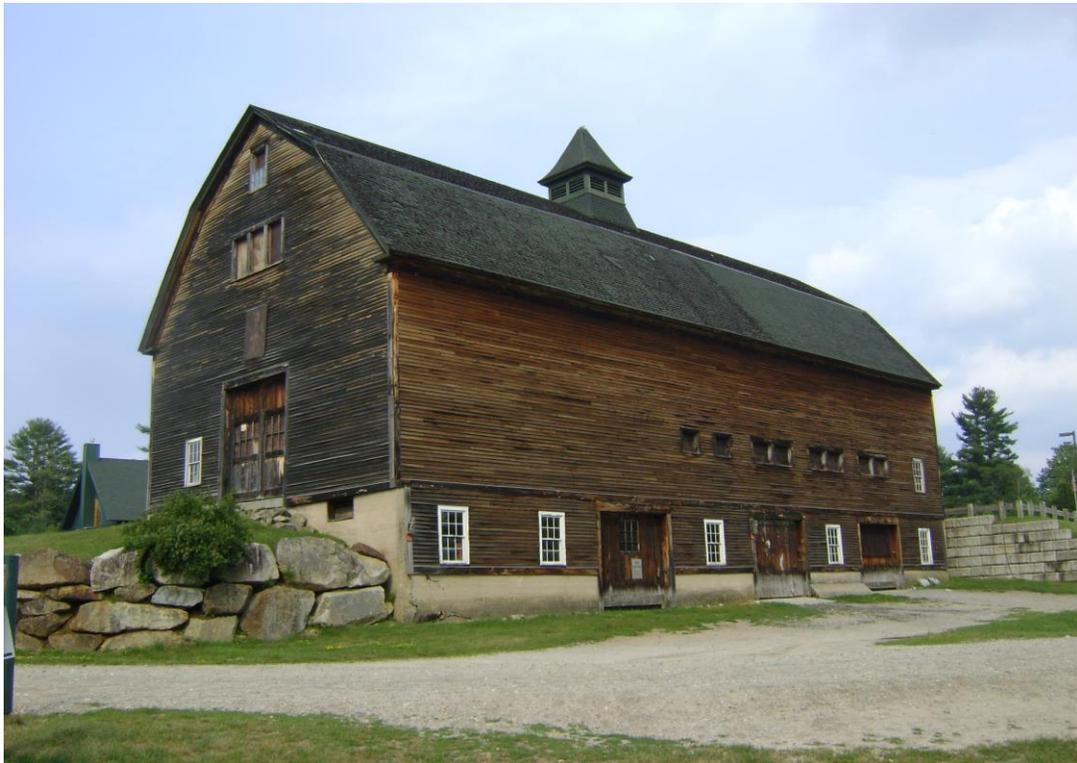
*Photo #22 - Houston Barn, viewed from southwest. August 2021*

The townspeople of Hopkinton-Contoocook have the good fortune of owning a building that was well designed and substantially constructed, which remains strong despite some current disrepair. They have chosen to protect it for over two decades already. While this report lists deficits, it can be said that the Houston Barn also retains many positive strengths and attributes.
