DEPARTMENT OF ENVIRONMENTAL SERVICES

RE: Unregistered Dams at Hopkinton/Webster Transfer Station

Based upon the results of the October 6, 2021 inspection, NHDES has determined that in its present configuration, the Hopkinton/Webster Transfer Station facility includes three separate and distinct jurisdictional dams as identified on the attached aerial image of the property. Therefore, you are required to submit an Application to Register an Existing Dam for each dam in accordance with the requirements of RSA 482:5. Other applicable statutes and rules have been reproduced below, as well as NHDES Dam Bureau's findings relative to present hazard classification and a preliminary condition assessment of each.

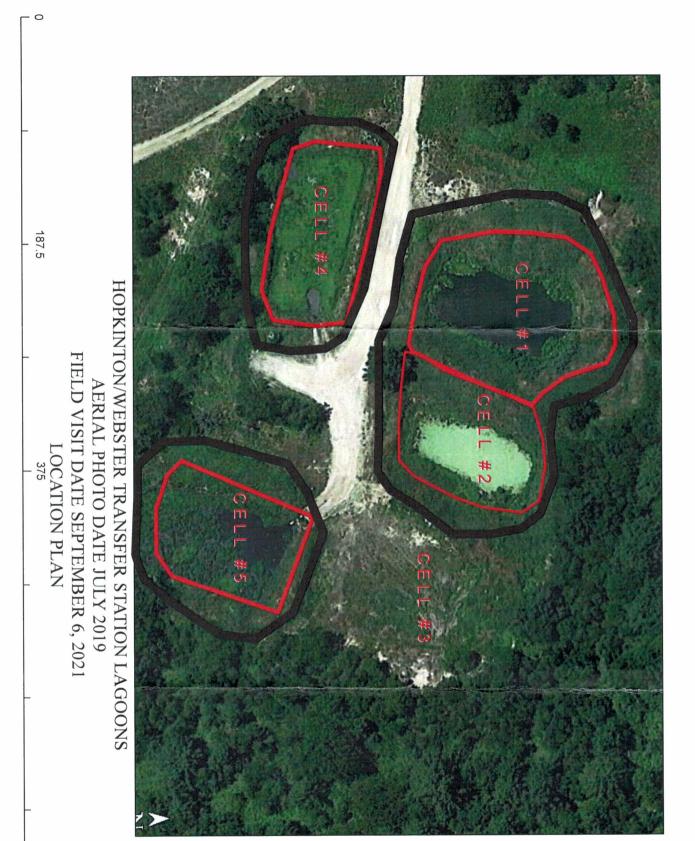
D121038, Transfer Station Lagoons Dam, Hopkinton: Inspected October 6, 2021

THE SURROUNDING TO NOT **SEPTEMBER ALIGNMENTS EMBANKMENT APPROXIMATE** NOTES: JURISDICTIONAL **APPROXIMATE EMBANKMENTS** 2. CELL #3 WAS **OBSERVED** INDICATE 1. THE RED LINES INDICATE THE INSPECTION. AT THE TIME OF LIMITS OF EACH LINE DELINEATES THE BLACK **OBSERVED** HAVE 6, 0N

- The embankments of the lagoons were observed to be steeper than 2.5H:1V, of inconsistent crest width and elevation, and showed some signs of surface sloughing/instability; and
- Vegetative growth on and adjacent to the lagoons has been poorly maintained.
